Report No. FHWA-RD-78-162

COUNTERMEASURES FOR HYDRAULIC PROBLEMS AT BRIDGES

Vol. I Analysis and Assessment

September 1978
Final Report

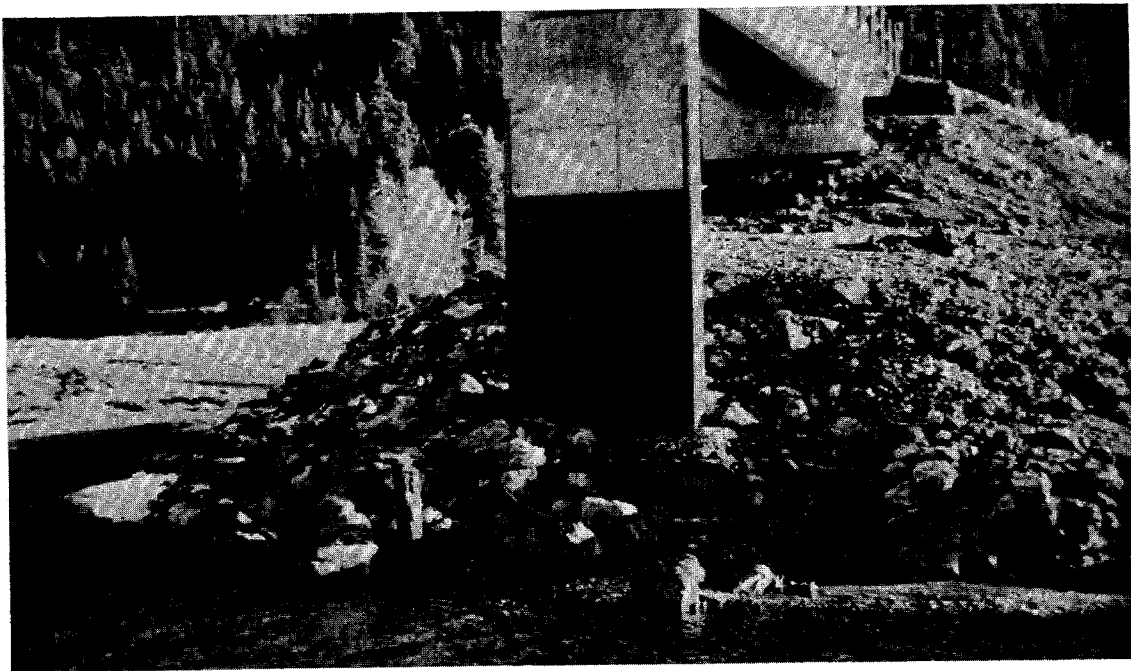
Each of the other causes for riprap failure is represented by only one site, and no generalizations about the causes are warranted from the case histories. Riprap that contains a high percentage of fine material, even if it also contains large stones, is liable to failure because of the washing out of the fines (fig. 7). Rounded stones, either from streambeds or from glacial drift, are widely used for riprap in regions where they are readily available (North Dakota, Saskatchewan, Montana). Although these are less desirable than angular stone, they are nevertheless effective (see, for example, Sites 250 and 260). Rounded stones less than 5 in (127 mm) in diameter have a significantly lower angle of repose than angular stones, but the angle of repose is not significantly different from larger diameters (see Simons and Senturk, 1977, fig. 7.16, p. 442).

Figure 7. Erosion of dumped rock riprap having a high percentage of fine-grained material. (North Fork Skokomish River, Wash., Site 267.)

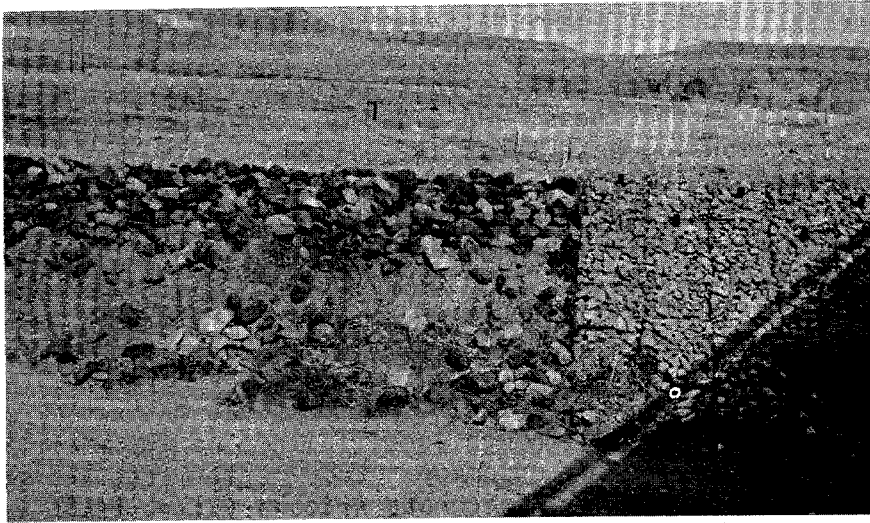
Figure 8. Dumped rock riprap, left, failed because of inadequate toe protection. Rock-and-wire mattress, right, remained intact despite inadequate toe protection. (Whalen Draw east of Guernsey, Wyo.; photograph from Wyoming Dept. of Transportation.)

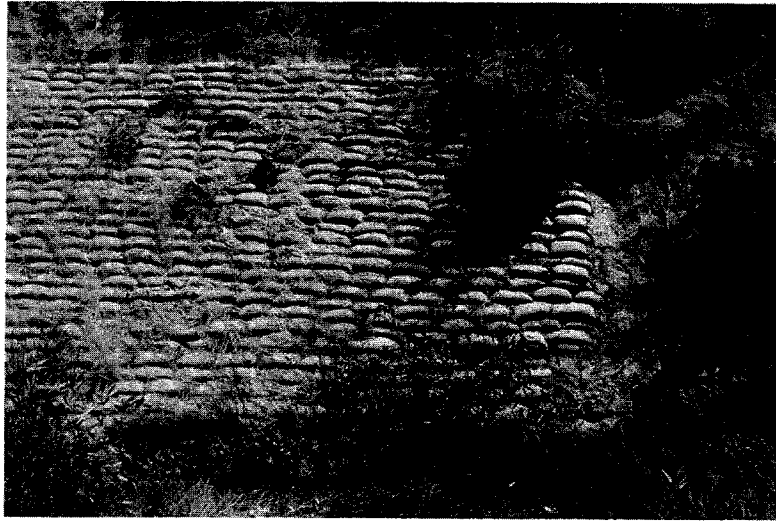
Figure 9. Sacked-concrete revetment, slightly undercut at upstream (right) end. (Stevens Creek, Calif., at SR-85.)

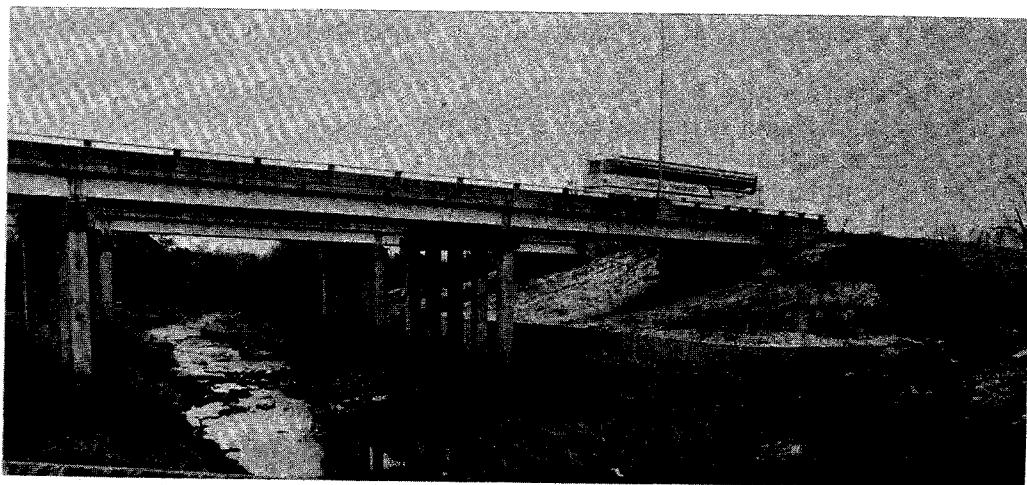
Figure 12. Use of steel sheet-pile bulkhead as a countermeasure for slumping of abutment fill-slope. (North Branch Ward Creek, La., Site 199.)

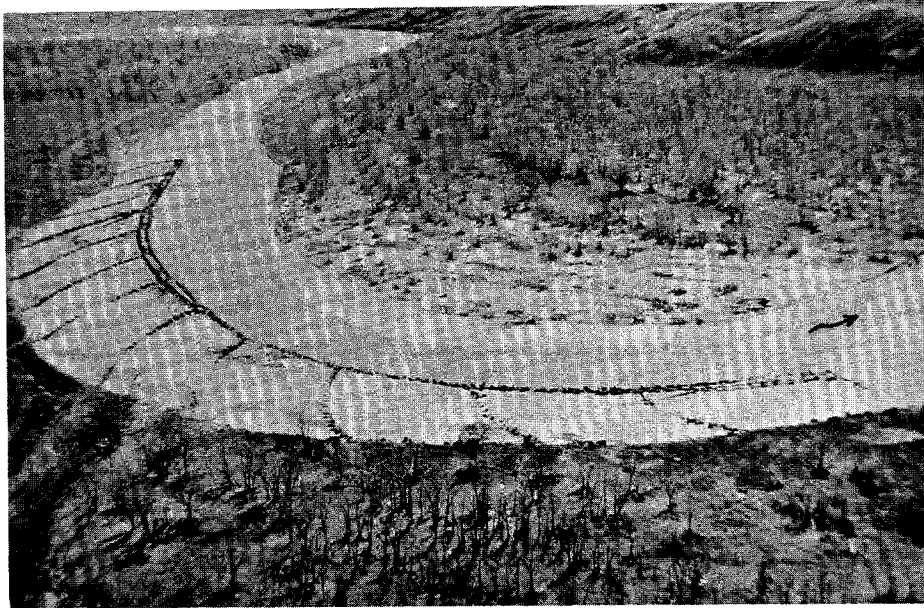
Figure 25. Steel-jack field at outside of meander. Sediment has accumulated at jacks, and performance of jacks in controlling bank erosion is good. (Cheyenne River near Creston, S. Dak.; photograph from South Dakota Dept. of Transportation.)

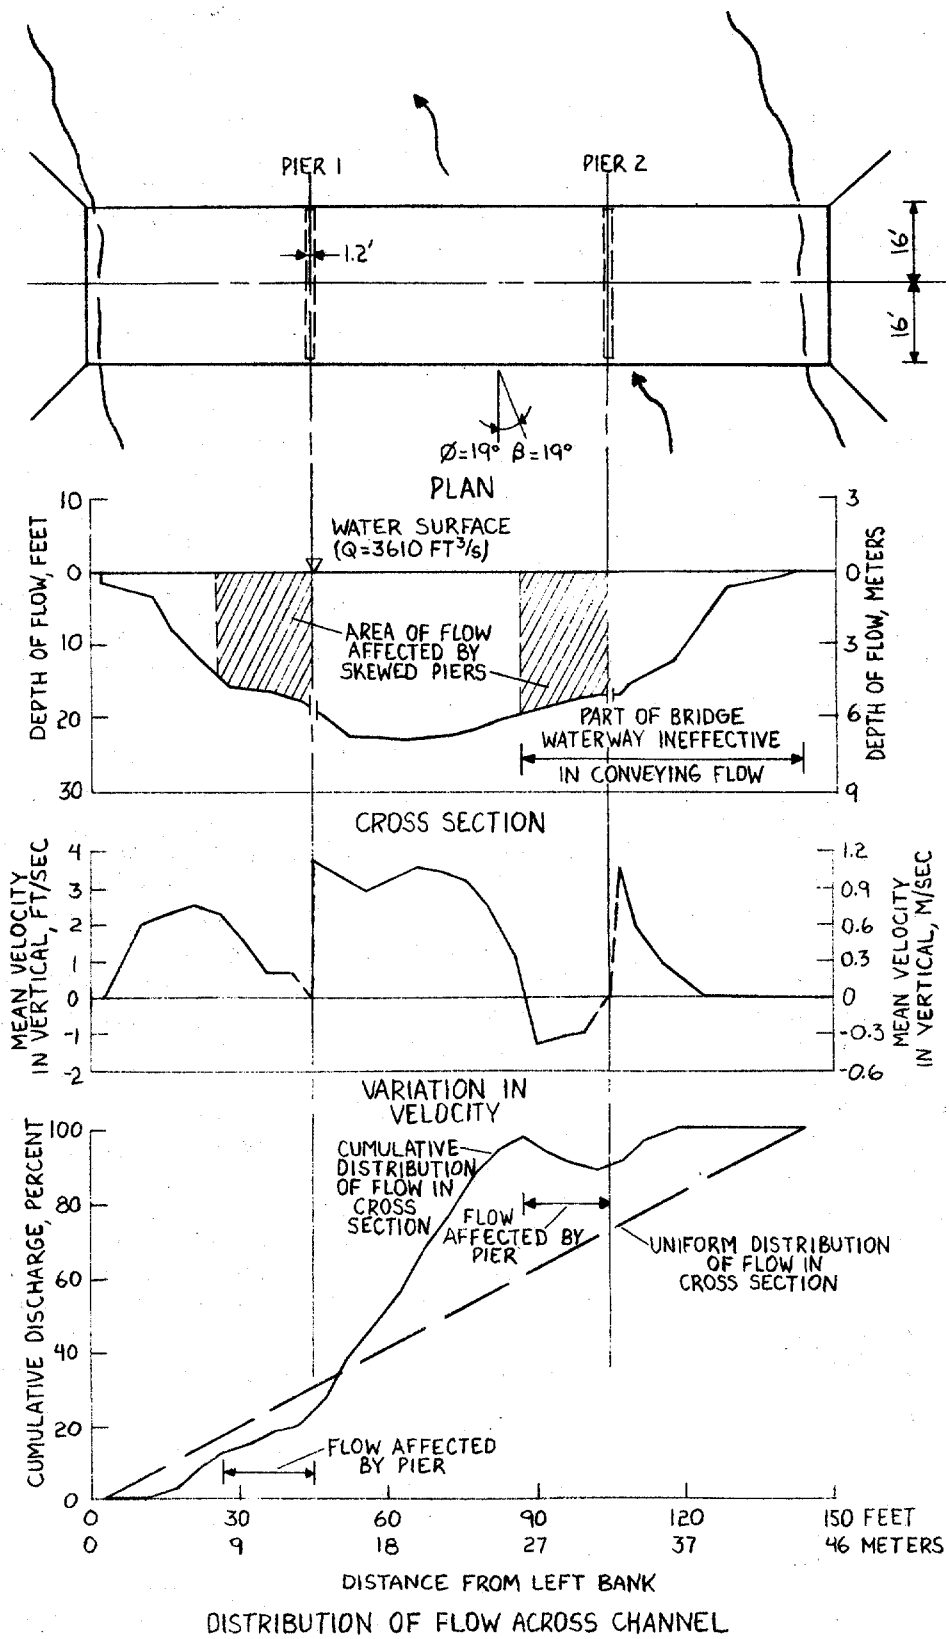
Figure 45. Effect of skewed wall-type piers on flow at downstream side of bridge, Butte Creek at Gridley-Colusa road crossing near Gridley, Calif.

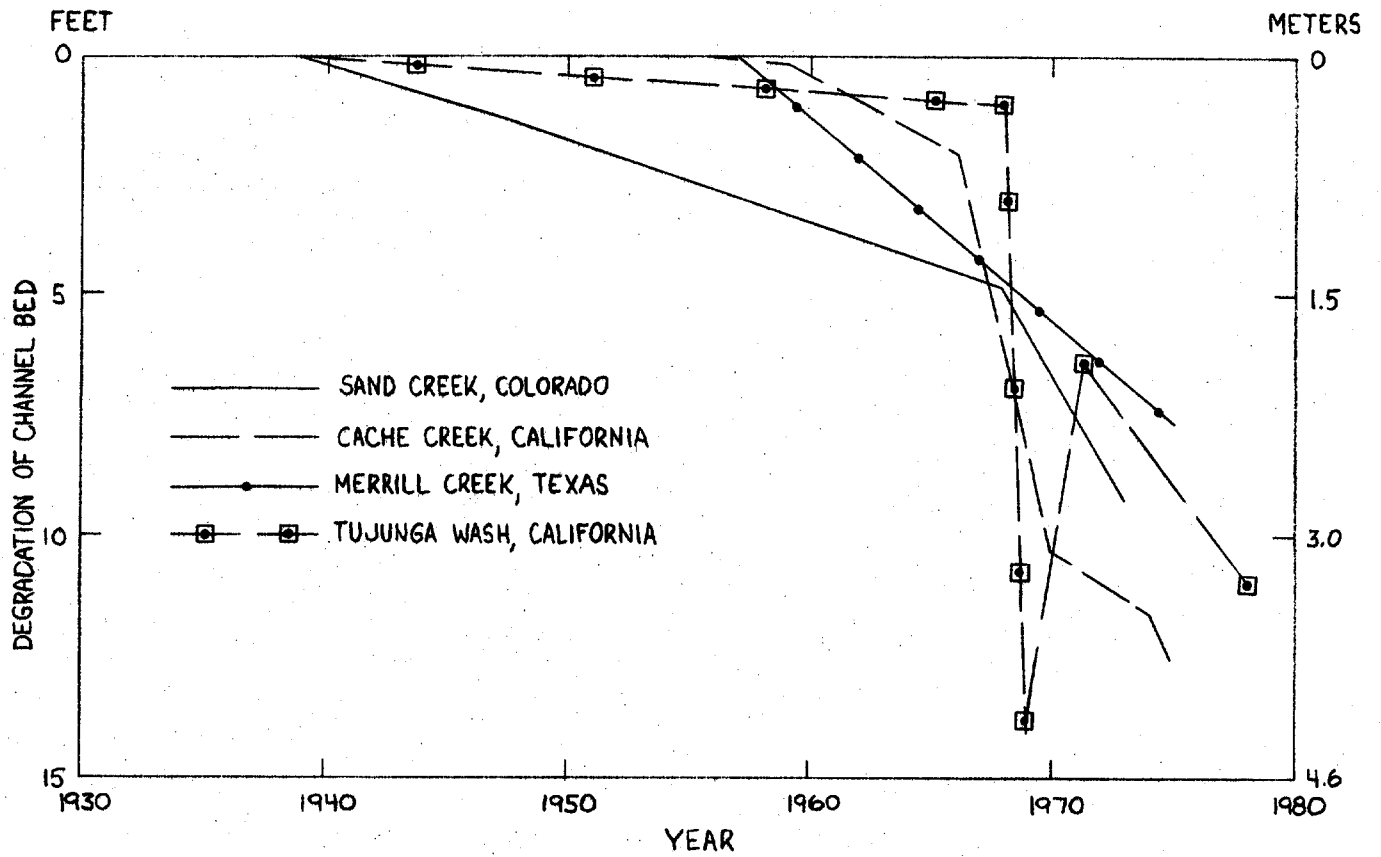
Figure 48. Channel degradation at four bridge sites, attributed to the works of man.
