**Federal Building and Fire Safety Investigation of the  
World Trade Center Disaster**

**Final Report of the  
National Construction Safety Team  
on the Collapses of the  
World Trade Center Towers (Draft)**

September 2005

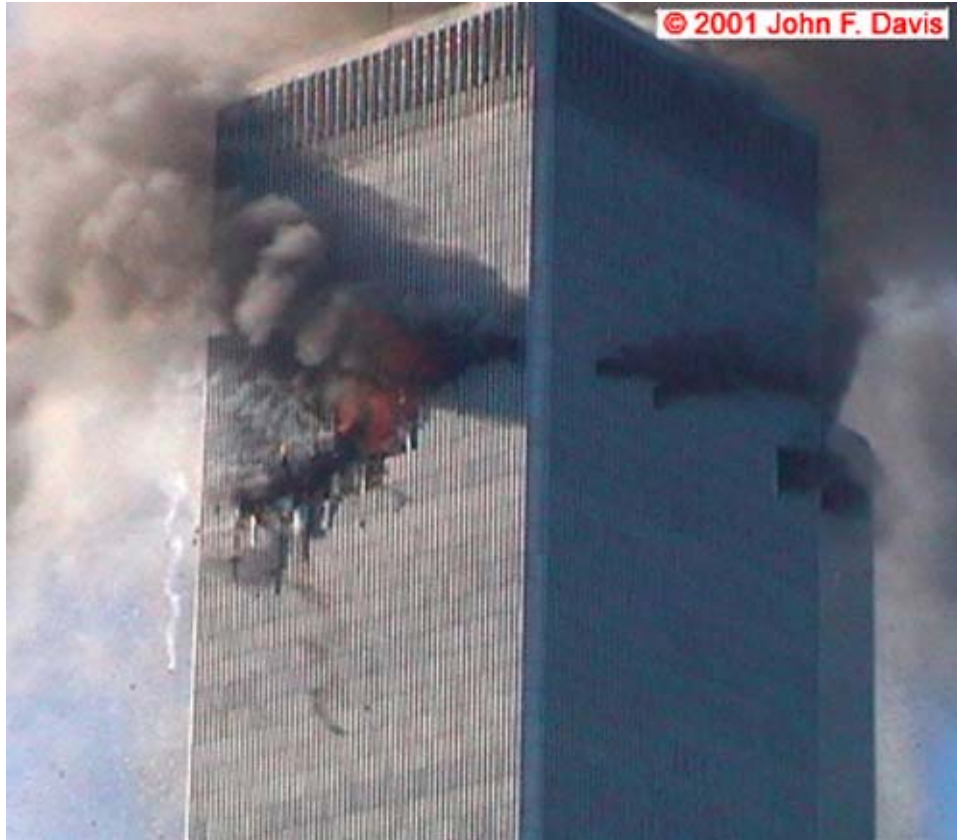
**Figure 2–2. Aircraft entry hole on the north side of WTC 1, photographed 30 s after impact.**

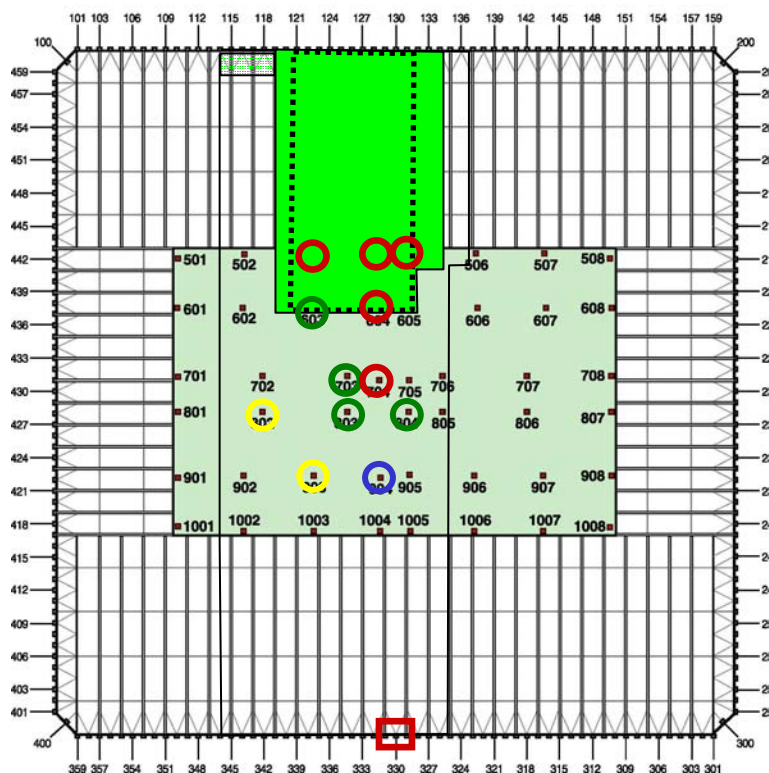
**Figure 2-4. Simulation of aircraft impact damage to the 96<sup>th</sup> floor in WTC 1.**

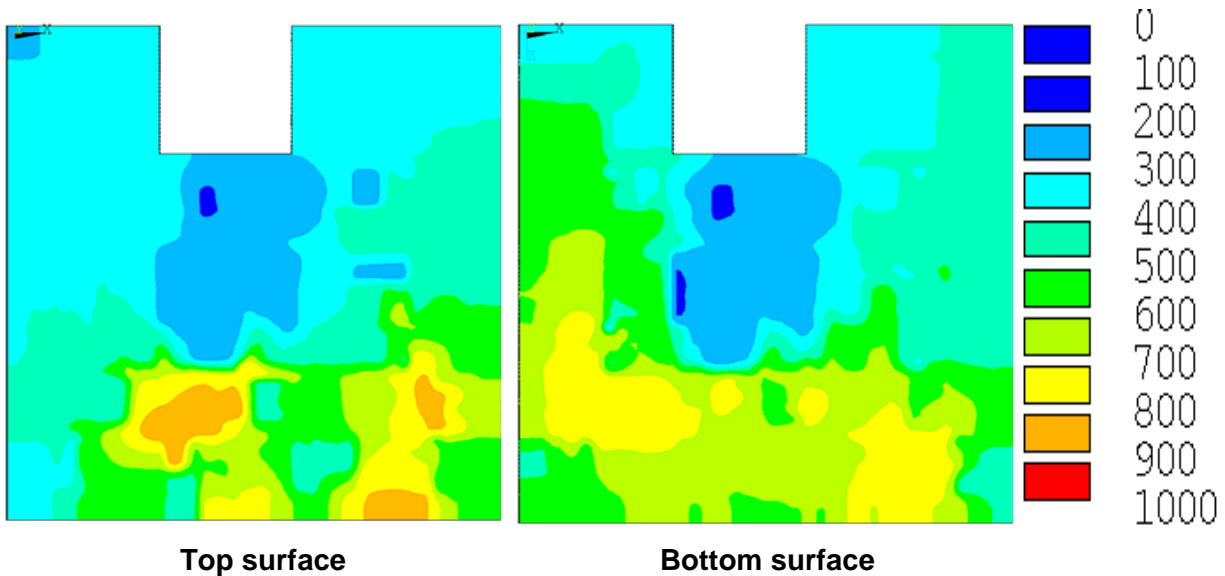
Simultaneously, the fires were creating another problem for the tower. The floors of the 93<sup>rd</sup> through the 97<sup>th</sup> stories were being heated both by the hot gases from below and by thermal radiation from the fires on the floor above (Figure 2–11). On the south side of the building, where the fires were heating the long-span trusses whose SFRM had been dislodged, the floors began to sag. In so doing, they began pulling inward on their connections to the south face and to the core columns. Pull-in forces due to the sagging floors did not fail the floor connections in most areas.

**Figure 2–11. Temperature contours on the top and bottom faces of the concrete slab (96<sup>th</sup> floor, WTC 1) at 100 min after impact. A portion of the concrete slab on the north face (top) was damaged by the impact of the aircraft.**

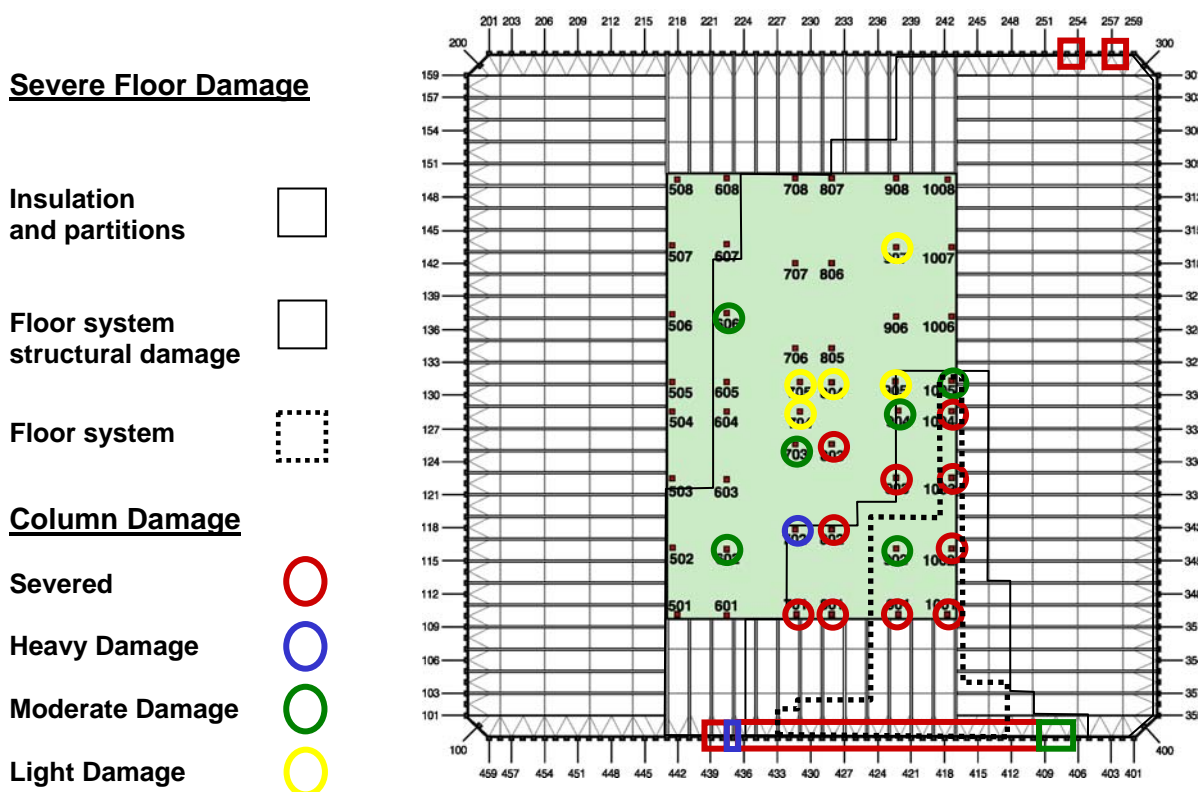
The bulk of the impact damage was confined to six floors. Figure 3–3 shows the combined damage. Floors 77, 84, and 85 were struck only by the outer extent of the wings. Empty of fuel, the light framing and aluminum sheet of the wing did little damage to the building structure or the SFRM on the columns and trusses on these floors. There were 433 broken windows on the north, east, and south facades.

**Figure 3–3. Simulation of aircraft impact damage to the 78<sup>th</sup> through 83<sup>rd</sup> floors in WTC 2.**

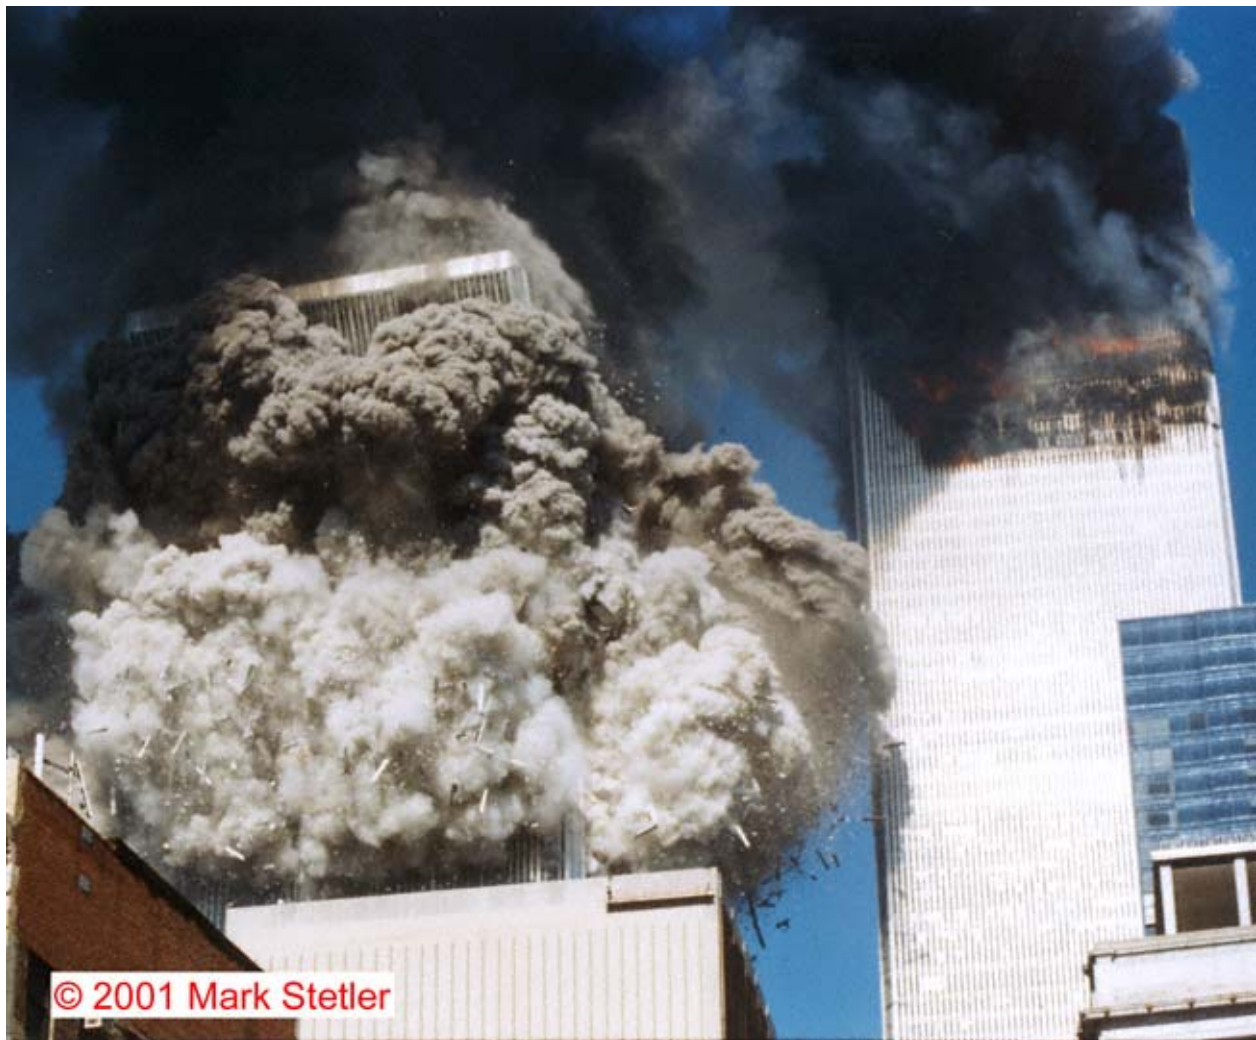
**Figure 3–5. Photograph of WTC 2 tilting to the southeast at the onset of collapse.**

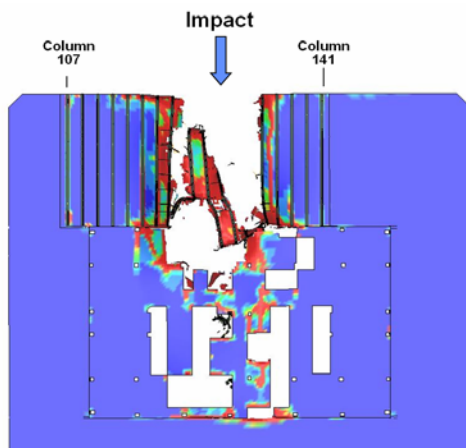
**Figure 6–20. Case B damage to the slab of floor 96 of WTC 1.**

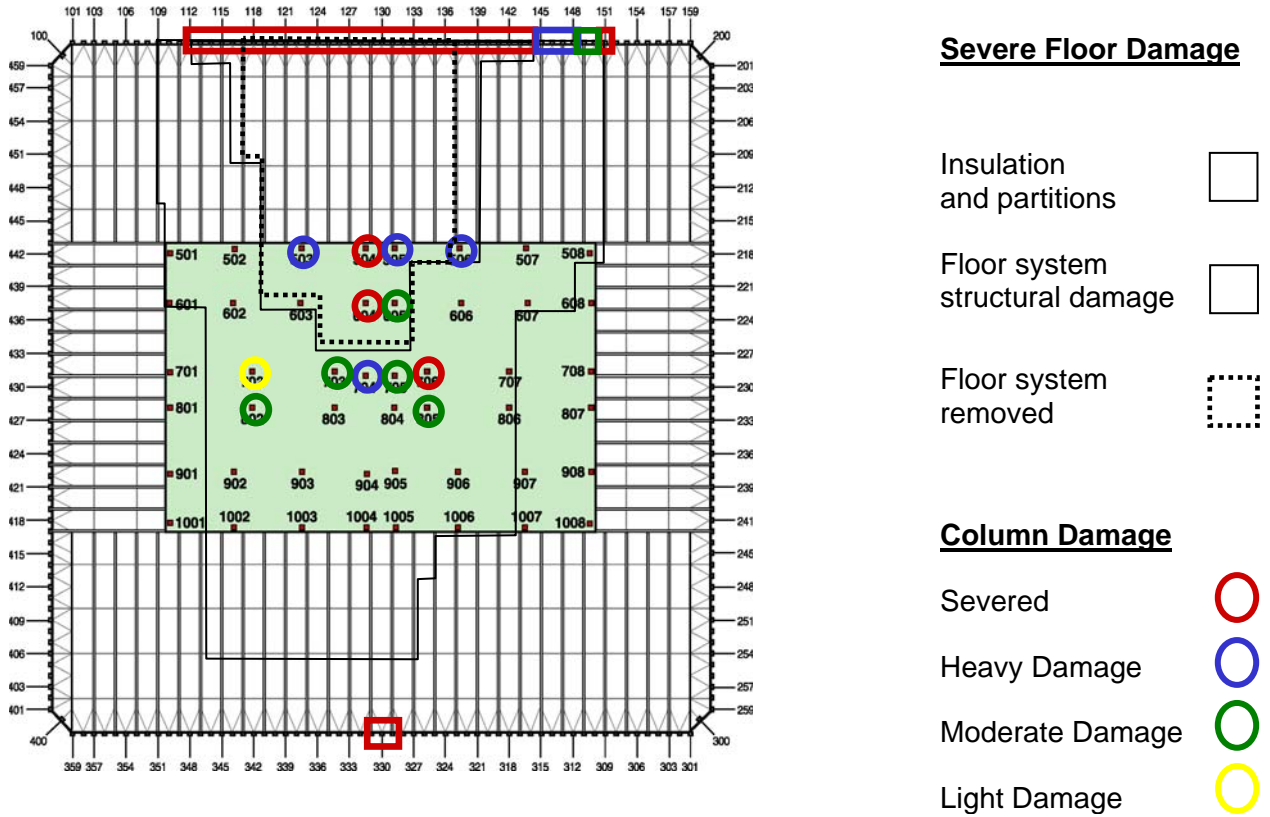
Figure 6-22. Combined structural damage to the floors and columns of WTC 1, Case A.

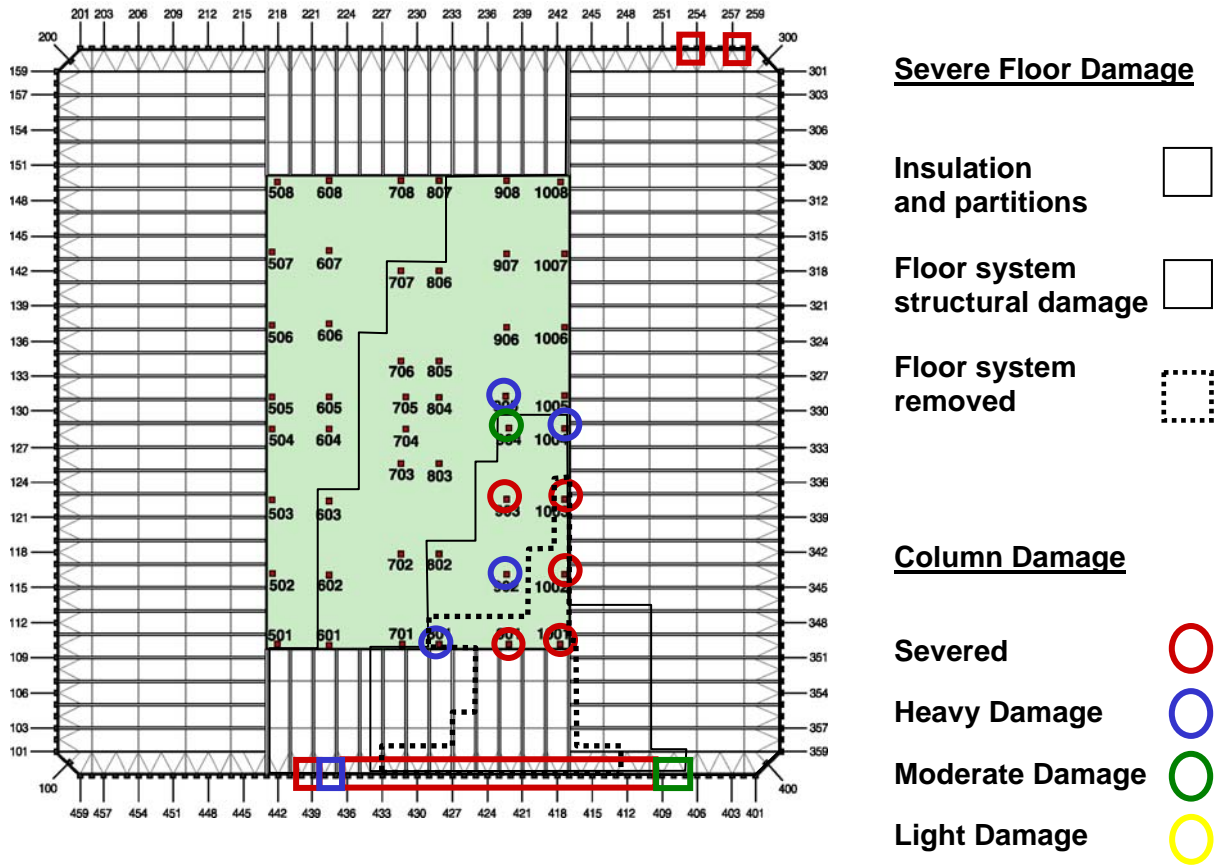
Figure 6-24. Combined structural damage to the floors and columns of WTC 2, Case C.

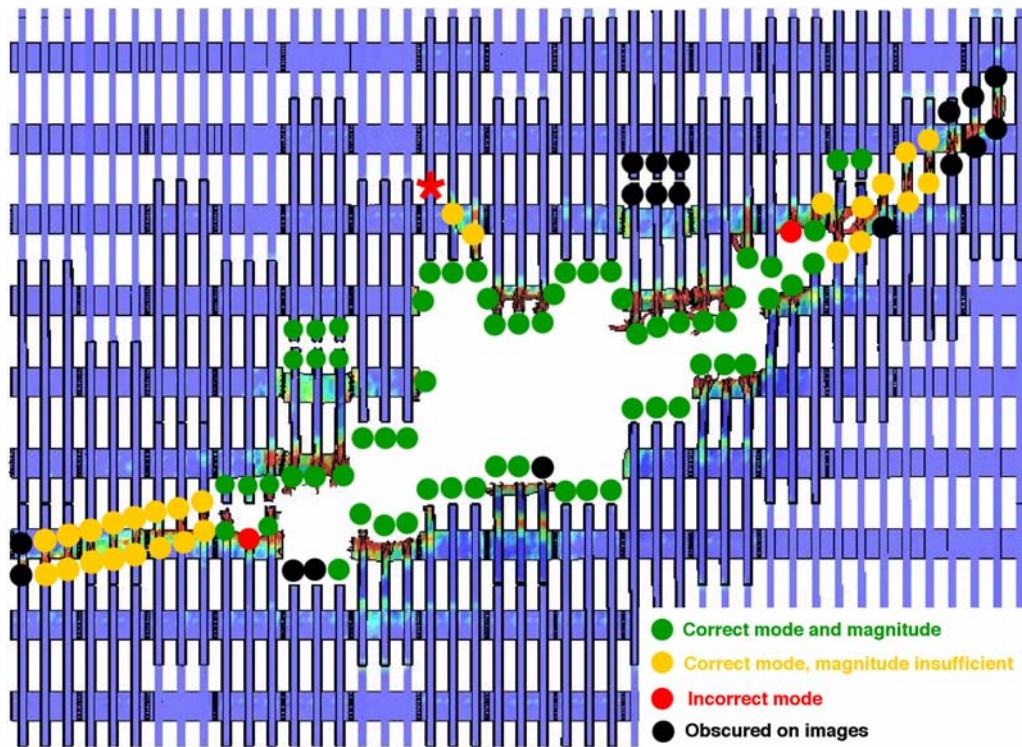
Figure 6–27. Schematic of observed damage (top) and Case A calculated damage (lower) to the north face of WTC 1.

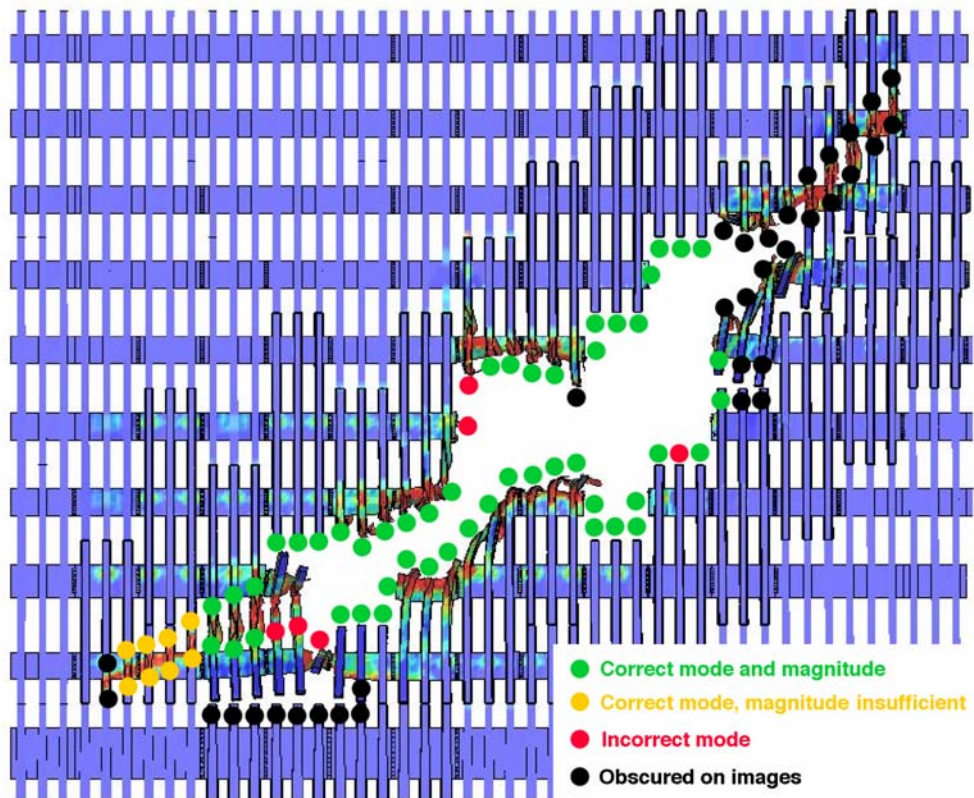
Figure 6–28. Schematic of observed damage (above) and Case C calculated damage (right) to the south face of WTC 2.

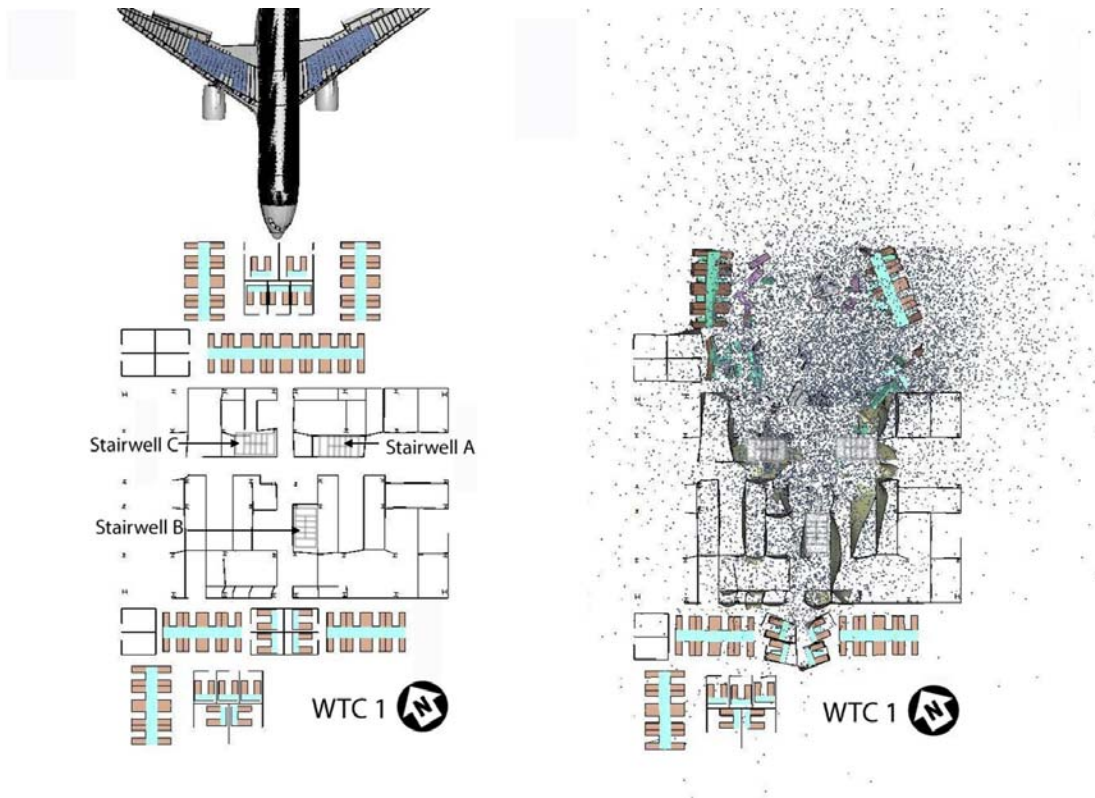
**Figure 7-1. Simulated impact damage to 95<sup>th</sup> floor of WTC 1, including stairwells, 0.7 s after impact.**

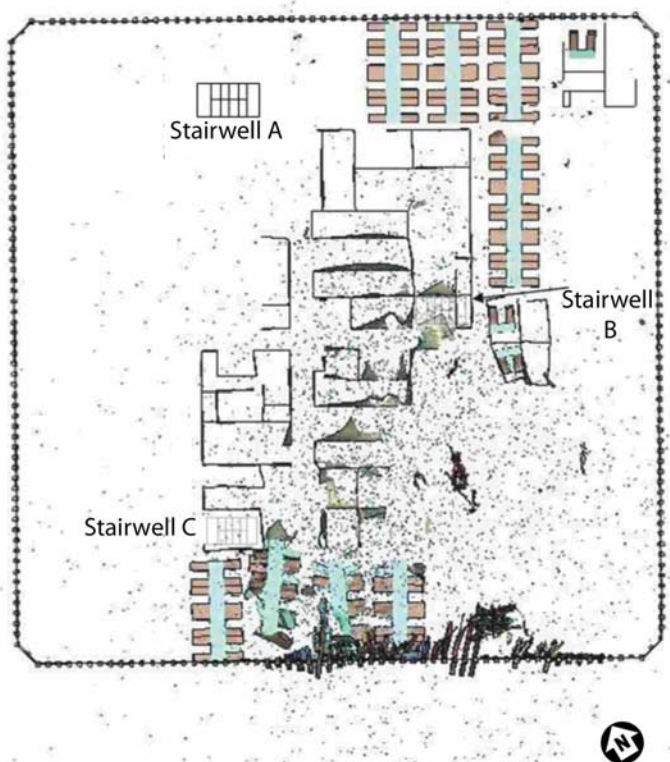
**Figure 7-2. Simulated impact damage to WTC 2 on floor 78, 0.62 s after impact.**
