**Lesson Learned Title:** Ineffective Laser Lab Personnel Sweep (“Near Miss”)

**Date:** June 18, 2007

**Statement:** During laser operations in the Jefferson Lab Free Electron Laser (FEL) Laboratory #1, control room staff unexpectedly discovered the presence of a worker in the laboratory. This discovery was made after a sweep to remove all workers was performed and laser operations were underway. The laser light was in operation for less than one minute when the worker was discovered and the laser light was immediately stopped. There was no exposure and no injuries to the worker. A DOE “near miss” occurrence report (ORPS #SC--TJSO-JSA-TJNAF-2006-0005) was submitted.

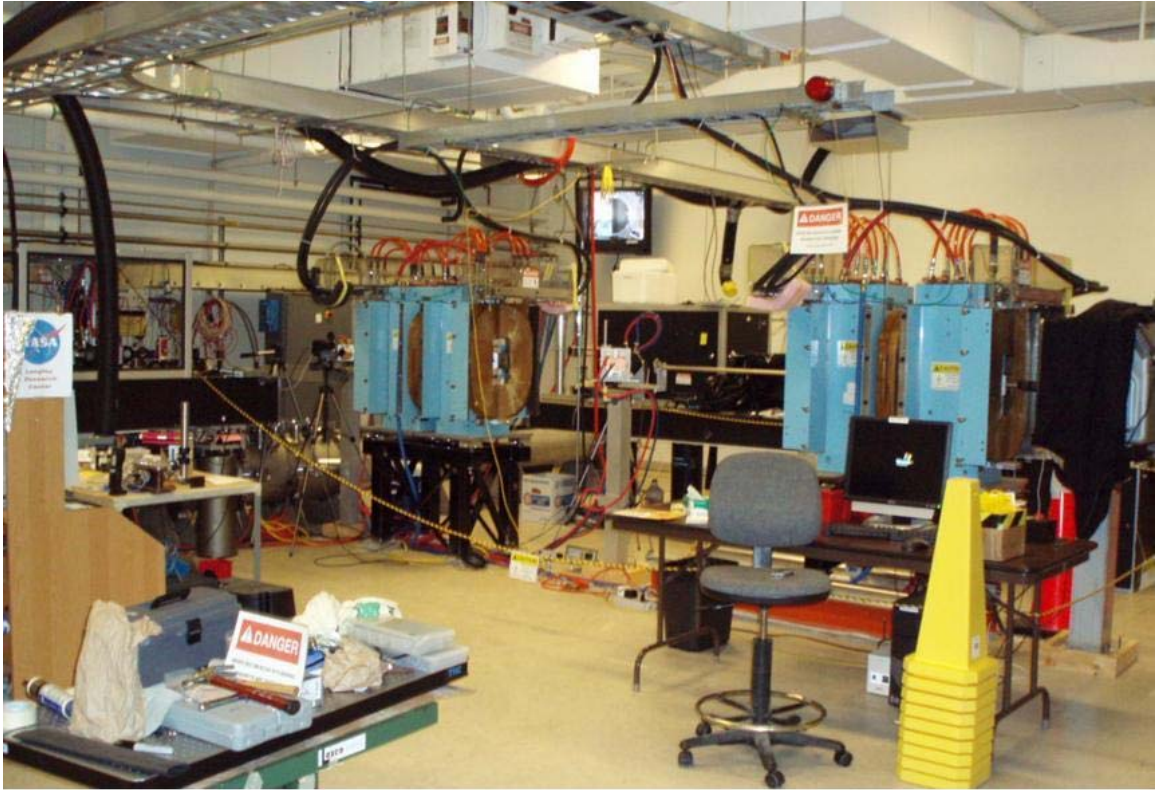
**View of Lab 1 from entrance door. Computer workstation is located along the wall on the right side of the lab, behind the magnet setup**

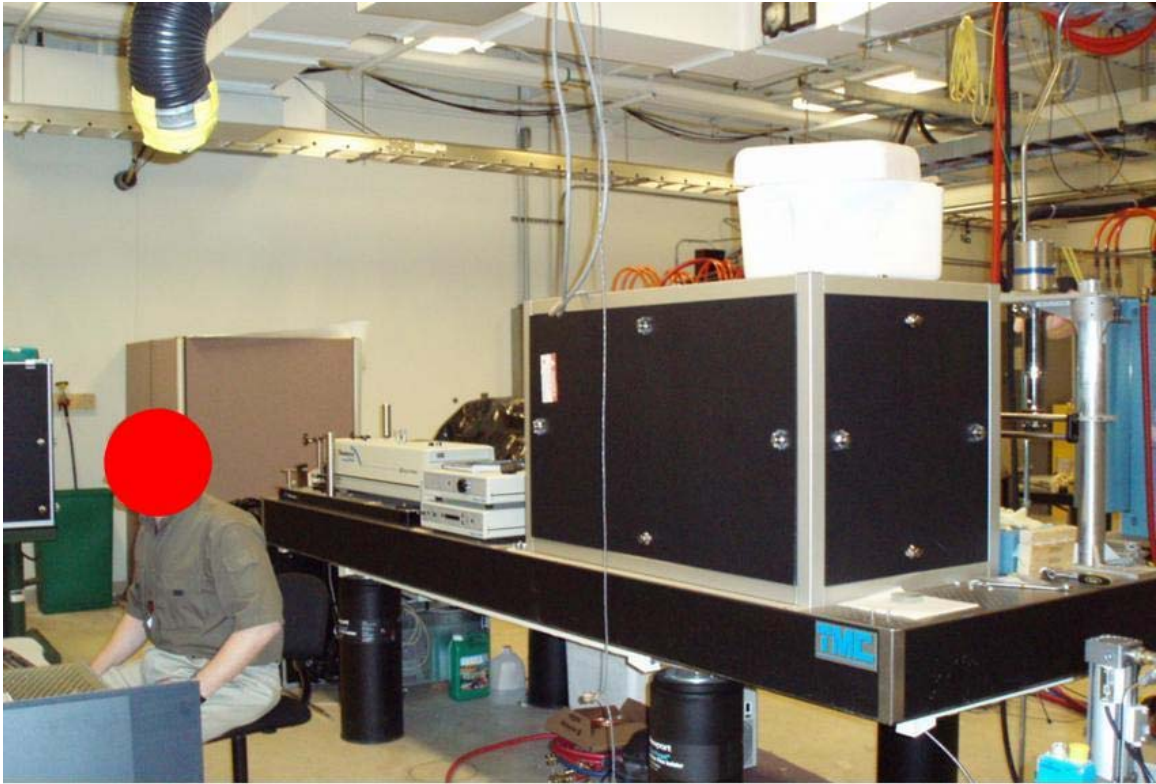
**Position of user at computer workstation in Lab 1. This view is from the right-rear corner of the lab.**
