Investigation of May 1987 Fire Lease OCS-G 2937 West Delta Block 109

Gulf of Mexico
Off the Louisiana Coast

by
Jack Hendricks
Rufus P. Kirk
William D. Terrebonne, Sr.
Carl A. Walker
Boyd S. Bennett

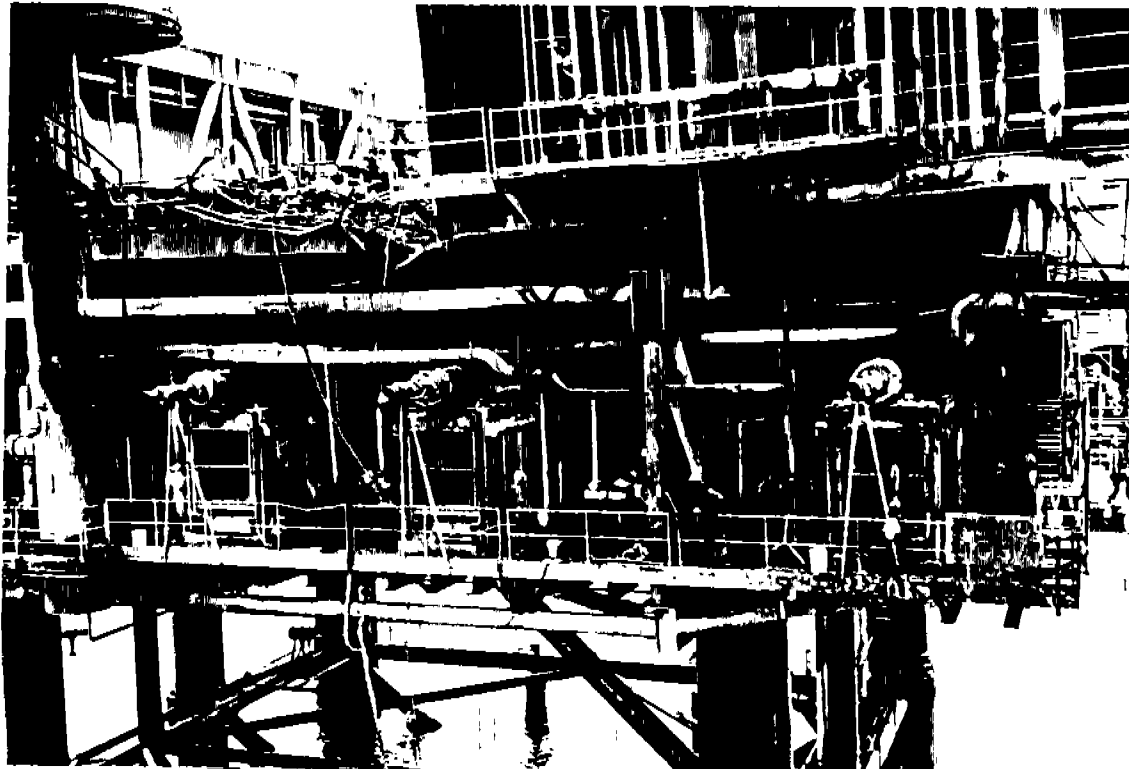
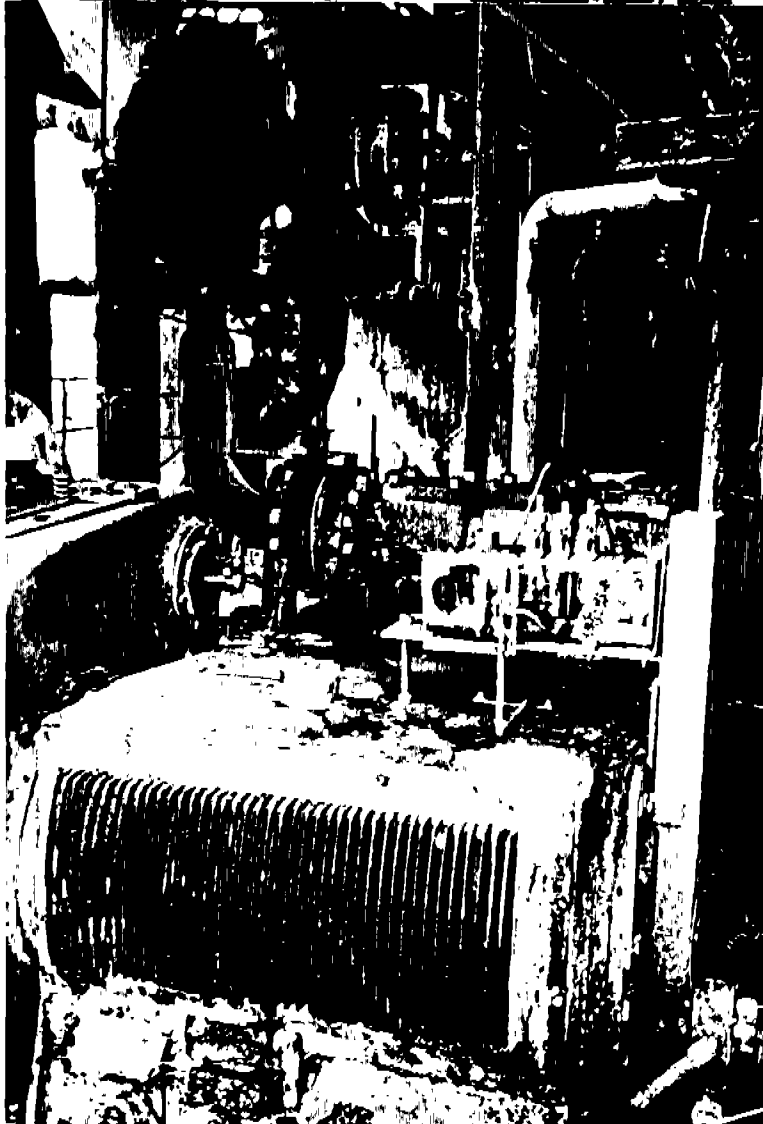
Platform Photographs

The pipeline pumps and gas engines were severely fire damaged and the pipeline pump control panels destroyed. All other equipment in the pipeline pump area within the fire walls was extensively damaged or destroyed, including the piping.

The compressor package received moderate structural damage due to bending of the supporting beams. The platform was extensively damaged in the area of the pipeline pumps and the compressor package. It is estimated that the total damage was in excess of 2 million dollars.

Pipeline Pump Area
and Compressor Area
