# **Investigation of Blowout Lease OCS-G 7871 Viosca Knoll Block 32 December 17, 1987**

**Gulf of Mexico  
Outer Continental Shelf**

by  
J. Chong  
J. Hennessey  
R. Lanza  
C. J. Schoennagel

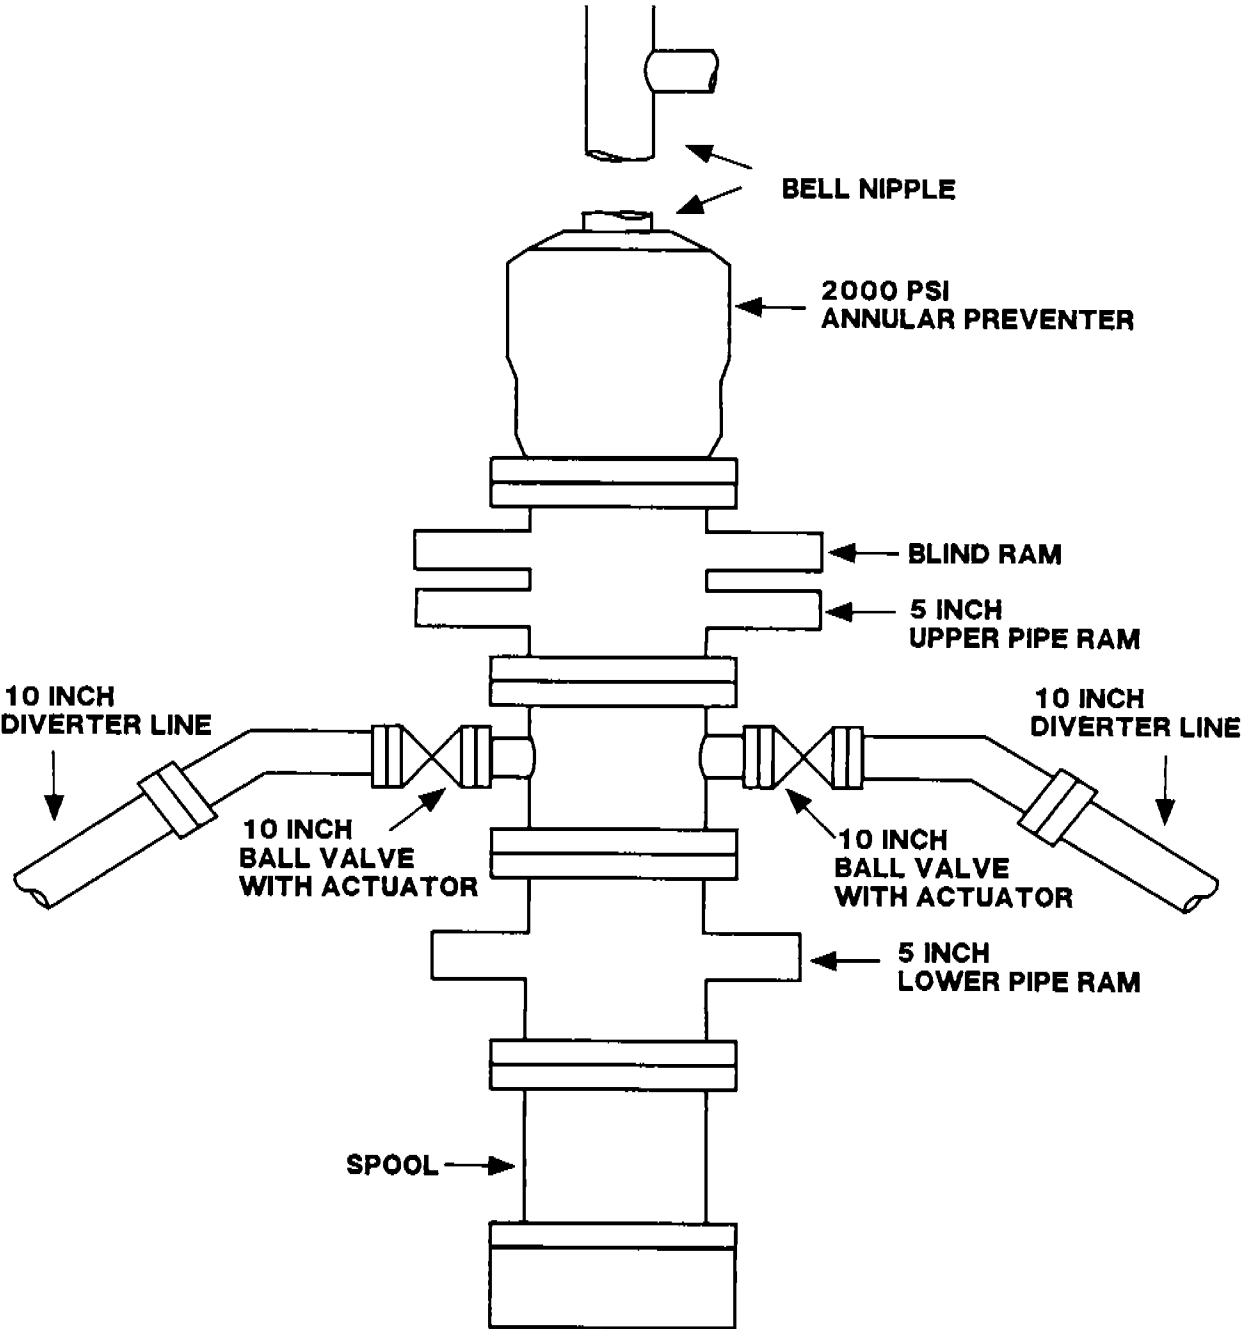
### SCHEMATIC OF BOP STACK

Since there was an indication of swabbing, the fifth stand was not broken out, and the five stands were run back into the well. For a short period of time the drill pipe was rotated in an attempt to knock off any gumbo that had accumulated on the stabilizer or drill bit. Next, the drill pipe was pulled up very slowly to see if the mud level would drop at the bell nipple. Since the mud level did not drop, circulation was begun with an initial background gas reading of six units. After approximately 10 minutes of circulation, gas was observed at the surface as the flow rate from the well increased at the shaker. The well was shut-in with the annular preventer. The starboard diverter valve was opened, and well flow was observed out the starboard diverter line. Although the annular preventer was not leaking, as an extra precaution the upper pipe rams were closed. (For schematic of BOP stack, see appendix, attachment 4.)

Subsequent investigation of the BOP stack showed that the lower rams had in fact closed. It is possible that the wear bushing had been pushed up the well and that the lower rams had, in fact, sealed with this bushing between the drill pipe and the ram sealing elements. This would explain both the early closure signal and the lack of decrease in well flow.

1. A full BOP system, including a choke line and a kill line, be installed, thus allowing for better control of well fluids during critical operations.
2. An additional string of casing be set as close to a producing zone as is safely feasible, thus allowing for better control of formation pressures and fluids.
