Investigation of Shell Offshore Inc. Hobbit Pipeline Leak Ship Shoal Block 281 January 24, 1990

Gulf of Mexico
Offshore Louisiana

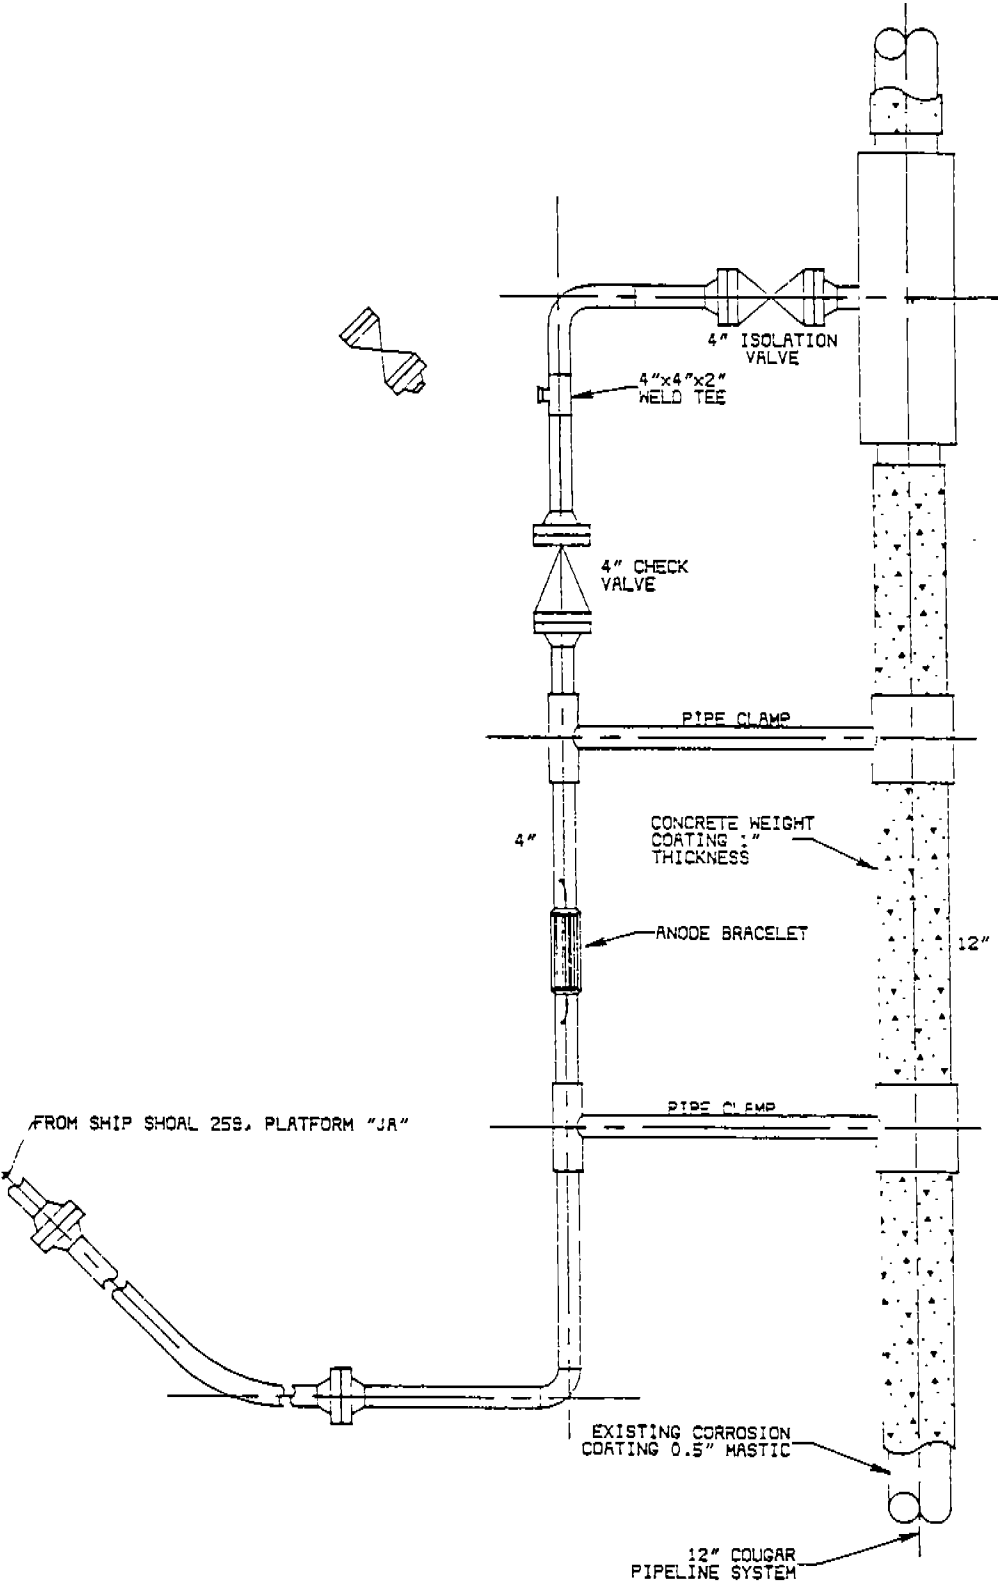
Hobbit Subsea Tie-in Assembly

Cal-Dive International in Morgan City, Louisiana, was contracted to locate and repair the leak. In the early afternoon of January 25, 1990, an inspection of the SSTI by Cal-Dive International revealed that a 2-inch valve on the 4-inch SSTI assembly had been separated from a 4-inch by 4-inch by 2-inch reducing weld-tee. The valve and the parted flange were found on the sea floor approximately 18 inches from the SSTI assembly (see Attachment 2).

On January 25, 1990, a few minutes after leaving the dive bell, the diver found the source of the leak. The 2-inch ANSI¹ 900 flange and valve had been broken off a 4-inch by 4-inch by 2-inch reducing weld-tee on the SSTI assembly. The flange and valve were lying on the seafloor approximately 18 inches from where they were originally attached. According to the

The diver reported that the SSTI assembly was covered with approximately 12 inches of sand and deteriorated pieces of burlap bags. The sand bags that were originally over the top of the manifold were rotten and disintegrated. He noted that three parts of the assembly were protruding above the sand cover and surmised that the actuator on top of the 2-inch valve had also been exposed prior to the spill. He reported that the sand had been scoured out of an area approximately 2 feet in diameter where the valve had been attached. The scour appeared to have been caused by flow from the break.

The break in the weld-tee was fairly clean in the heat-affected zone and almost perpendicular to the center line of the flange. The repair crew believes the damage was cause by an anchor or a cable of a fishing net that hooked the 2-inch valve handle and broke it off. However, there was no indication of anchor scars in the vicinity of the SSTI.

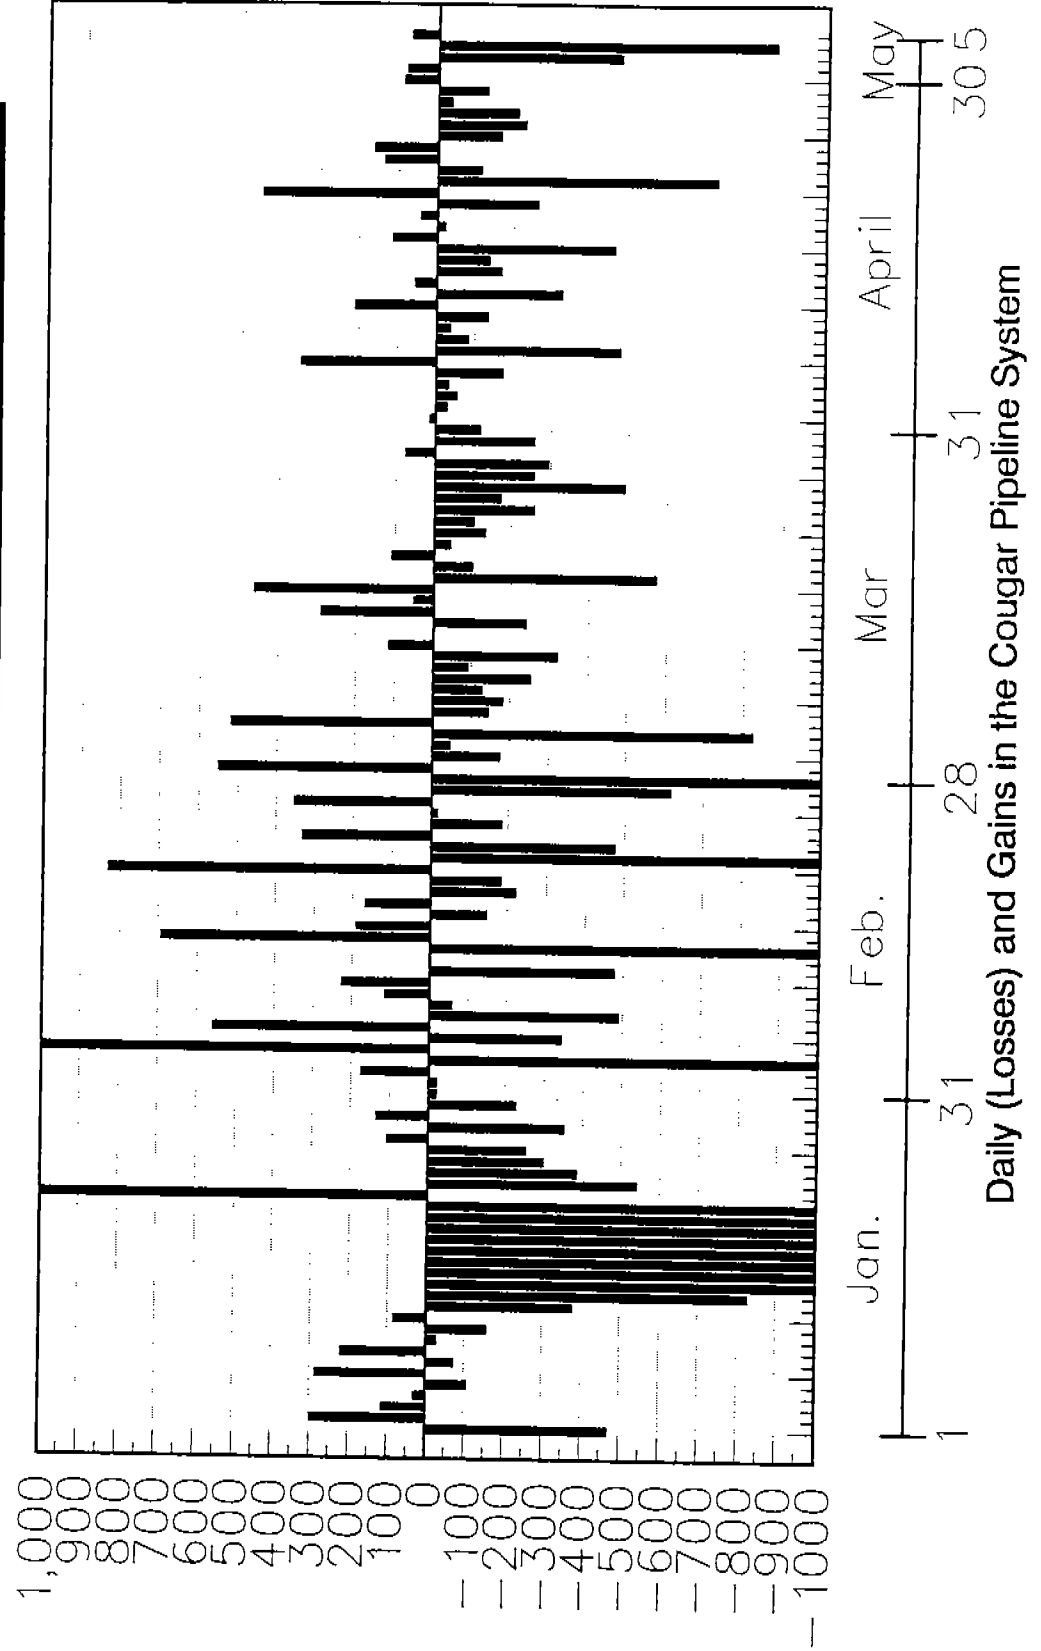
***Tabulation Of Daily Losses And Gains
In The Cougar Pipeline System***

Table 1 lists the actual losses and gains of the Cougar Pipeline System throughput, as calculated by the investigating panel members using run tickets from each input source and the readings from the check meter at Ship Shoal Block 208 for the beginning of 1990. (Graphical representation of this data can be found in Attachment 4.)

Upon reviewing this data, considerable losses, indicative of an upset in the system, can be seen for the 12-day period from January 12, 1990, through discovery of the leak on January 24, 1990. This prompted the panel to investigate the high probability that oil had leaked from the pipeline for several days prior to its discovery. Although this information was available to SPLC, the huge shortage was not discovered until tabulation of the data after January 31, 1990. Despite the fact that the Cougar Pipeline System had a slight tendency to show a shortage during the first quarter of Calendar Year 1990, the losses shown in Table 1 lead the panel to believe that a significantly larger amount of oil had been spilled than was present on the water surface on January 24, 1990.

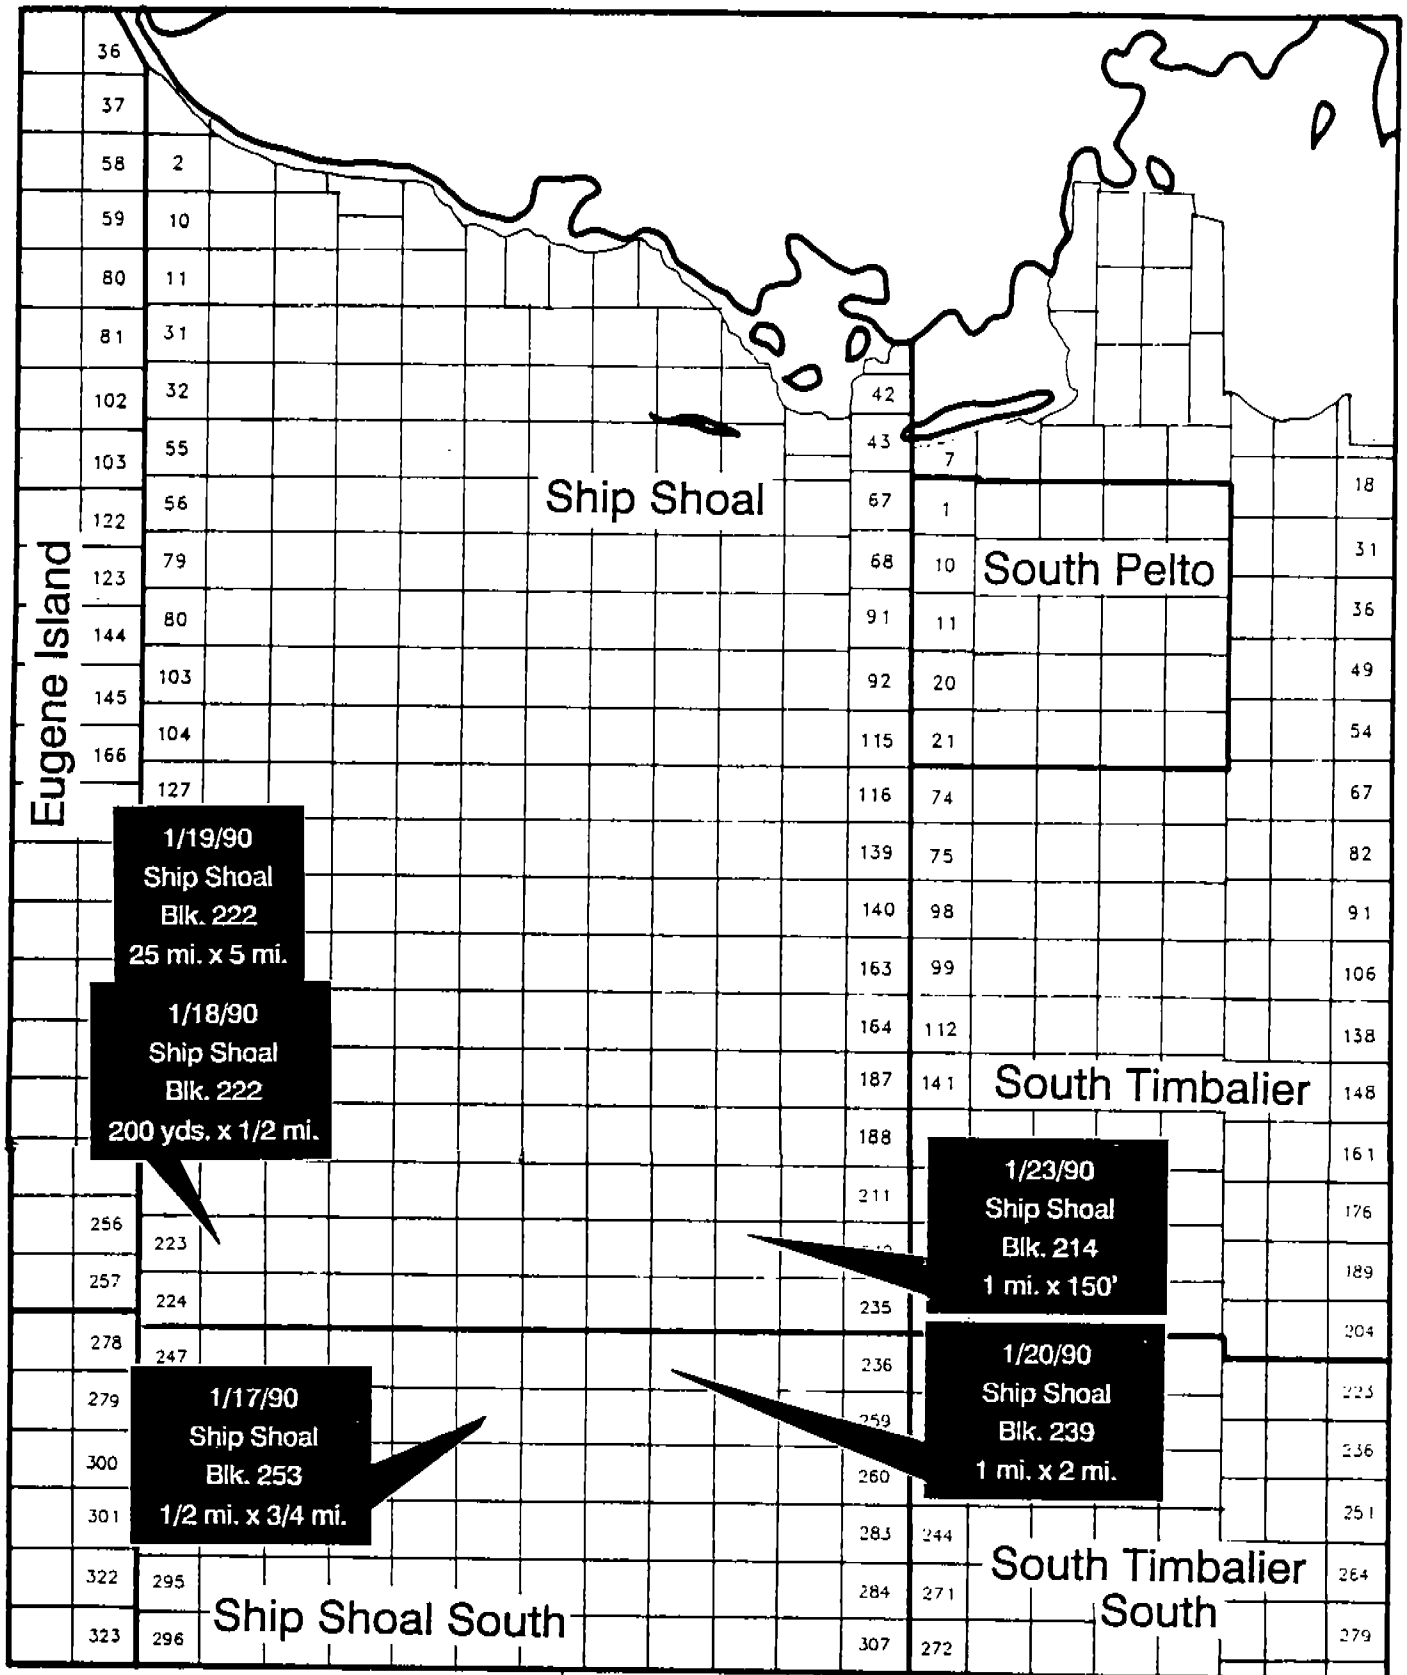
Projected Trajectories of Cougar Pipeline Oil Spills

The prevailing weather data for this period and a trajectory analysis simulating both a continuous leak and batch release of oil during the 12-day period were also reviewed. The plotting of the trajectory information and the unidentified sightings supported the theory that the pipeline had probably intermittently spilled varying quantities of oil over a period of several days (see Attachment 5).

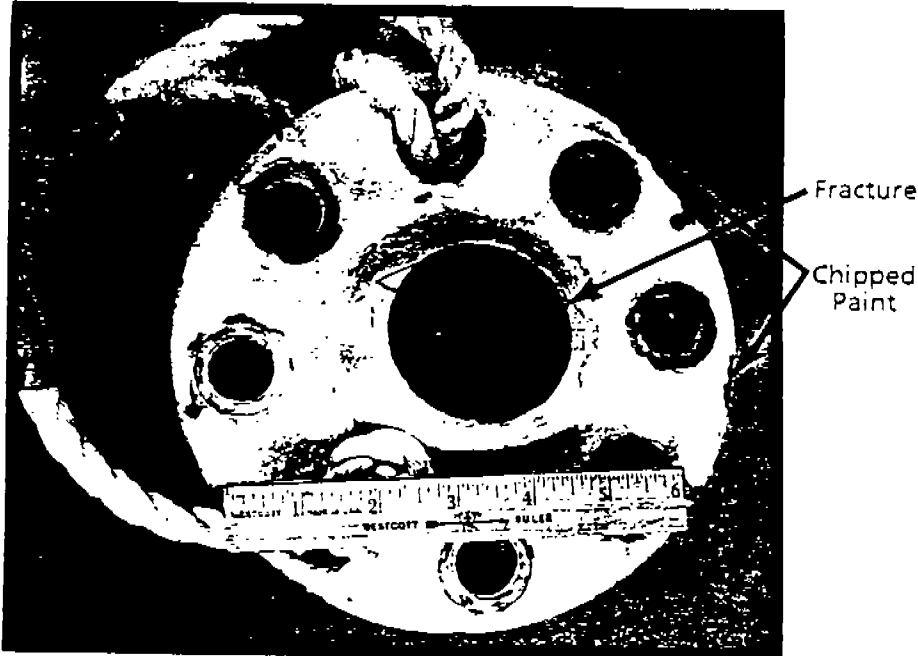
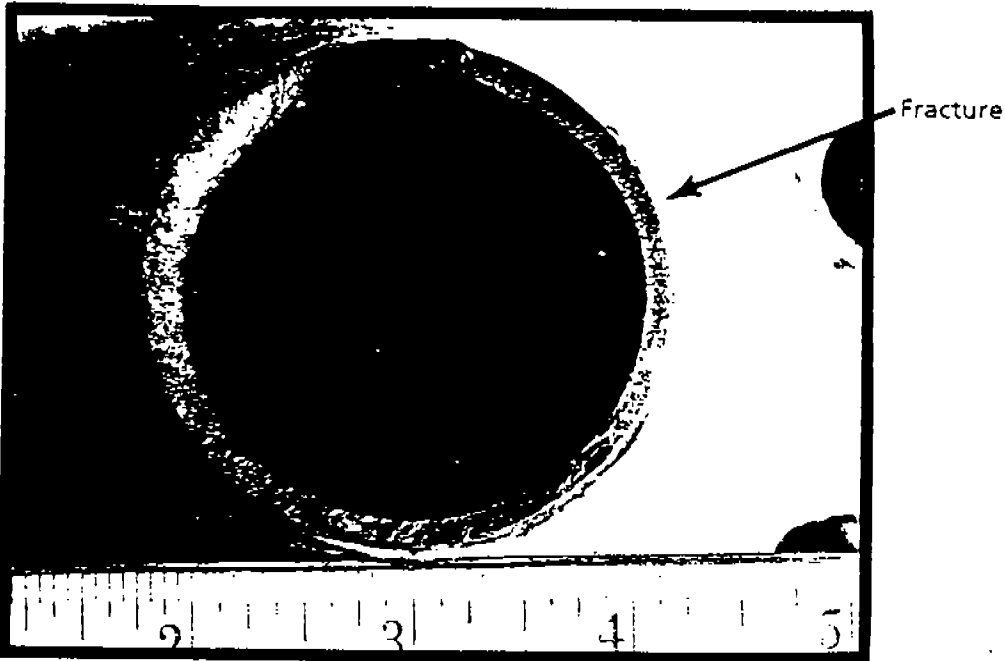
Fractured Flange from Subsea Manifold, Cougar Pipeline

"Our analysis of the failure indicates that large tensile or bending loads would have been necessary to fracture the flange; the load from the cantilevered components would be insufficient to have caused the failure. Although we saw no evidence of any mechanical damage to the flange, it is possible that the cantilevered ball valve may have been pulled by something such as an anchor."

The fracture at the weld neck was in the area of minimum cross-section. Wall thickness measurements made approximately 1/4 inch from the fracture varied between 0.140 inch and 0.199 inch. The nominal thickness of a Schedule 40 flange is 0.154 inch.

The entire fractured surface was at 45° to the axis of the flange, suggesting an overload-type failure. No evidence of any flat fractures, typical of what might be encountered in fatigue, could be found (see Attachment 6).

- The metallurgical and failure analysis, as well as the initial diver's survey, identified the cause of the damage to the pipeline as external forces exerted on the 2-inch valve.

- Due to the absence of anchor scars around the SSTI assembly and the lack of external damage to the 2-inch valve, the consensus of the panel is that the 2-inch valve was protruding from the sand covering and was snagged by cable from a fishing net or anchor.

- The MMS should investigate the applicability of pipeline leak detection systems other than low-pressure sensors.
- The MMS should modify current regulations to require improved protection of subsea appurtenances and periodic inspection of all subsea appurtenances to ensure adequate protection from damage.
- The MMS should immediately issue a Safety Alert to notify all lessees and pipeline ROW holders of the potential problems with protecting subsea appurtenances.
- The SPLC and other operators associated with the Cougar Pipeline System should immediately implement an automated or manual system of routinely balancing deliveries and receipts at a frequency greater than once daily.
