**Investigation of the
Exxon Company U.S.A.
Pipeline Leak
Eugene Island Block 314
May 6, 1990**

Gulf of Mexico
Off the Louisiana Coast

Don Howard
John Guidry
William Hauser
Jack Leezy

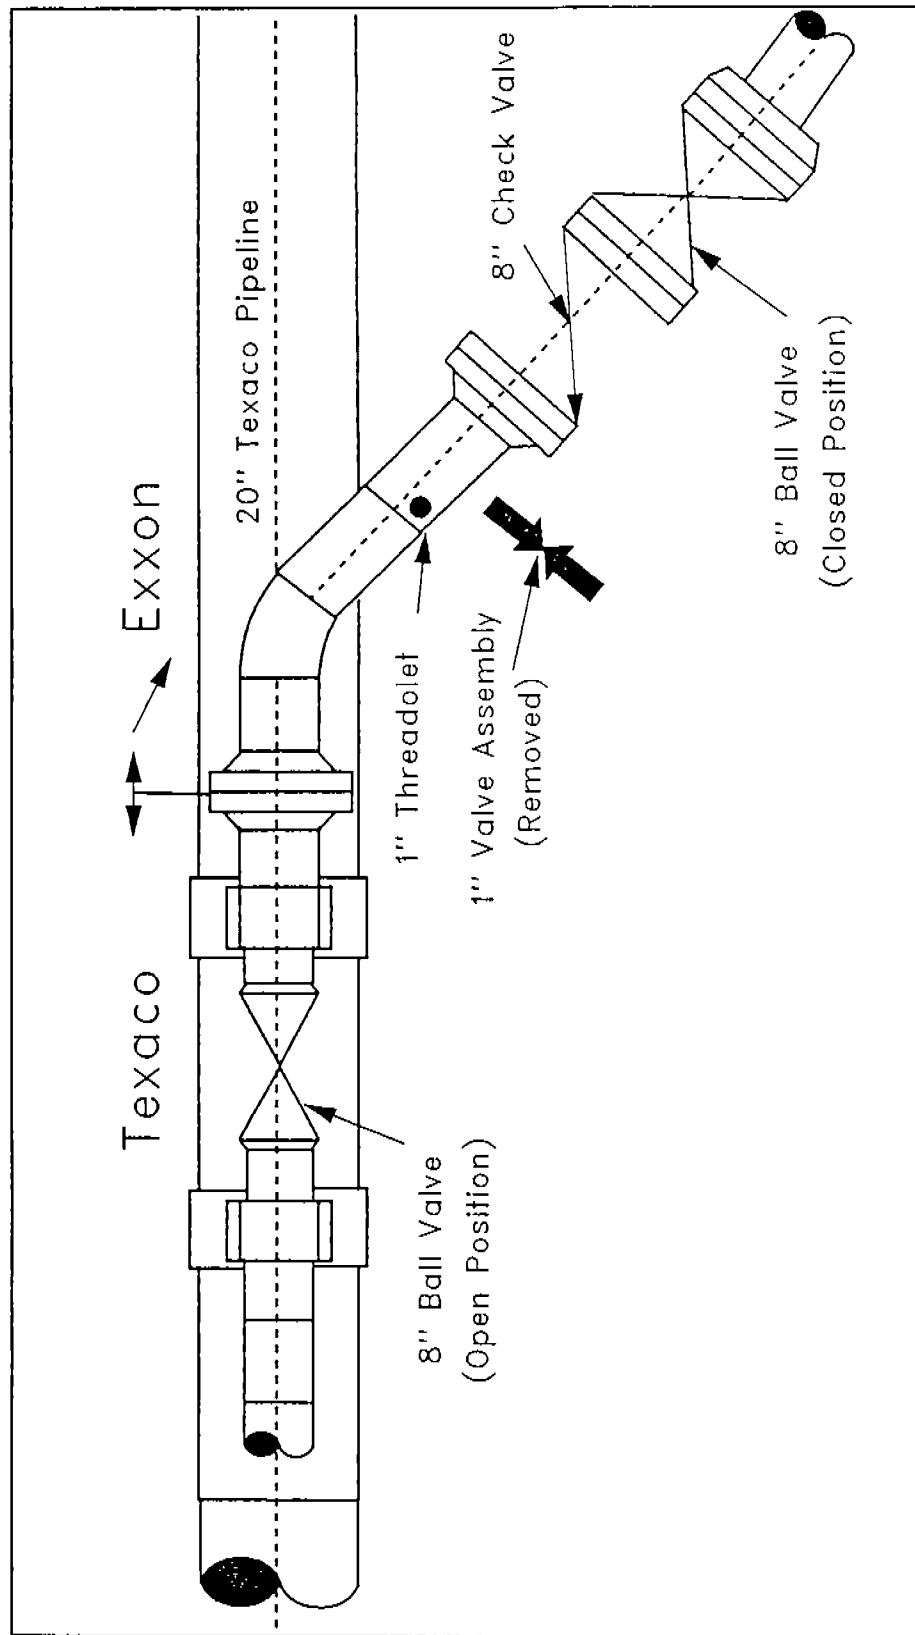
Subsea Tie-in at Time of Incident (Plan View).

The leak involved an 8 5/8-inch spool piece, connecting an 8 5/8-inch Exxon pipeline to the EIPS 20-inch pipeline. The pipeline Segment No. 4030 extends 5,000 feet from Exxon's Platform B to a subsea tie-in (SSTI) on the EIPS 20-inch pipeline, all located in Eugene Island Block 314, Lease OCS-G 2111. (See Attachment 1.) Pipeline Segment No. 4030 was

On May 9, 1990, a diver found the source of the leak. A 1-inch valve had been torn out of a threadolet. The valve's pipe threads had been torn, indicating the valve had been forcibly removed. It was found on the seafloor near the threadolet. The 1-inch valve had been located on a spool piece of 8 5/8-inch pipe between Texaco's block valve and Exxon's block valve. Texaco's block valve was open and Exxon's block valve was closed. (See Attachment 2.) When the valve was removed, oil backflowed from the EIPS 20-inch pipeline through the open Texaco valve to the spool piece and out of the threadolet.

The SSTI assembly did not have the required minimum coverage and was not protected by a structure to prevent damage from commercial fishing operations at the time of the spill incident.

Subsea pipeline tie-ins should be buried in accordance with Department of Transportation Regulations or, in lieu of burial, cages, domes, or sandbags should be placed to protect tie-ins from damage.

Pipeline operators should orient subsea tie-in assembly bleed-off valves whereby if coverage is lost the valve would not pose a hazard to commercial fishing operations.

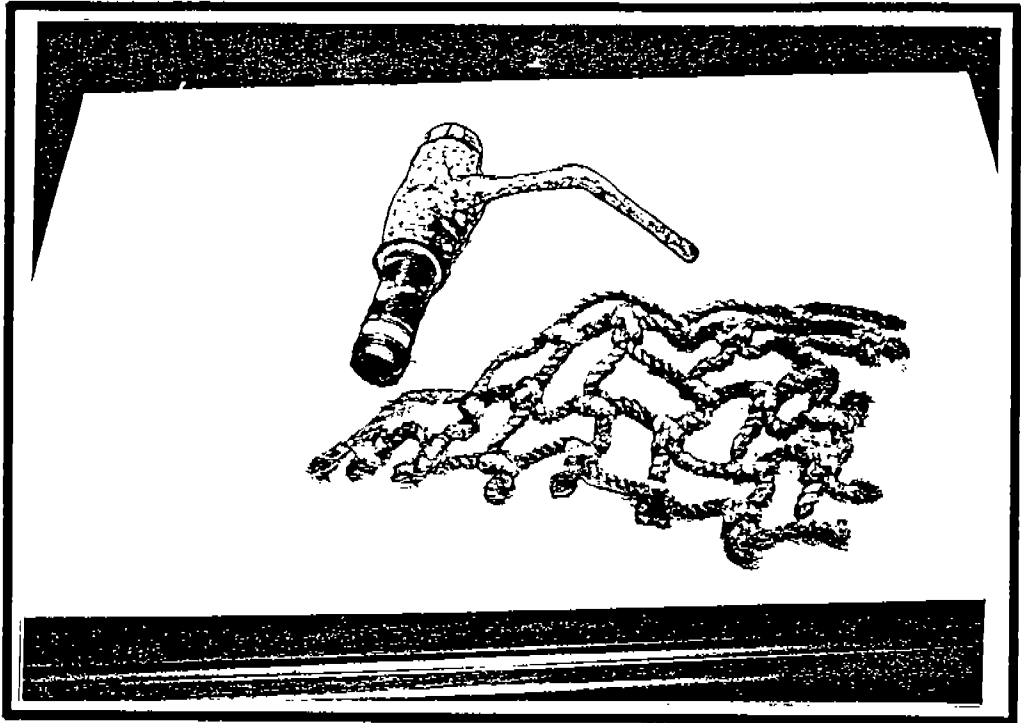
One-inch Valve Assembly.

The underwater video and photographs of the 1-inch pipe threadolet and the 1-inch valve indicate that a lateral, external force pulled or pushed the 1-inch valve from the threadolet, stripping its threads. The 1-inch valve appeared to have been initially positioned vertically. It was found on the seafloor near the location of the threadolet. Inspection of the damaged valve and threadolet showed no corrosion on the surfaces that had made a metal-to-metal seal; this lack of corrosion indicated that the valve had been removed recently. Further, the valve piping had been bent approximately 15 degrees before the threads stripped, allowing the pipe to separate from the threadolet.

The diver reported that the subsea tie-in (SSTI) assembly was not buried below the mud line and that there were pieces of a trawling net in the area, which he recovered along with the 1-inch valve. (See Attachment 3.) The repair crew believes that the damage was caused by a trawling net that hooked the 1-inch valve and stripped it from the threadolet.

Because of the absence of anchor scars near the SSTI assembly, the panel concluded that the protruding 1-inch valve was snagged by a trawl net and pulled from the threadolet.

The MMS should modify current regulations to require improved protection of subsea appurtenances and periodic inspection of all subsea appurtenances to ensure adequate protection from damage.
