**Investigation of Fire, Fatality, and Injuries
Eugene Island Block 108
December 23, 1998**

**Gulf of Mexico
Off the Louisiana Coast**

**U.S. Department of the Interior
Minerals Management Service
Gulf of Mexico OCS Regional Office**

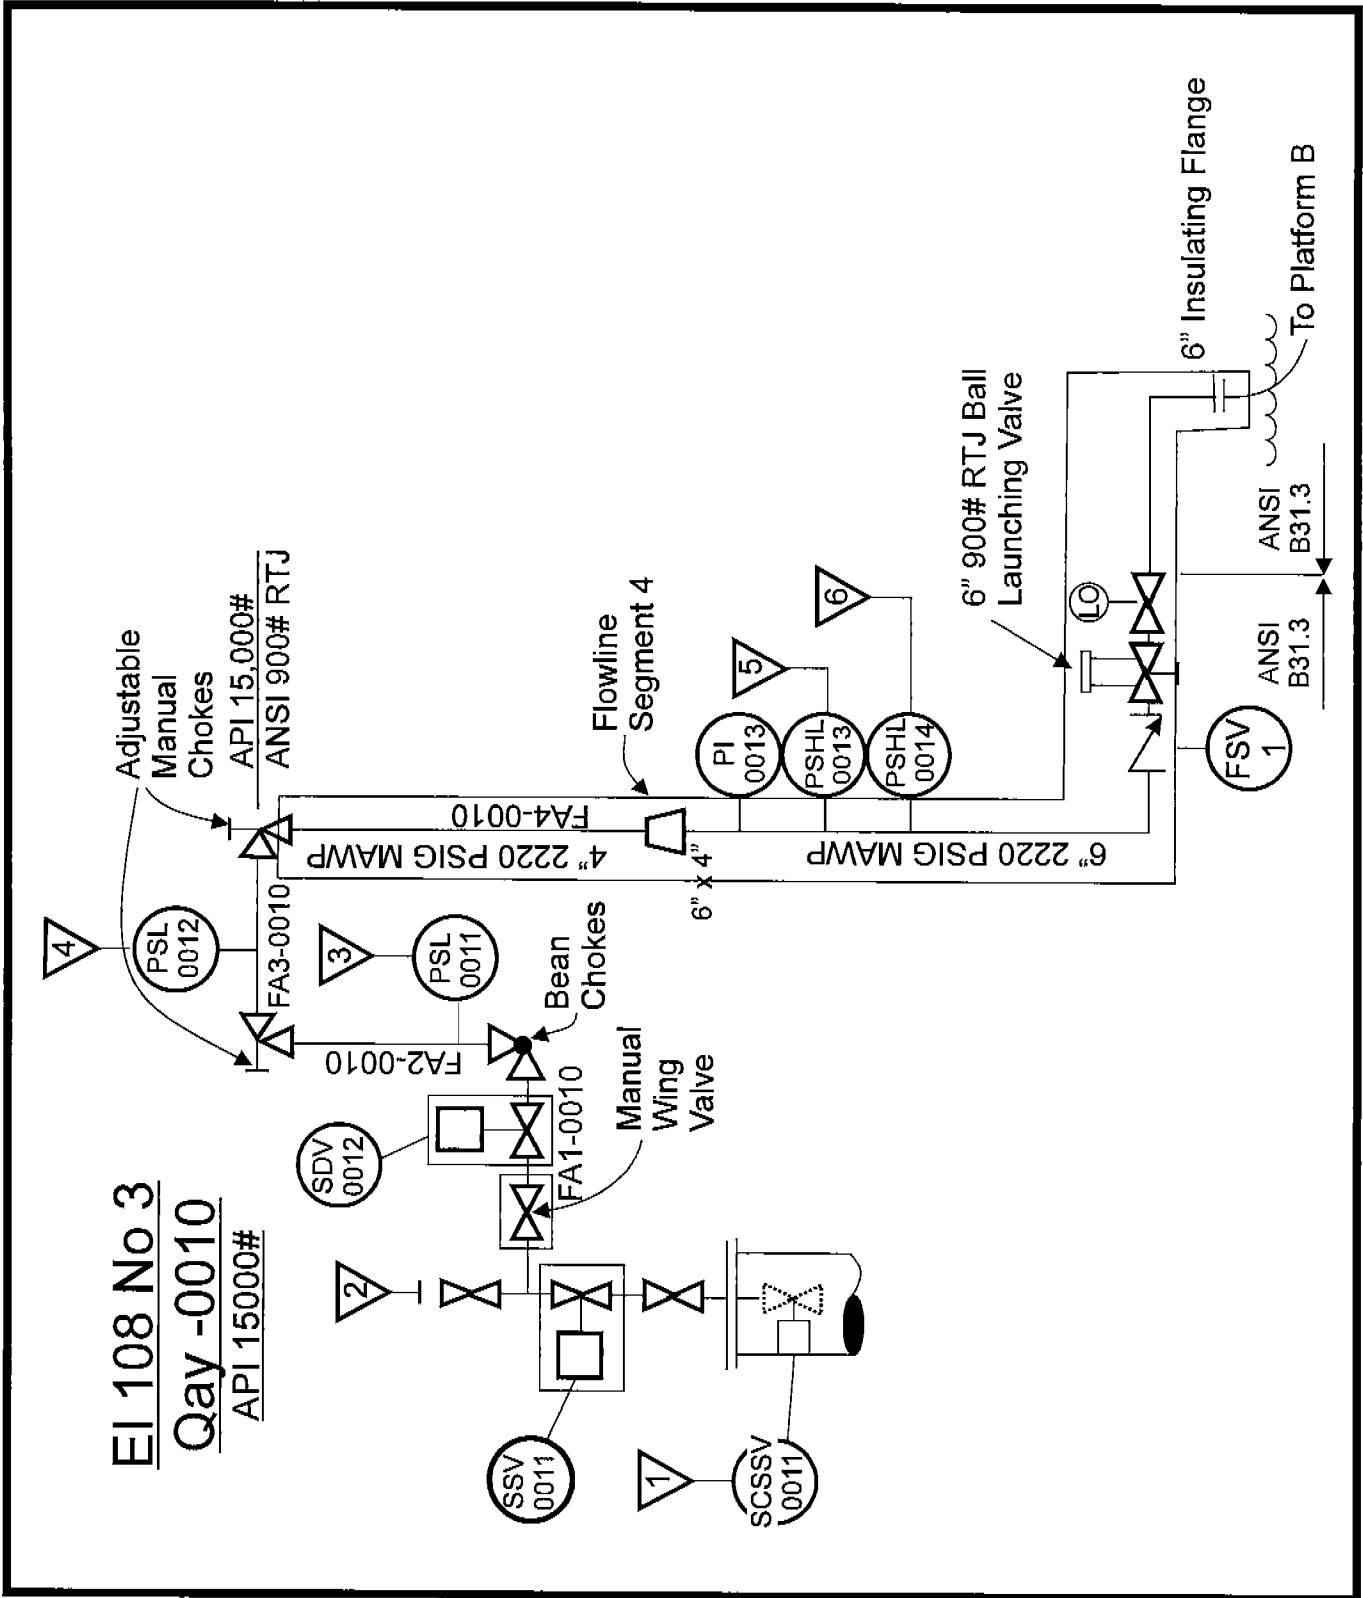
Simplified Schematic of Platform No.3

Eugene Island Block 108 No. 3 well is a producing gas well with a flowing tubing pressure of approximately 5,100 psi and a shut-in tubing pressure of approximately 7,600 psi. The wellhead, flowline segments 1, 2, and 3, and associated equipment are rated for 15,000 psi. Flowline segment 4, its associated equipment, and the departing pipeline are rated for a maximum allowable working pressure of 2,200 psi. For the purpose of this report, the pertinent equipment on Platform No. 3 comprises the surface controlled subsurface safety valve (SCSSV), the master surface safety valve (SSV), the manual wing valve, the wing shut-down valve (SDV), the pressure safety high low (PSHL) sensors, the flow safety valve (FSV), the pig launcher, and the safety device relay panel. Each of the PSHL's sensors independently activates both the SSV and SDV. The FSV and the pig launcher are located in flowline segment No. 4. The SSV, SDV, and the SCSSV are activated by the platform's Emergency Shut Down system (ESD) even when the relays are pinned out. A bean choke separates segments 1 and 2. Adjustable manual chokes separate segments 2 and 3 and segments 3 and 4.

The normal operating pressure range at sensing points 5 and 6 was approximately 1,135 to 1,145 psi. At the time of the accident, the PSH sensors were set at approximately 1,517 psi. The closing of the SDV on Platform B caused the pressure at sensing point 5 to increase to 1,562 psi at 1052 hours, which precipitated the tripping of the relays and the closing of the SDV and SSV. After rising to 1,588 psi and 1,558 psi, respectively, the pressures at points 5 and 6 gradually decreased to 1,498 and 1,513 psi, respectively, at the time Employees 1 and 2 arrived at Platform No. 3. While the exact cause of the pressure decreases is not known, a leak in the boarding SDV is a possibility. Therefore, while on Platform No. 3, Employee 1, after Employee 2 closed the manual wing valve, would not have had to pin out the SSV and SDV relays to open the SSV and SDV, but rather just pull or reset the relay. The relay would have stayed in service, i.e., the SSV and SDV would have opened and remained so, and the indicator would have been green, indicating that the pressure was within the PSHL's sensor settings range. At 1437 hours pressure reached 4,050 psi and 3,657 psi at points 5 and 6, respectively. As previously stated, flowline segment 4 is rated for a maximum allowable working pressure of 2,200 psi.

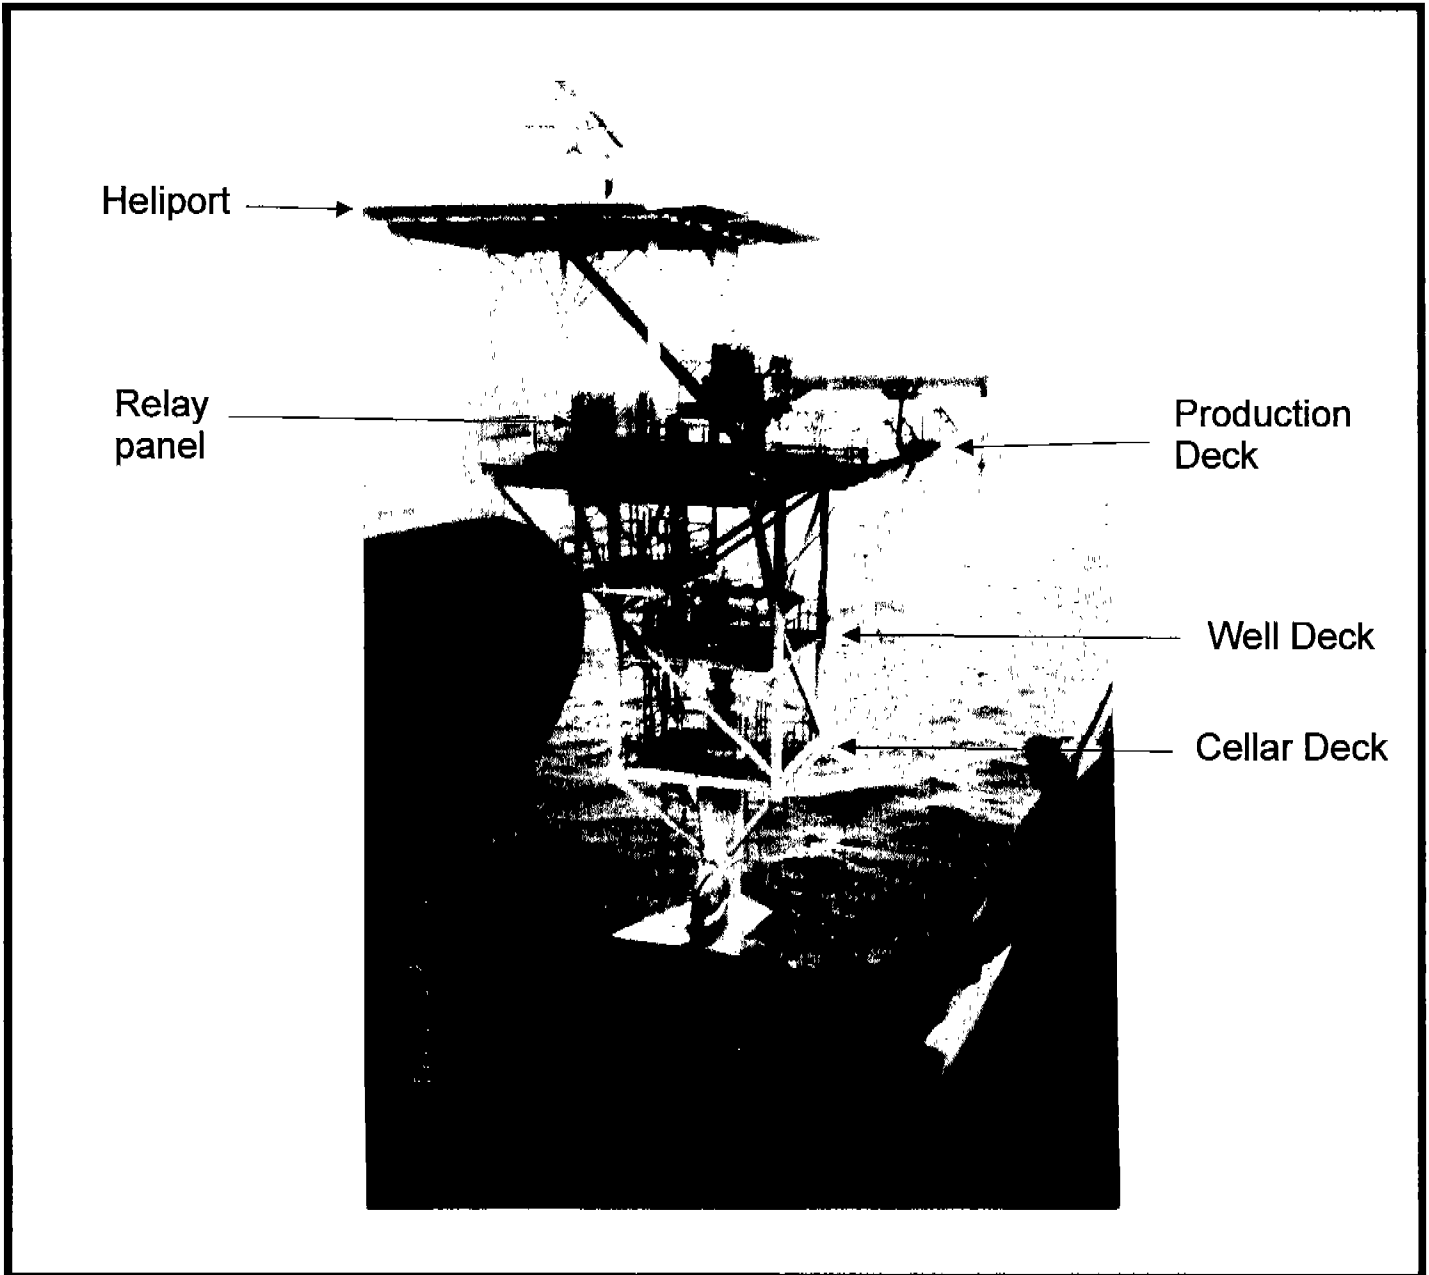
Photograph of Platform No. 3

For a photograph of Platform No. 3, see Attachment 5. The SSV, SDV, manual wing valve, PSHL sensing points, FSV, pig launcher, and pressure gauges are located on the well deck.
