# **Investigation of Fire and Fatality East Cameron Block 60 April 9, 1999**

**Gulf of Mexico  
Off the Louisiana Coast**

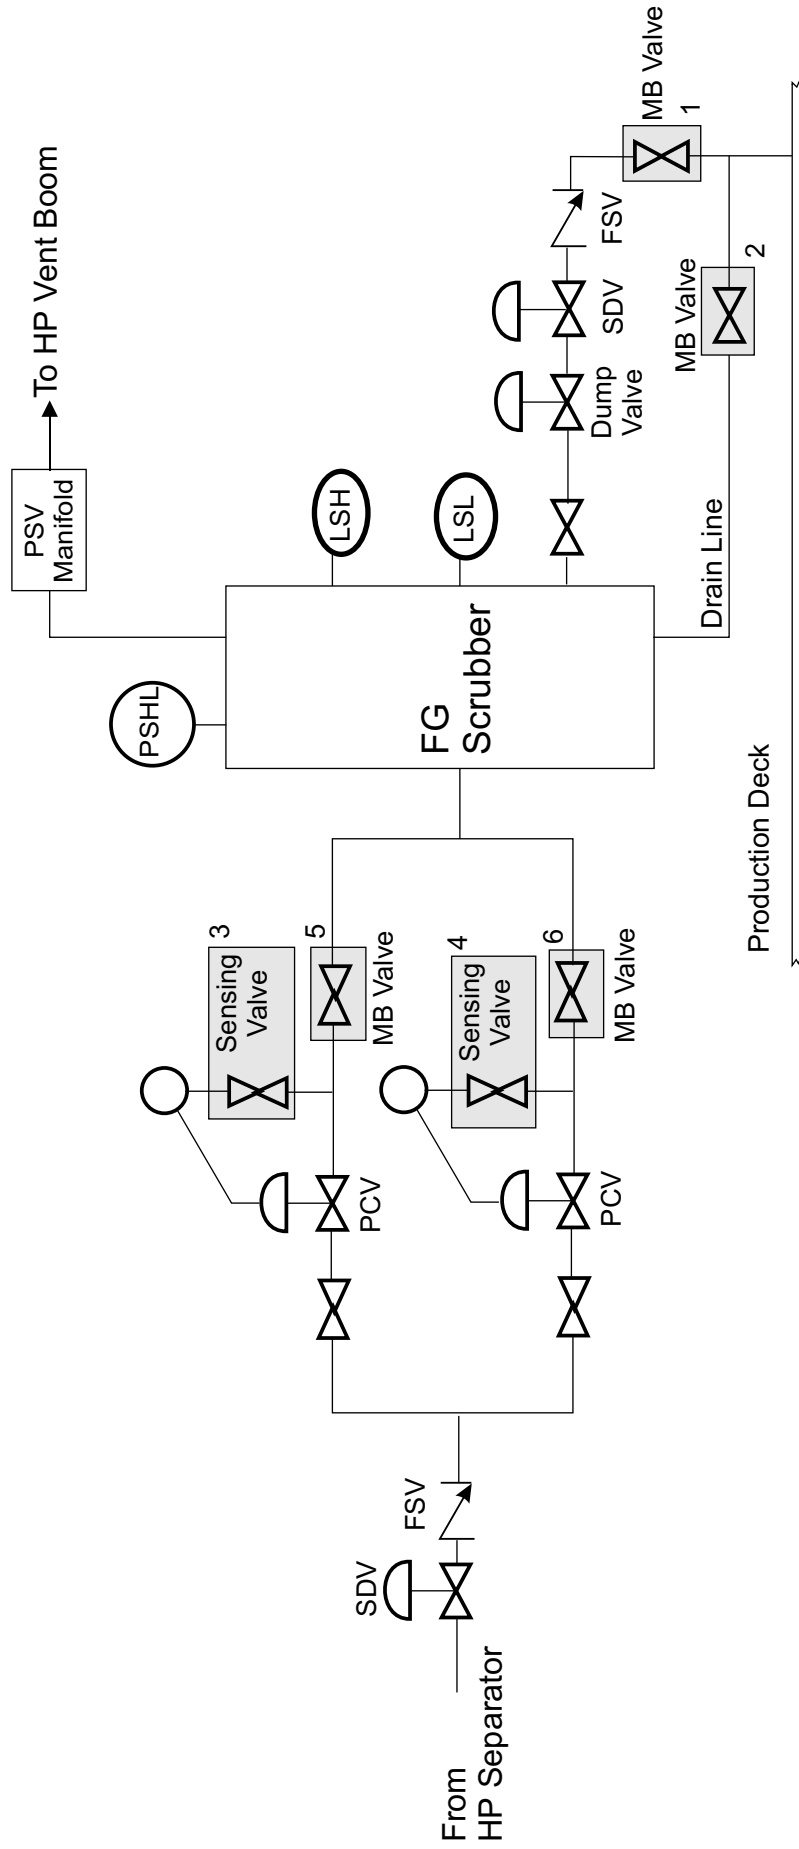
Simplified Flow Schematic of Fuel Gas Scrubber

To isolate the FG Scrubber from downstream components, D-2 stated that he closed the MB Valves on both the FG Scrubber dump and drain lines (shaded areas 1 and 2 on Attachment 3). He stated that the MB Valve on the FG Scrubber drain line was already closed. The closing of both valves would effectively achieve downstream isolation. D-2 stated that he red-flagged both lines. To achieve upstream isolation, D-2 stated that he then closed the needle sensing valves for the upstream PCV's (shaded areas 3 and 4 on Attachment 3), believing them to be the incoming block valves (shaded areas 5 and 6). This resulted in both the incoming MB Valves and PCV's remaining open, thereby allowing communication between the FG Scrubber and the HP Separator during the blowdown operations.

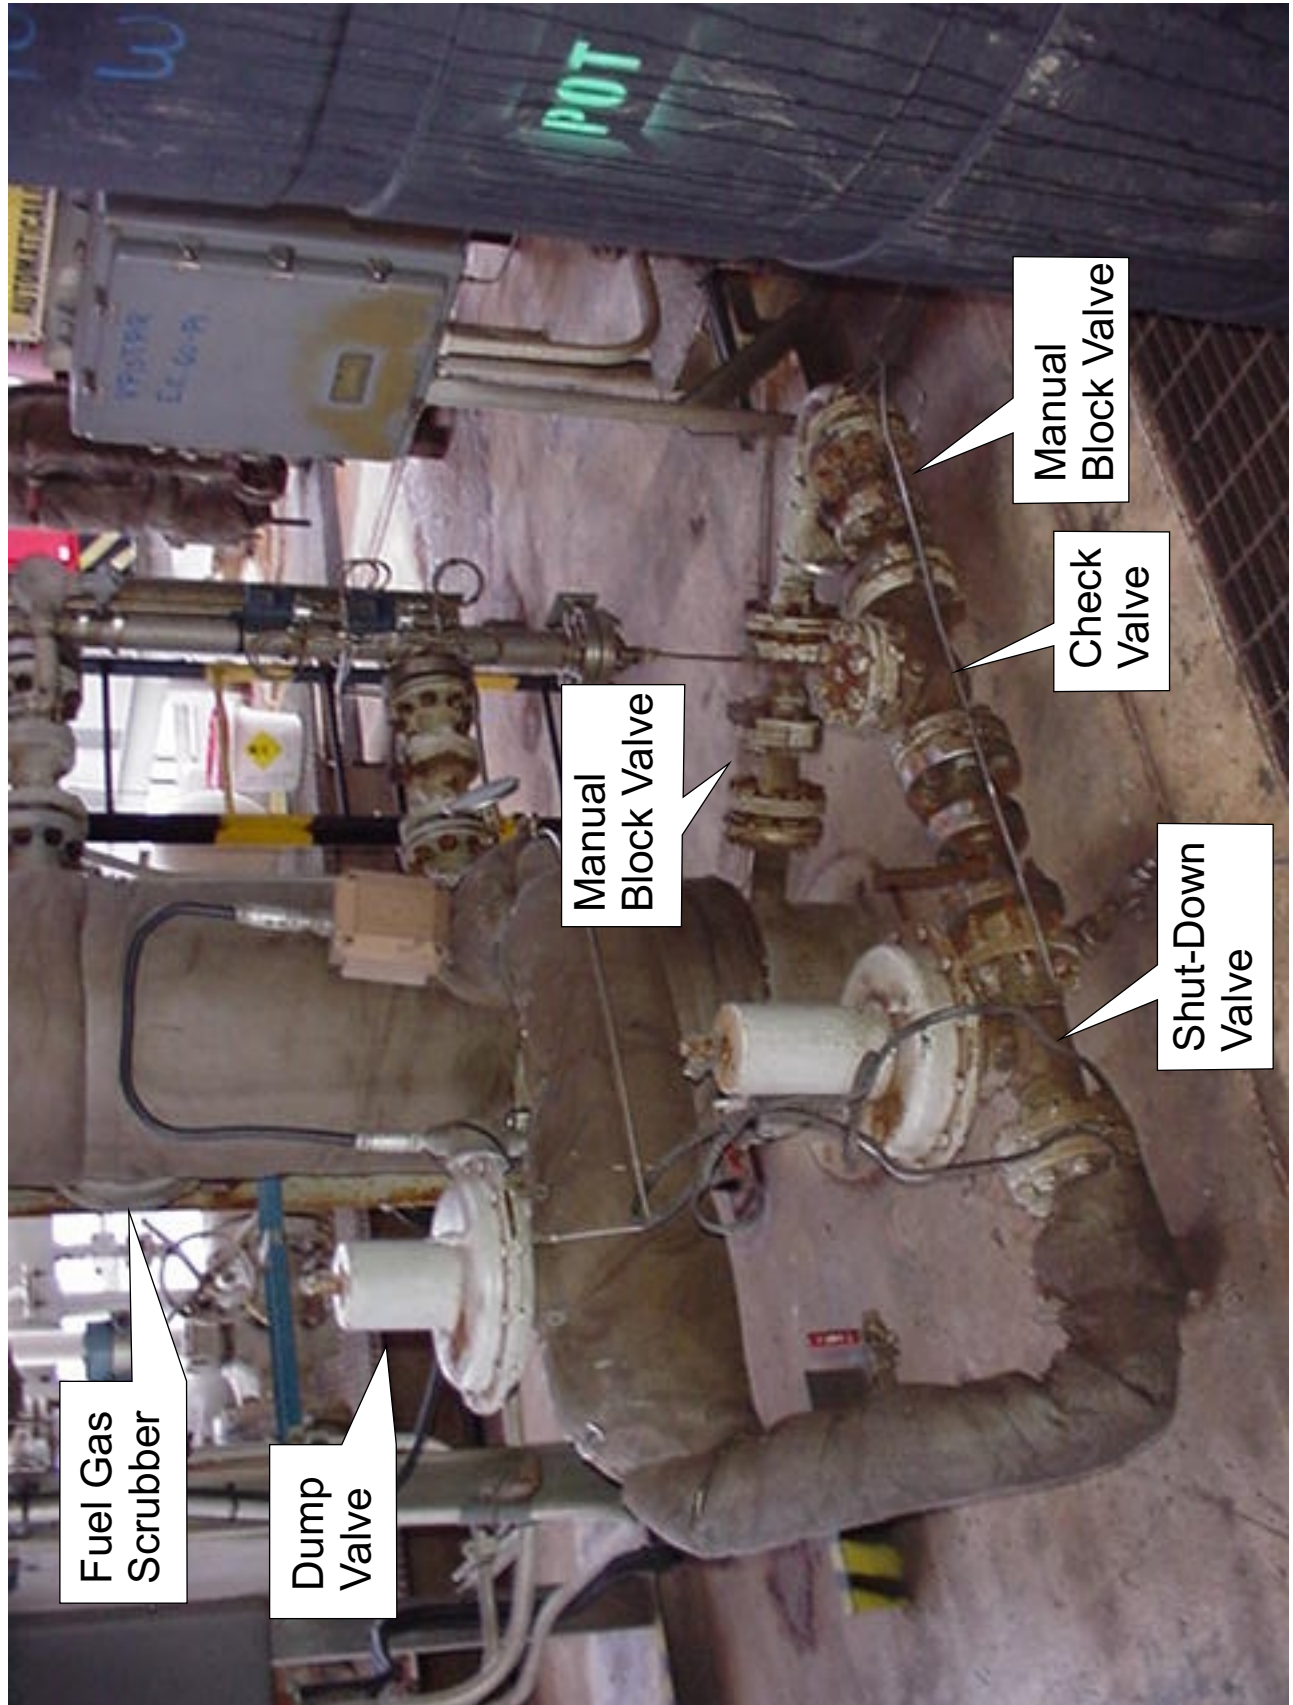
Photograph of Fuel Gas Scrubber

FG Scrubber dump line and the SDV located upstream of the FG Scrubber. The FG Scrubber also is equipped with a pressure safety valve manifold (PSV Manifold), which allows FG Scrubber blowdown to a High-Pressure Vent Boom (HP Vent Boom). *For a simplified flow schematic of the FG Scrubber, see Attachment 3. For a photograph of the FG Scrubber, see Attachment 4.*

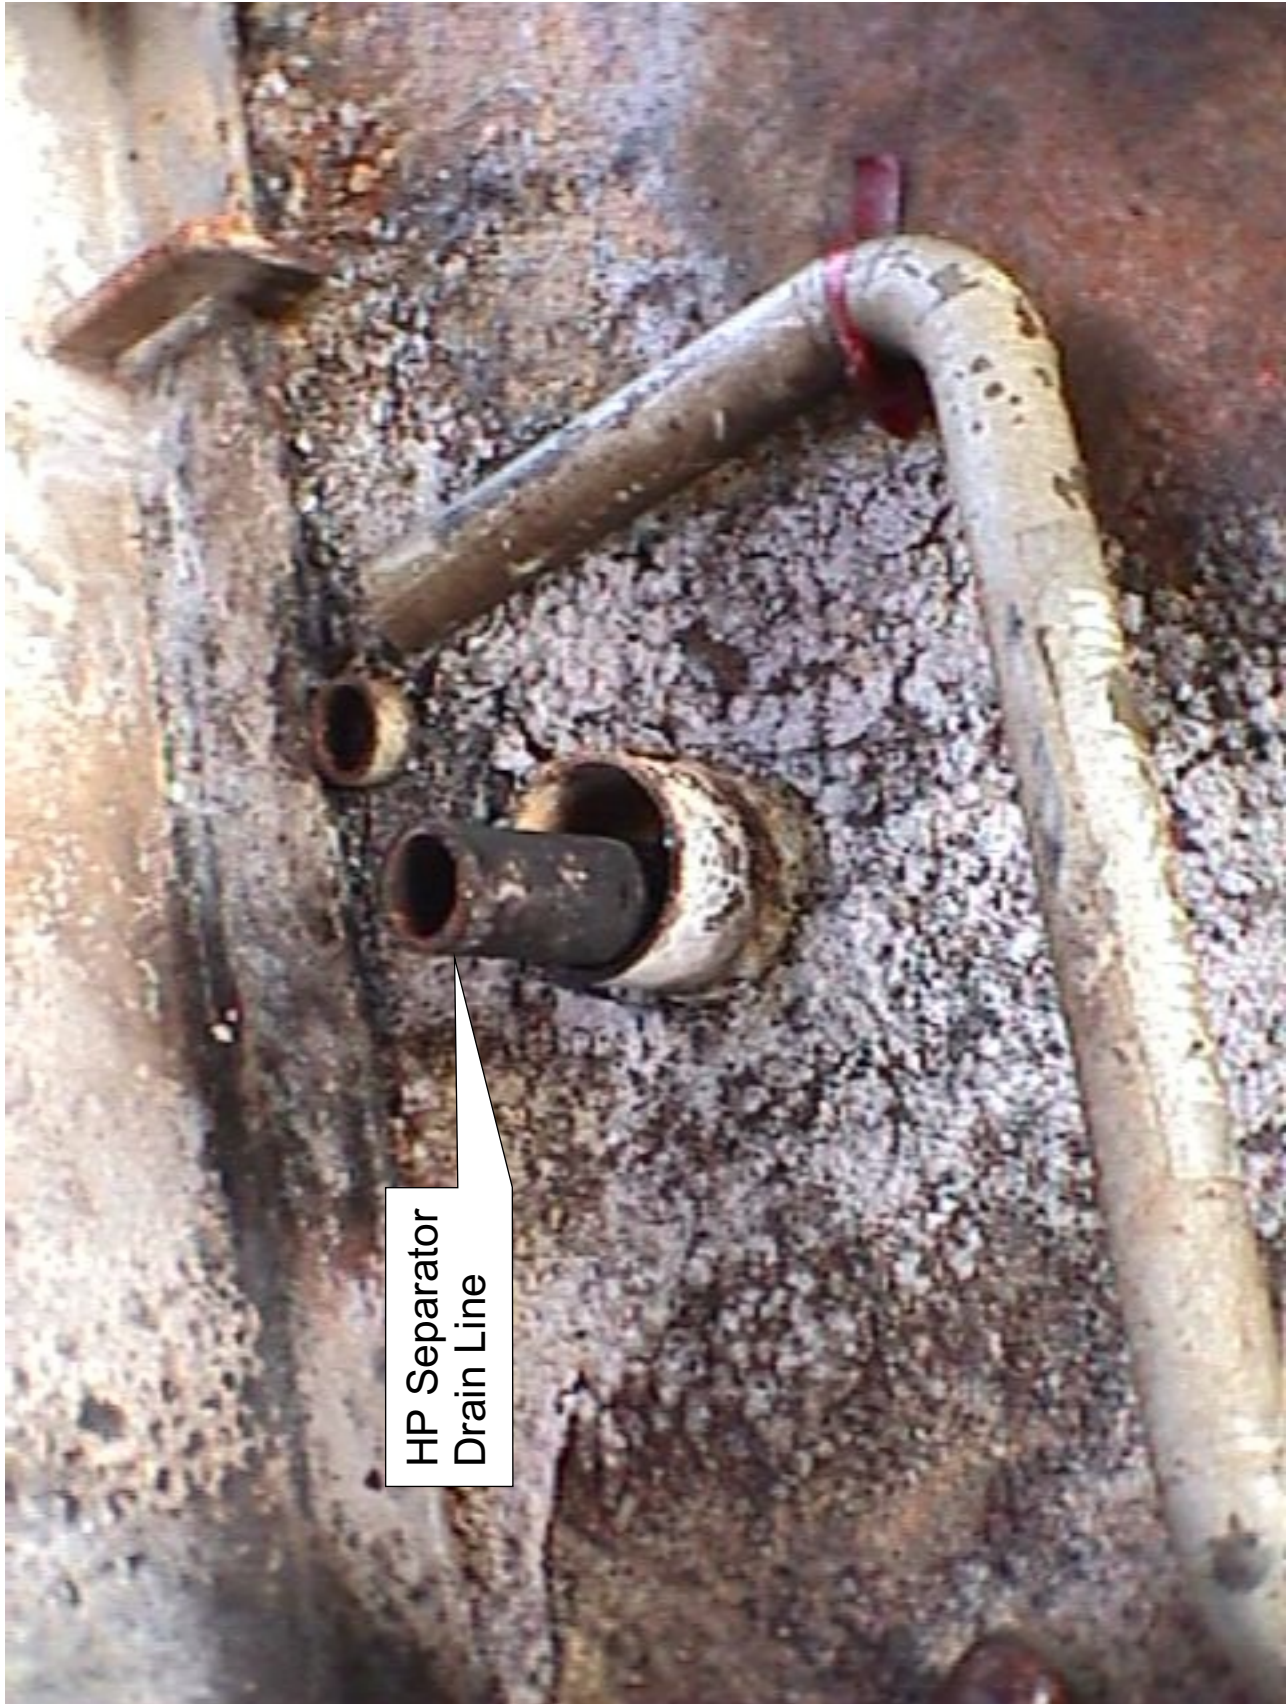
Photograph of Severed HP Separator Drain Line on Production Deck

After leaving the production deck and returning with U-2 and U-3, U-1 saw that the cut on the HP Separator was made too close to the deck and, resultantly, could not be threaded. *For a photograph of the severed HP Separator drain line, see Attachment 6.* The decision was made by U-1 to cut the pipe below the production deck at a location on the subcellar deck. From this point forward, the exact correlation of the movements of U-2 and U-3 with respect to those of U-1 cannot be determined with a great degree of accuracy. U-1 stated that he brought U-2 and U-3 to the subcellar deck and gave them instructions to cut the pipe with an electric bandsaw. U-1 stated that he felt that the previously mentioned assumed permit applied to this pipe as well, since the pipe to be cut at

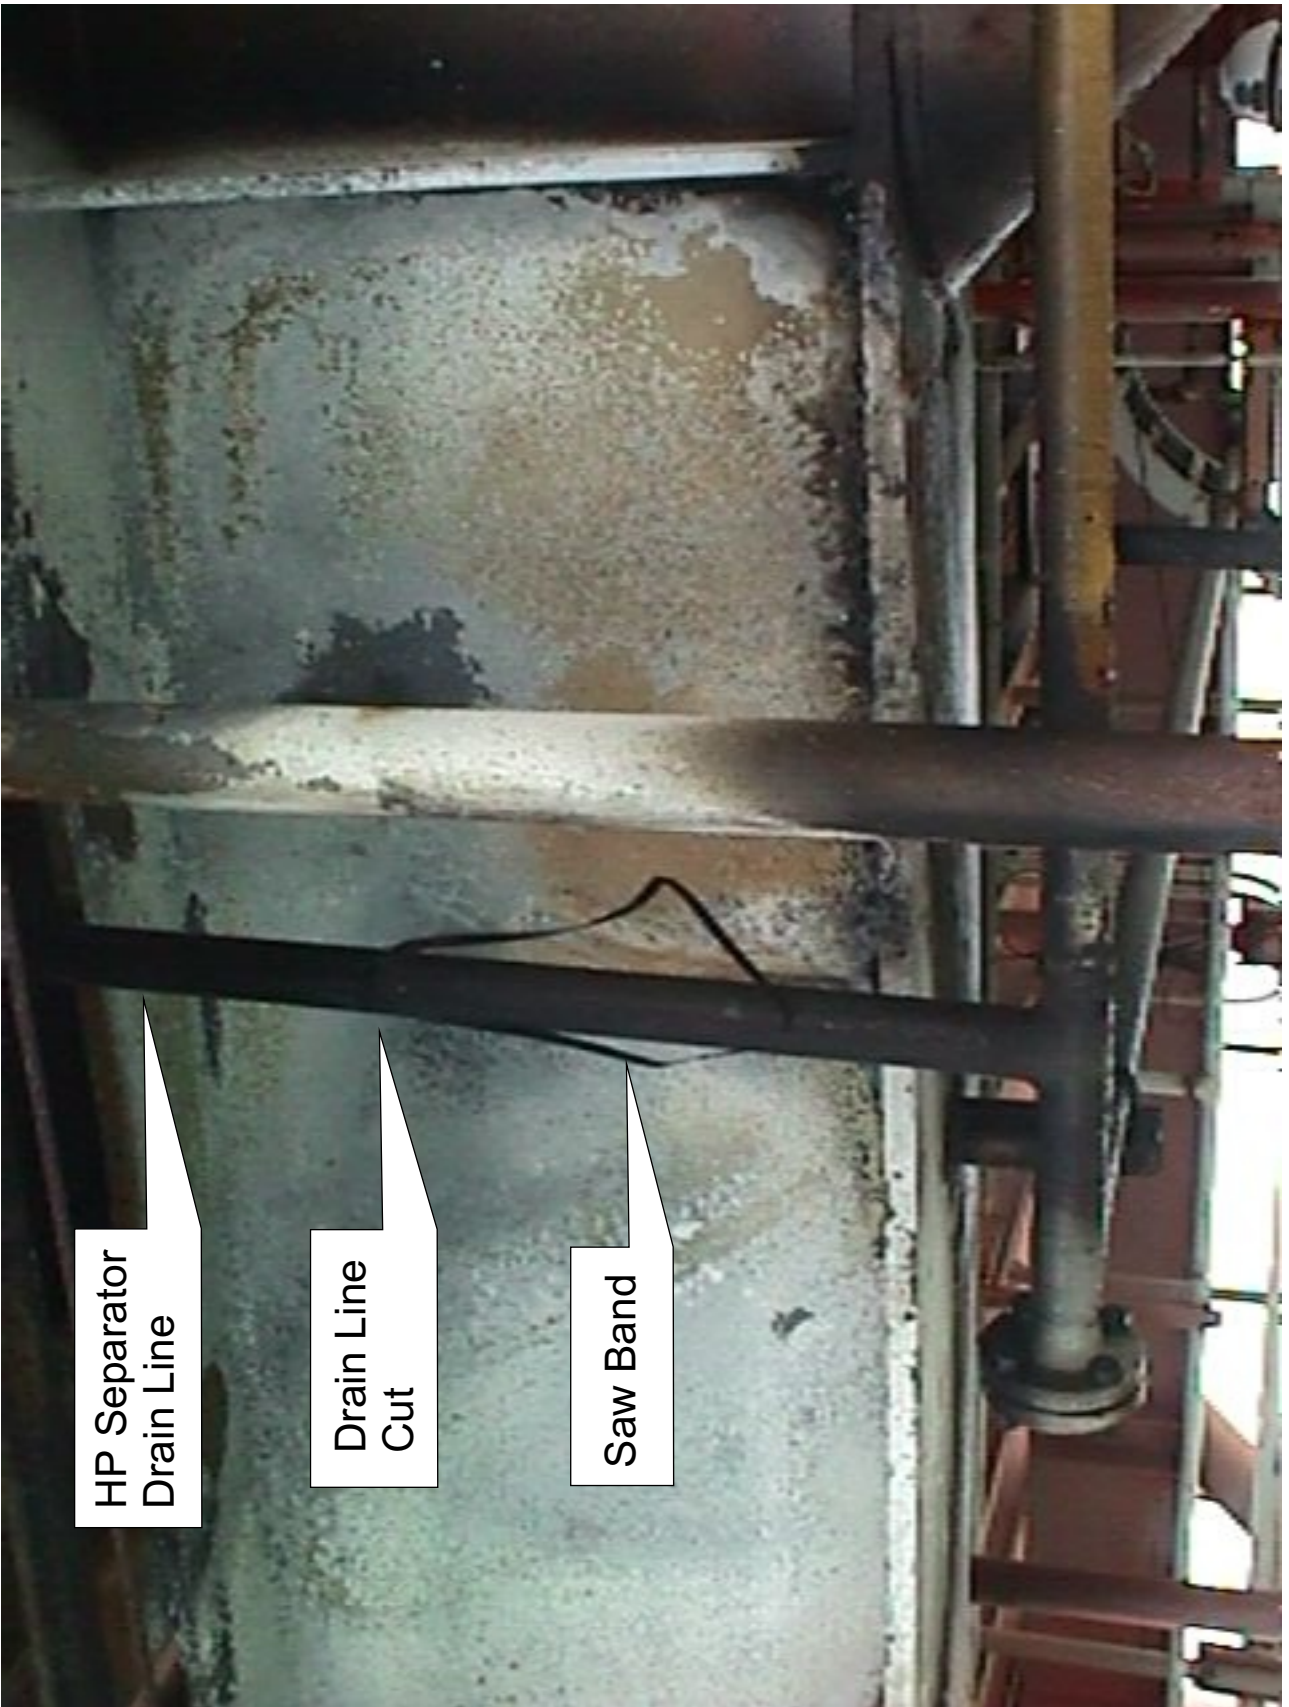
HP Separator  
Drain Line

*For a photograph of the HP Separator's drain line with the saw's band*

*attached to the cut, see Attachment 7.*

Therefore, **contributing causes** of the accident were D-2's closing of the FG Scrubber's upstream PCV needle sensing valves and the failure of D-2 to close the incoming MV Valves to the FG Scrubber. A **major cause** of the accident was the opening of the FG Scrubber's drain line MB Valve by either D-2 or D-3. A **major cause** of the accident was the decision by U-2 and U-3 to use the electric bandsaw after condensate was seen flowing from the first cut made on the HP Separator drain line on the subcellar deck.

Drain Line  
Cut
