**Investigation of Loss of Well Control
East Cameron Block 23
OCS-G 02853
February 17, 2004**

**Gulf of Mexico
Off the Louisiana Coast**

**U.S. Department of the Interior
Minerals Management Service
Gulf of Mexico OCS Regional Office**

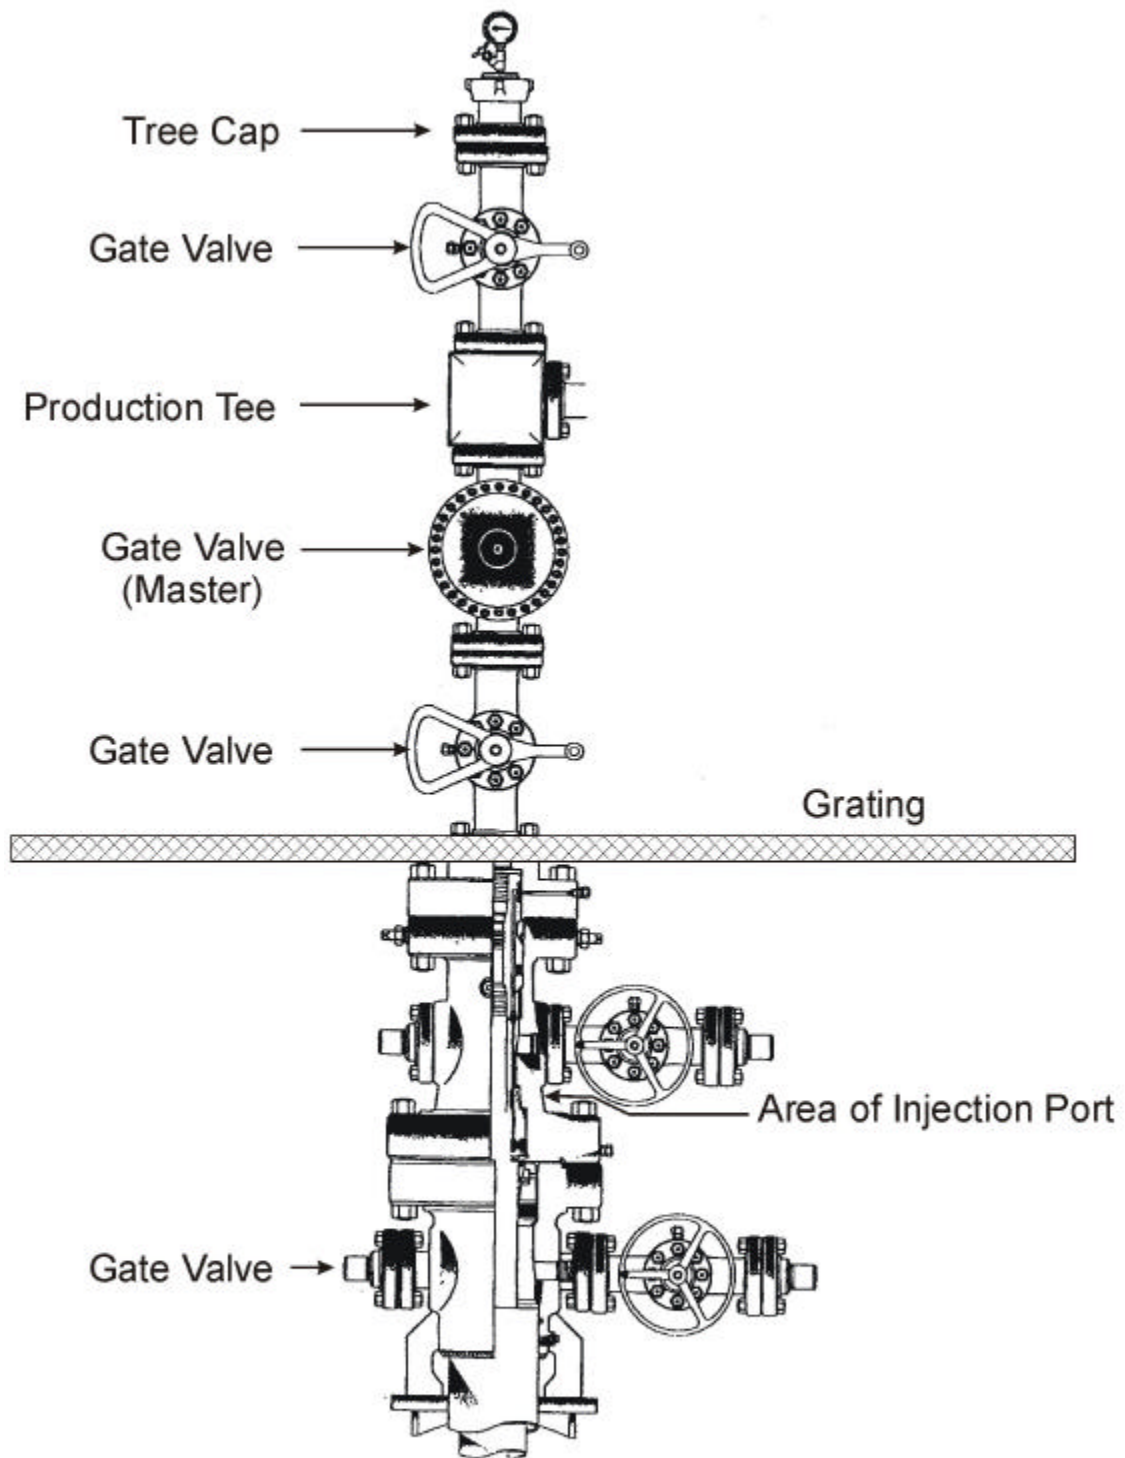
Wellhead Diagram

The seal assembly is designed with a bi-directional Chevron packing set that is energized by plastic packing injected through the packing ports. If the seal assembly had been present and was functional, by design, the pressure could not have been present at the packing injection port. However, with the seal assembly absent or not functional, any pressure from the well could have migrated to the port from above or below the seal assembly. In this incident, casing pressure was noted during the well kill stage of the project.

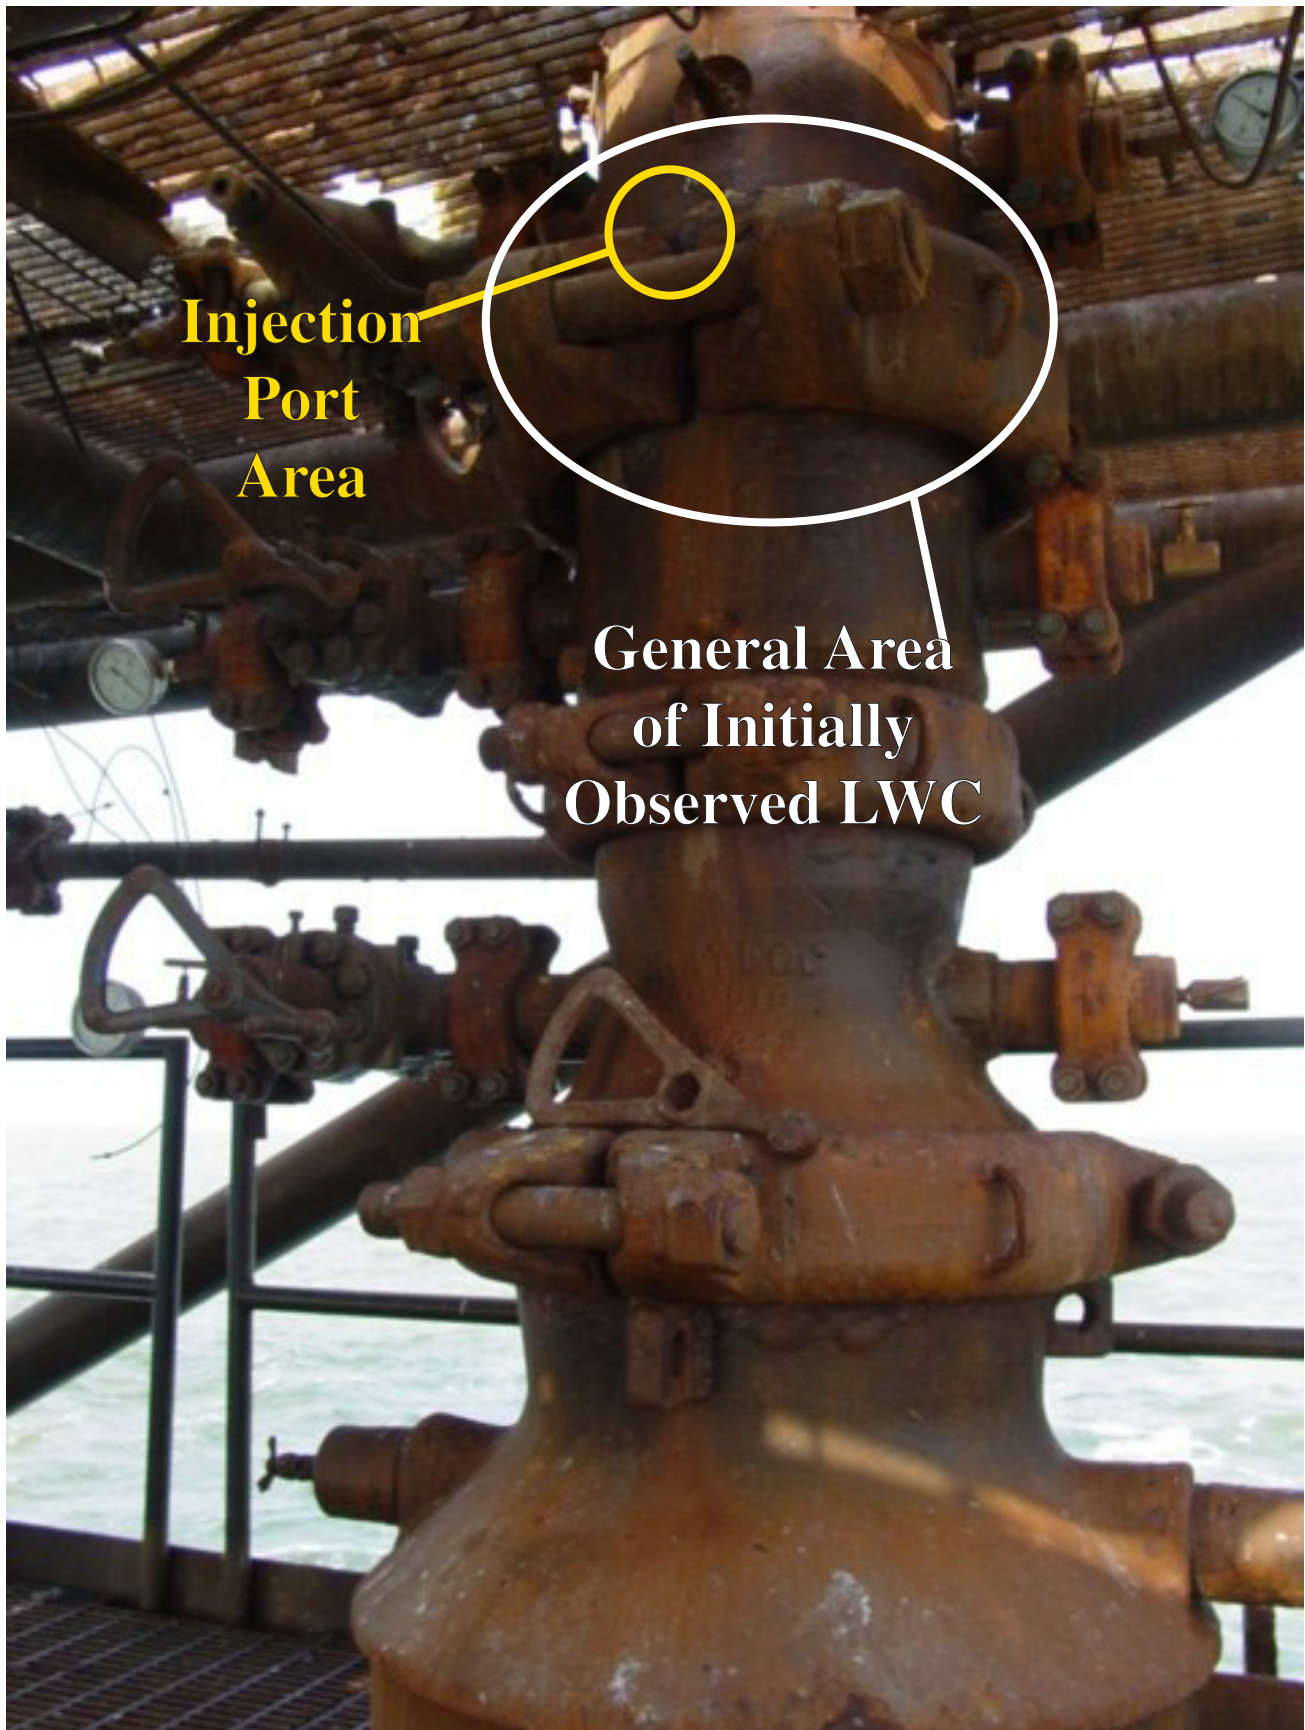
Photograph of Wellhead Below Workover BOP

leaking from around the wellhead, below the BOP stack. The rig crew started pumping seawater as the kill fluid, and non-essential personnel were evacuated by 1100 hours. Well Control experts arrived by 1430 hours, and the wellhead pressure was reduced to 0 psig by the next day. There were no injuries and no pollution associated with this LWC. The injection fitting port on the wellhead that is used to inject a plastic energizer for the wellhead seal assembly failed. The failed port, together with a missing wellhead seal assembly, allowed for the LWC.

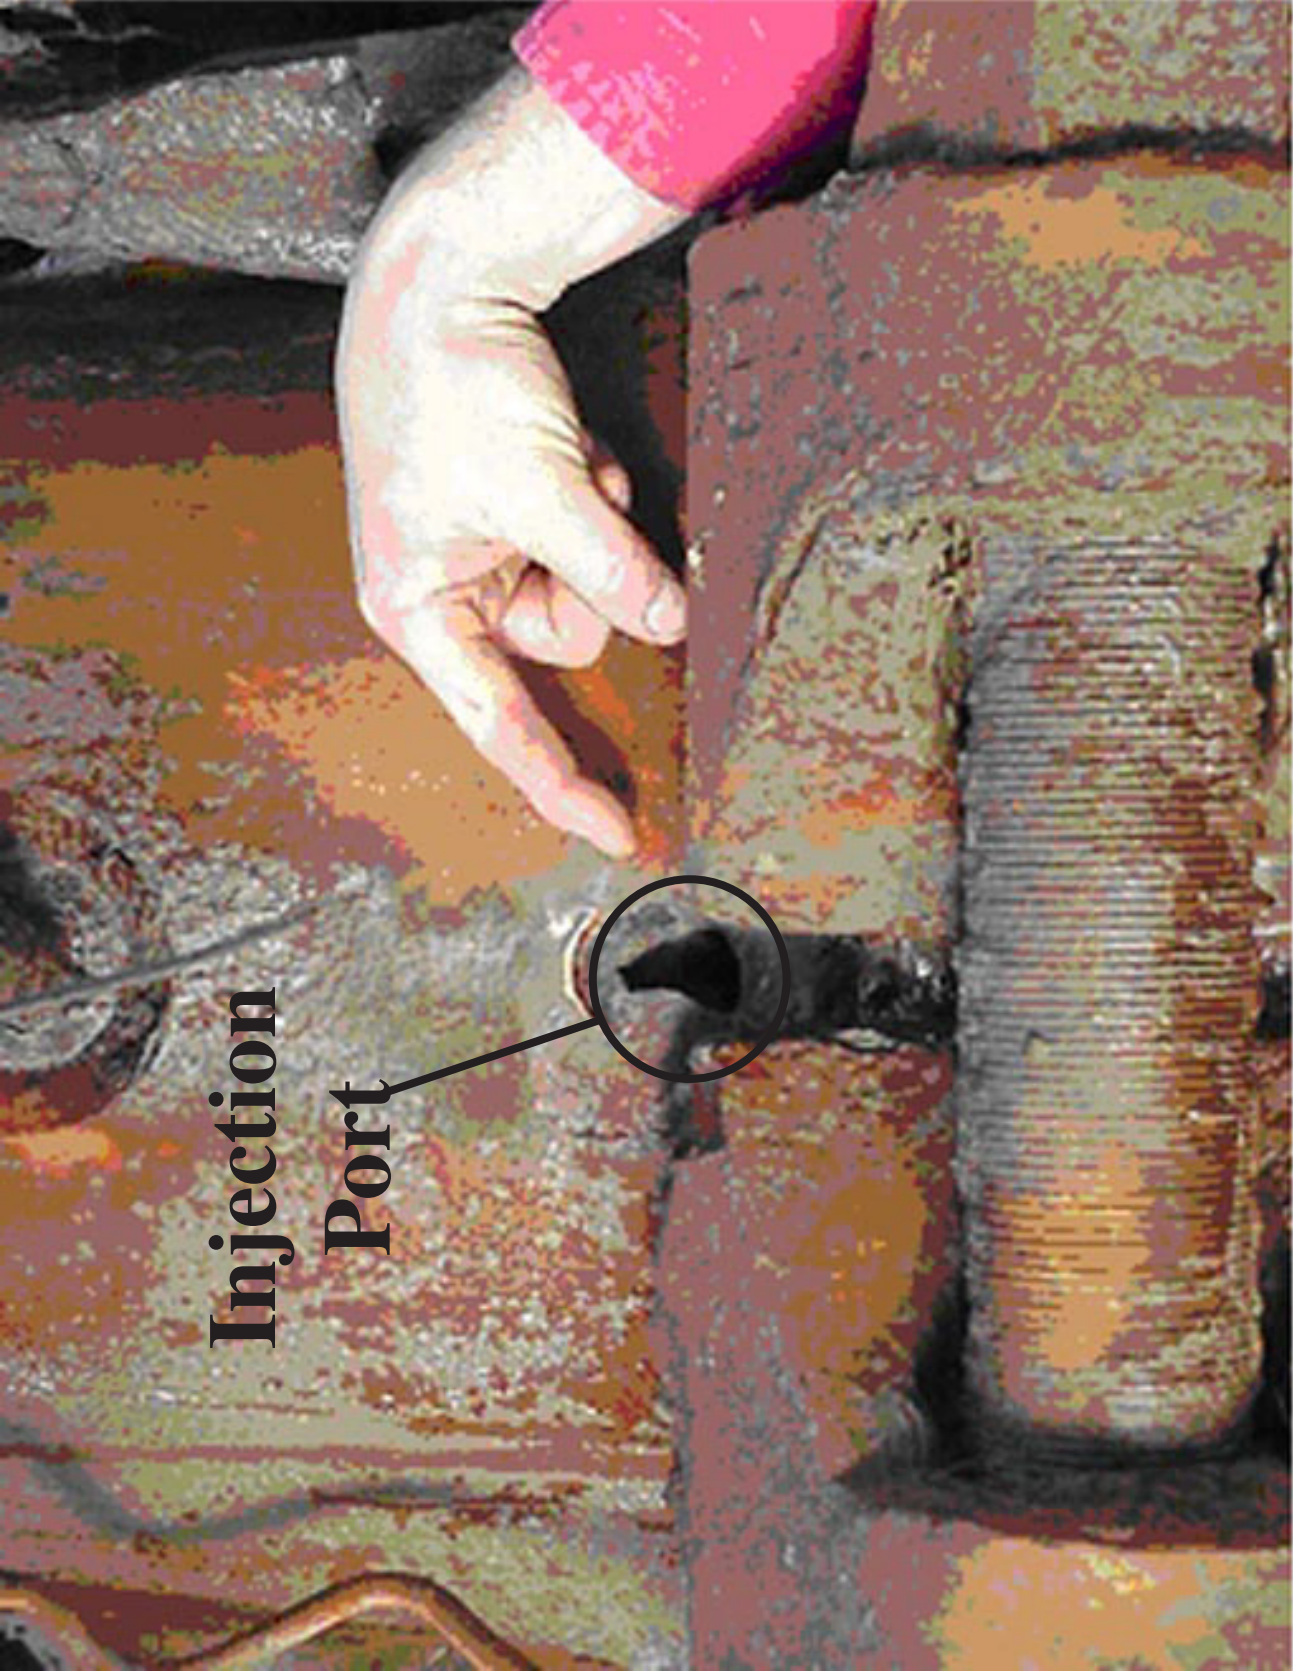
Photograph of Injection Port

Between 1015 and 2400 hours, pressure increased on the annulus with sand and gas blowing from the injection port on the wellhead. *For a photograph of the injection port area (where the fitting was prior to the LWC), see Attachment 5. For a photograph for another corroded injection port and fitting on Well CA-1, see Attachment 6.* The injection port welded fitting was absent. All nonessential personnel were evacuated by 1100 hours. Well control specialists (Boots and Coots) arrived on location at 1430 hours.

The injection fitting port that failed on the wellhead is designed to contain (trap) pressure around the pack-off assembly. Under normal circumstances, the seal assembly would have isolated the section of the tubing head above the pack-off from tubing/casing annulus pressure below. Once pressure is relieved above the pack-off assembly (as would have happened if the seal assembly and packing failed), the wellbore pressure below or above would be in communication with the injection port. Similarly, if there were no seal assembly installed in the wellhead, well pressure could be exerted on the injection port.

This LWC event was a result of the compromised plastic injection fitting port which, when breached, released trapped pressure to the atmosphere. Severe corrosion and metallurgical fatigue from extended service within the harsh “splash zone,” coupled with the absence of historic maintenance, caused the plastic injection port fitting to fail. Increased pressure was momentarily seen on the port as a result of a missing seal assembly and packing in the Gray tubing head.

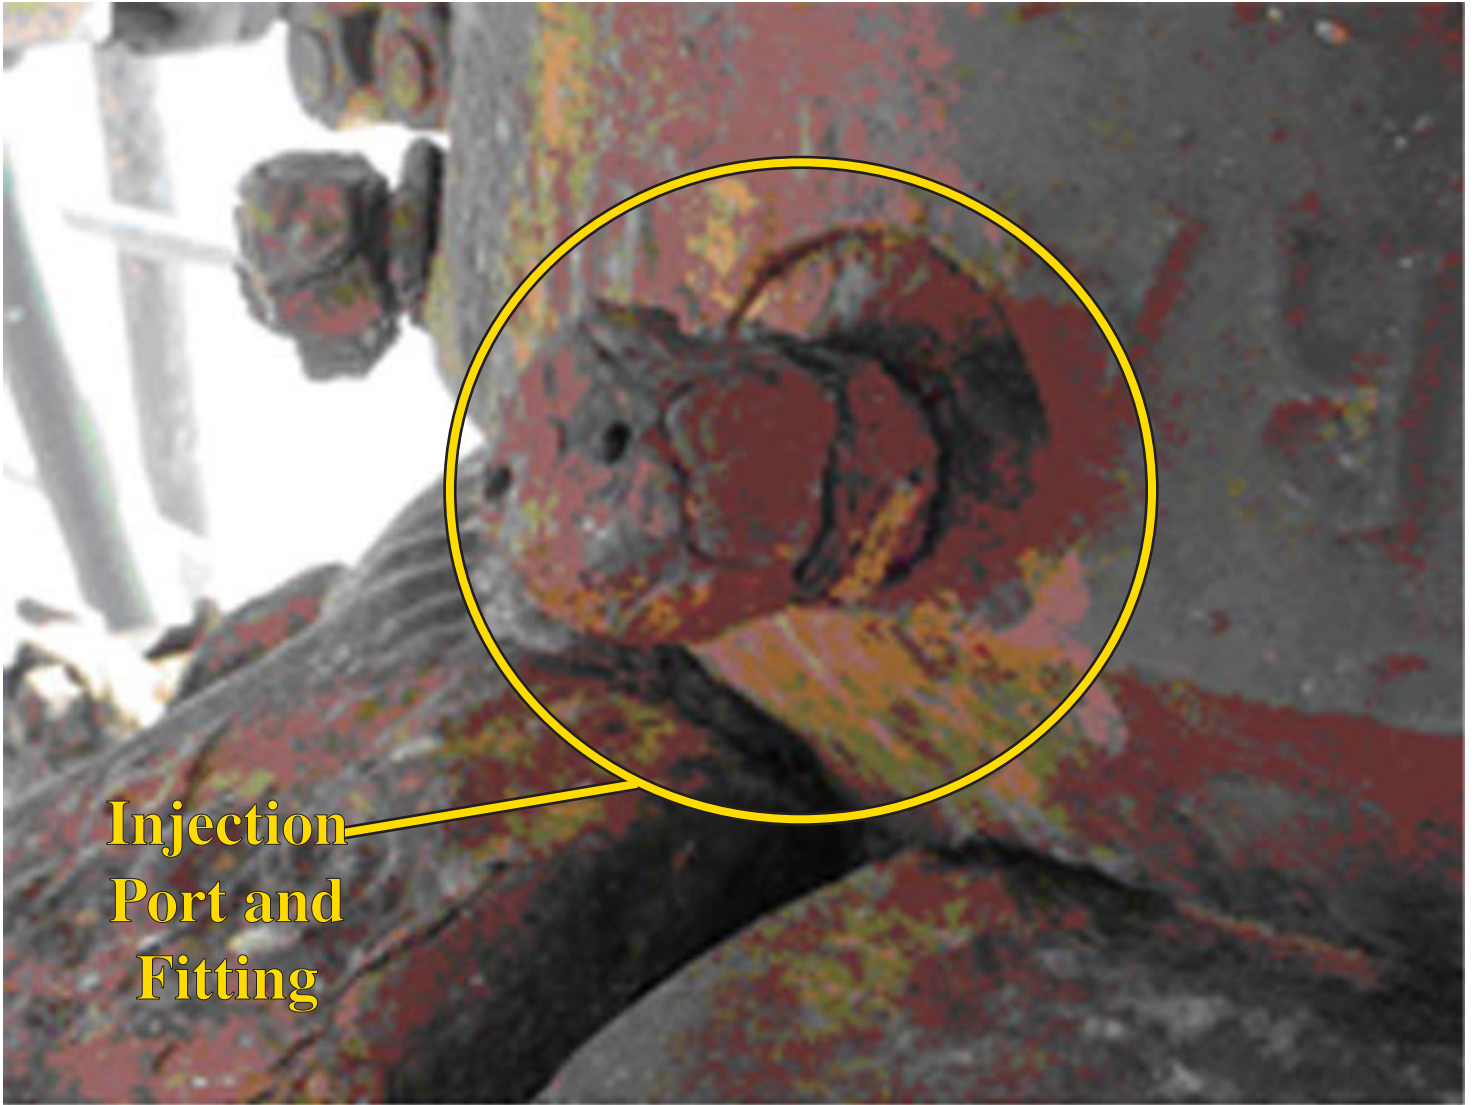
**Injection
Port and
Fitting**

Discussions were held by the panel members with ABB Vetco Gray (ABB), the manufacturer of the wellhead equipment. ABB indicated in a written statement to the panel members that this type of leak is extremely rare, and that they have not witnessed this type of failure on their high-pressure wellhead equipment before. ABB indicated that the failure was not due to galvanic corrosion since the tubing head was manufactured from low-alloy (85,000 psig) material, and the fitting was manufactured from carbon steel.

Photograph of Corroded Injection Port and Fitting

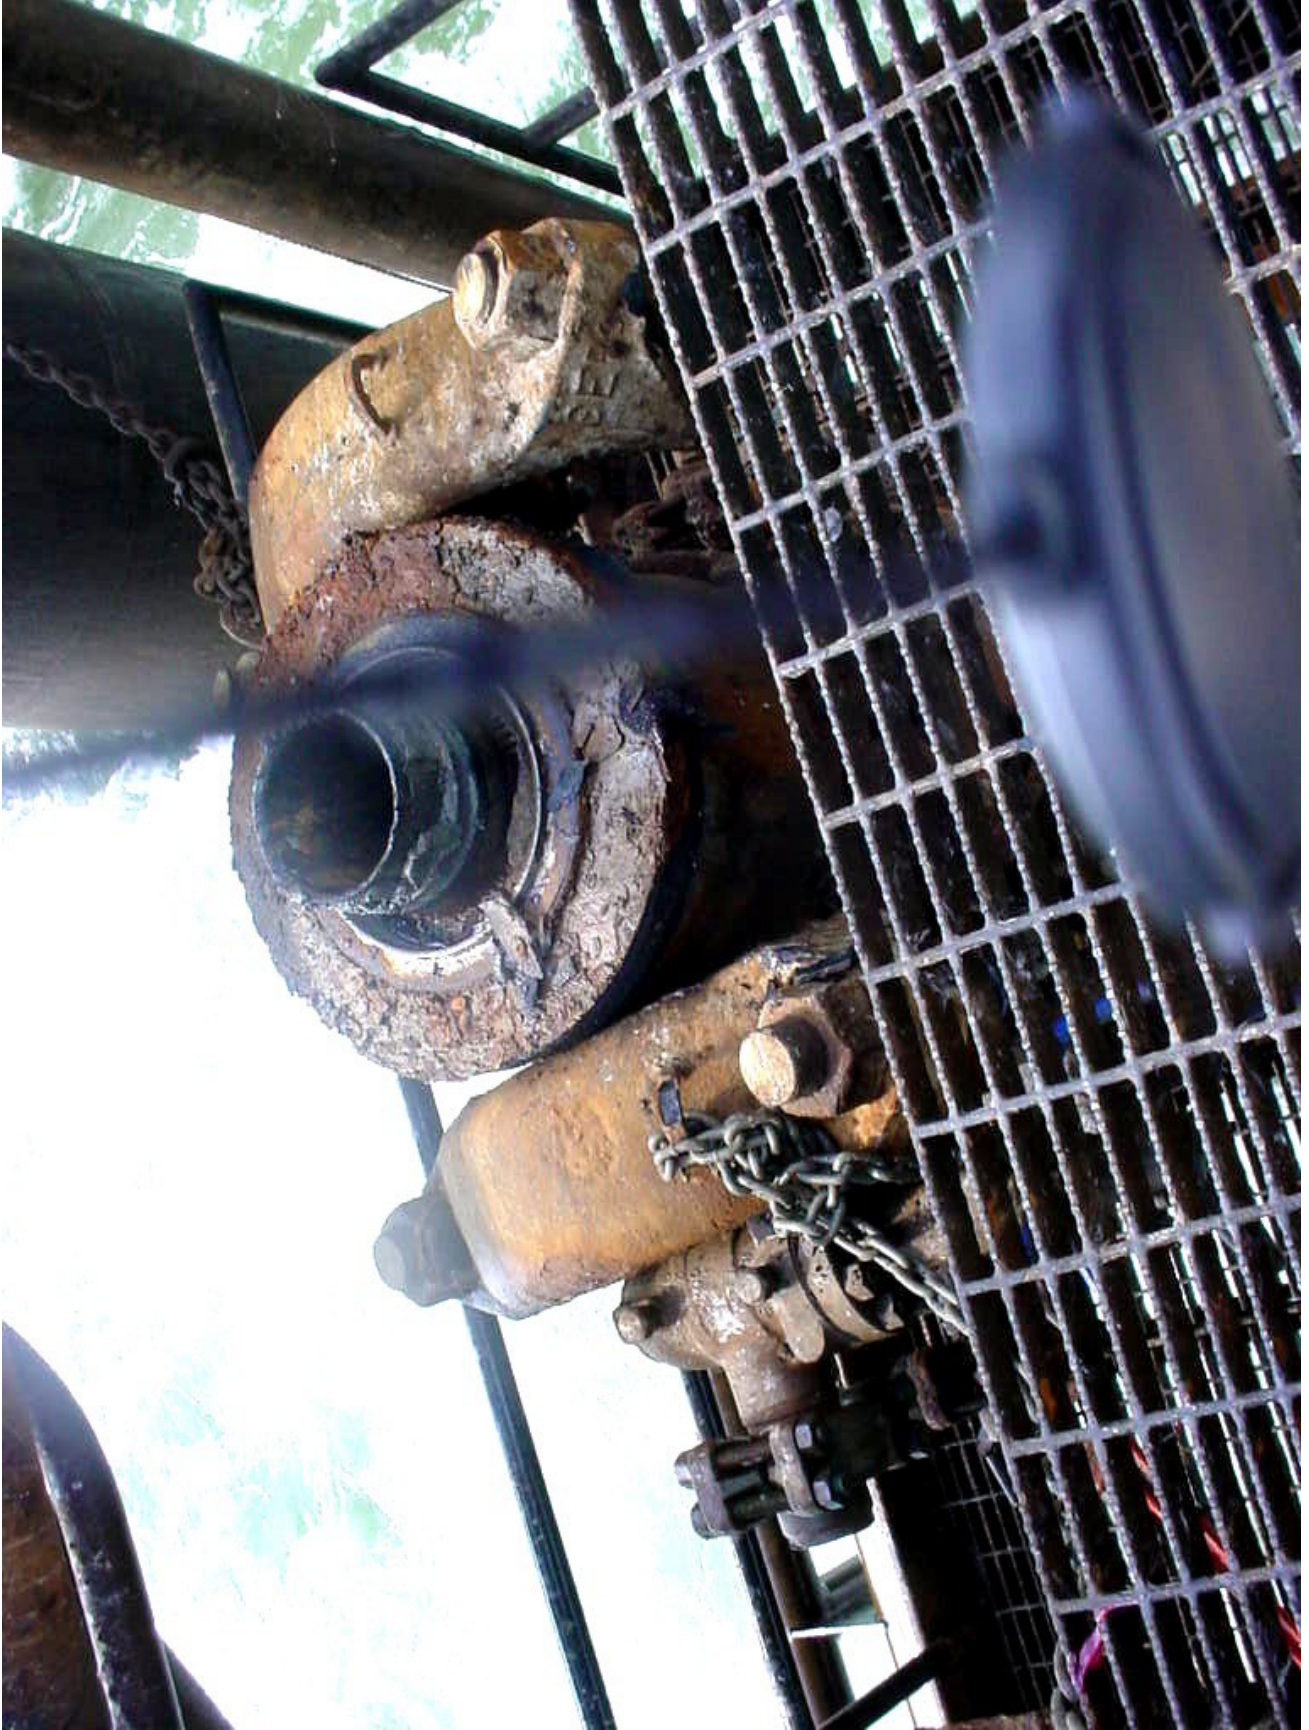
Photograph of Wellhead

After the incident was brought under control and the well secured, Orca commissioned Petroleum Professionals International (PPI), an oil field engineering consulting firm in Houston, Texas, to witness and report observations during the removal of the damaged wellhead. *For a photograph of wellhead and tubing head, see Attachments 7 and 8, respectively.* The PPI report states in part that there was no evidence of any seal assembly and packing in place in the Vetco Gray tubing head and that there was external corrosion of the wellhead and packing injectors. *For a photograph of wellhead showing the corrosion, see Attachment 7. For a diagram of the wellhead, see Attachment 9.*

repair. Parts listed for replacement or repair included grease fittings, packing injection fittings, pipe plugs, ring gaskets, bull plugs, studs and nuts, lock screw assemblies for tubing spool, bonnet for annulus valve and bonnet seal ring, as well as blasting and painting requirements on lower wellhead connections. For most of the 47 wells inspected, including the subject well, it was confirmed that most components on the wellheads and casing heads were severely corroded and their functionality was questionable.
