OCS Report  
MMS 2004-078

**Investigation of Fatal Accident  
West Cameron Block 424, Well No. 1  
OCS-G 24745  
7 April 2004**

Gulf of Mexico  
Off the Louisiana Coast

U.S. Department of the Interior  
Minerals Management Service  
Gulf of Mexico OCS Regional Office

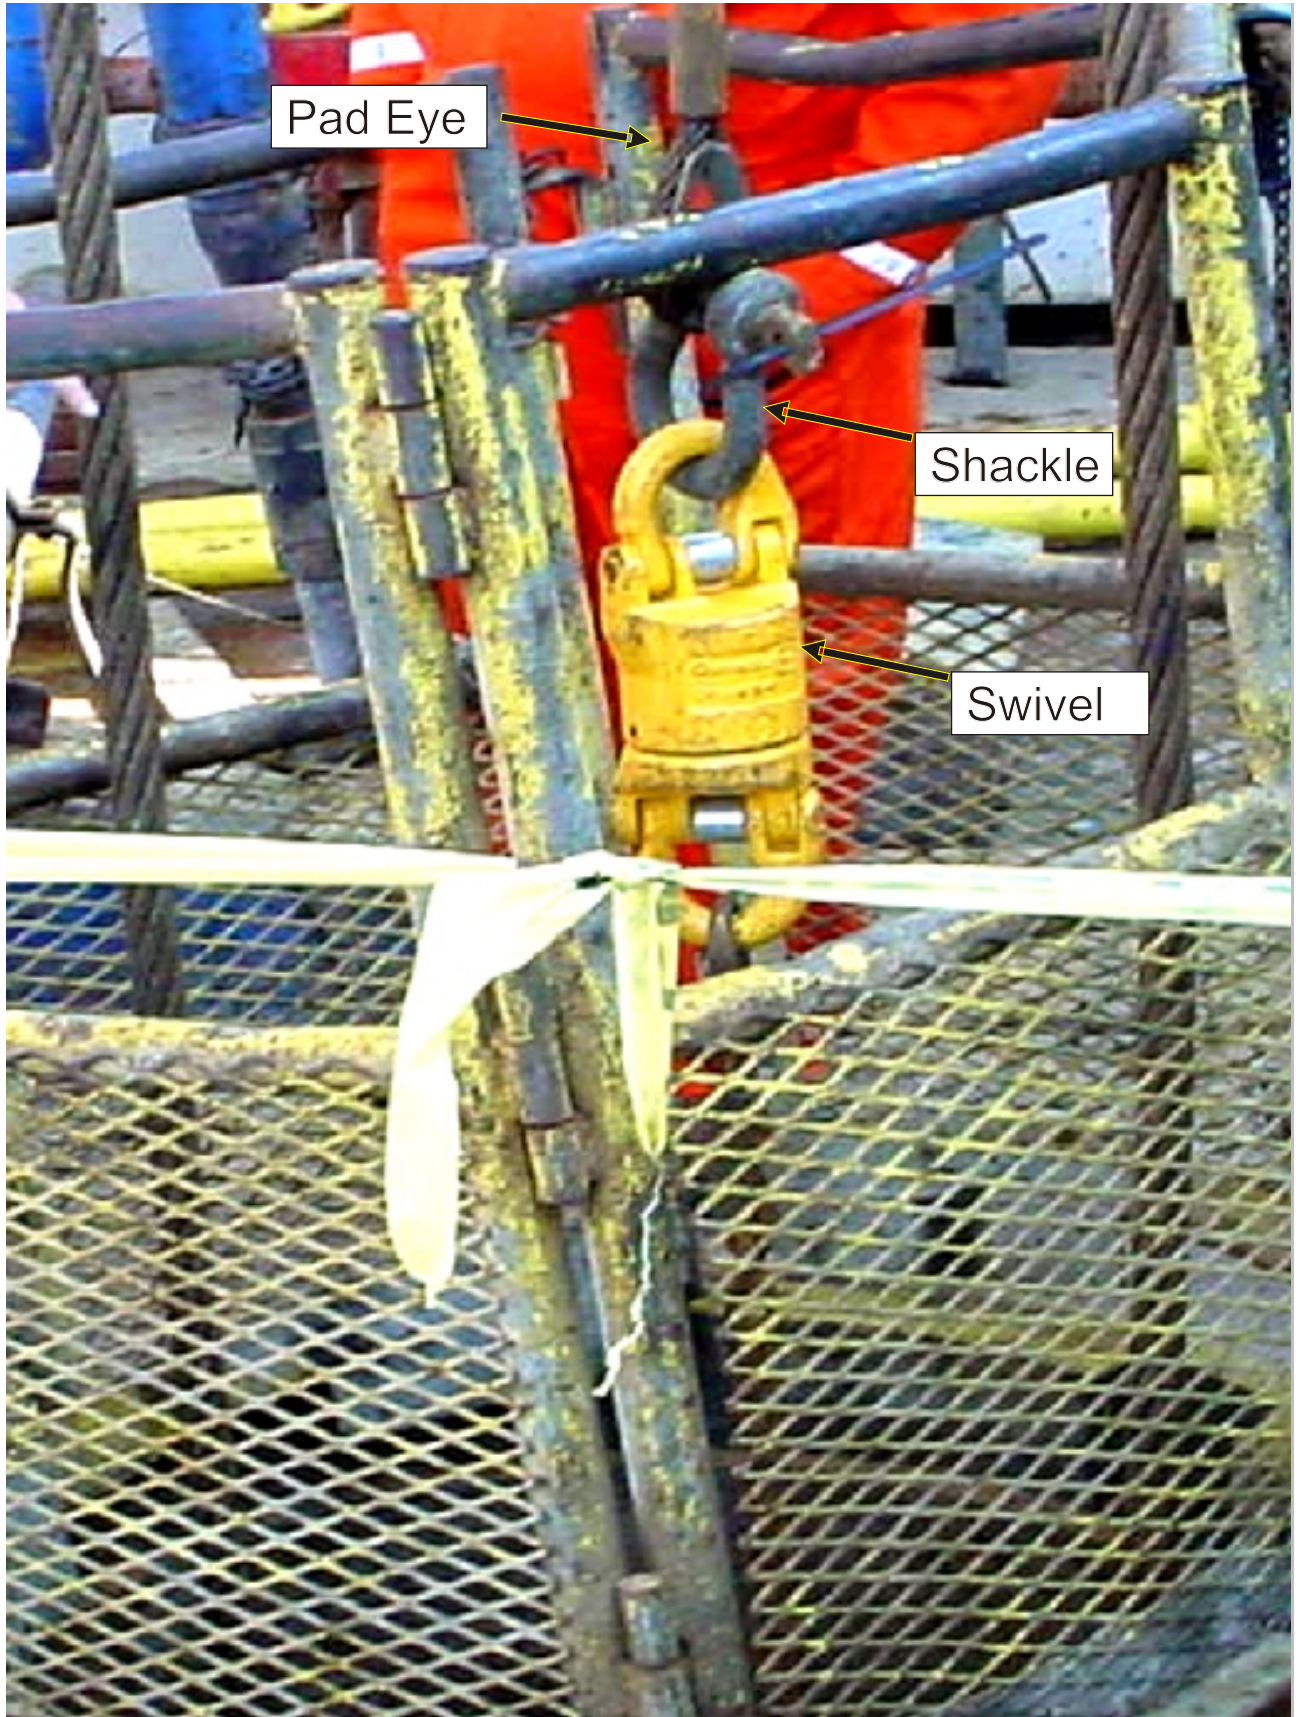
**1700 hrs** – The day shift, crew “B,” rigged down surface lines. From testimony, the hoist assembly was installed by the day shift, crew “B,” prior to the start of duty of the night shift, crew “B.” The hoist system included the *Ingersoll-Rand Model HUL-40* hoist, the *Kennedy Wire Rope and Sling Company* hoist chain assembly with weighted swivel, and a 7/8-inch *Crosby* shackle (*see Attachment 2*).

1. It is probable that the method of employing the shackle in the hoist assembly directly contributed to the accident.

(a) The shackle was installed, pin facing up, with the load suspended from the bow of the shackle. Had the shackle been installed with the pin down, it is probable that the pin could not have caught the barricade securely enough to lift it.

Hoist Assembly Including Shackle, Swivel, Pad Eye.

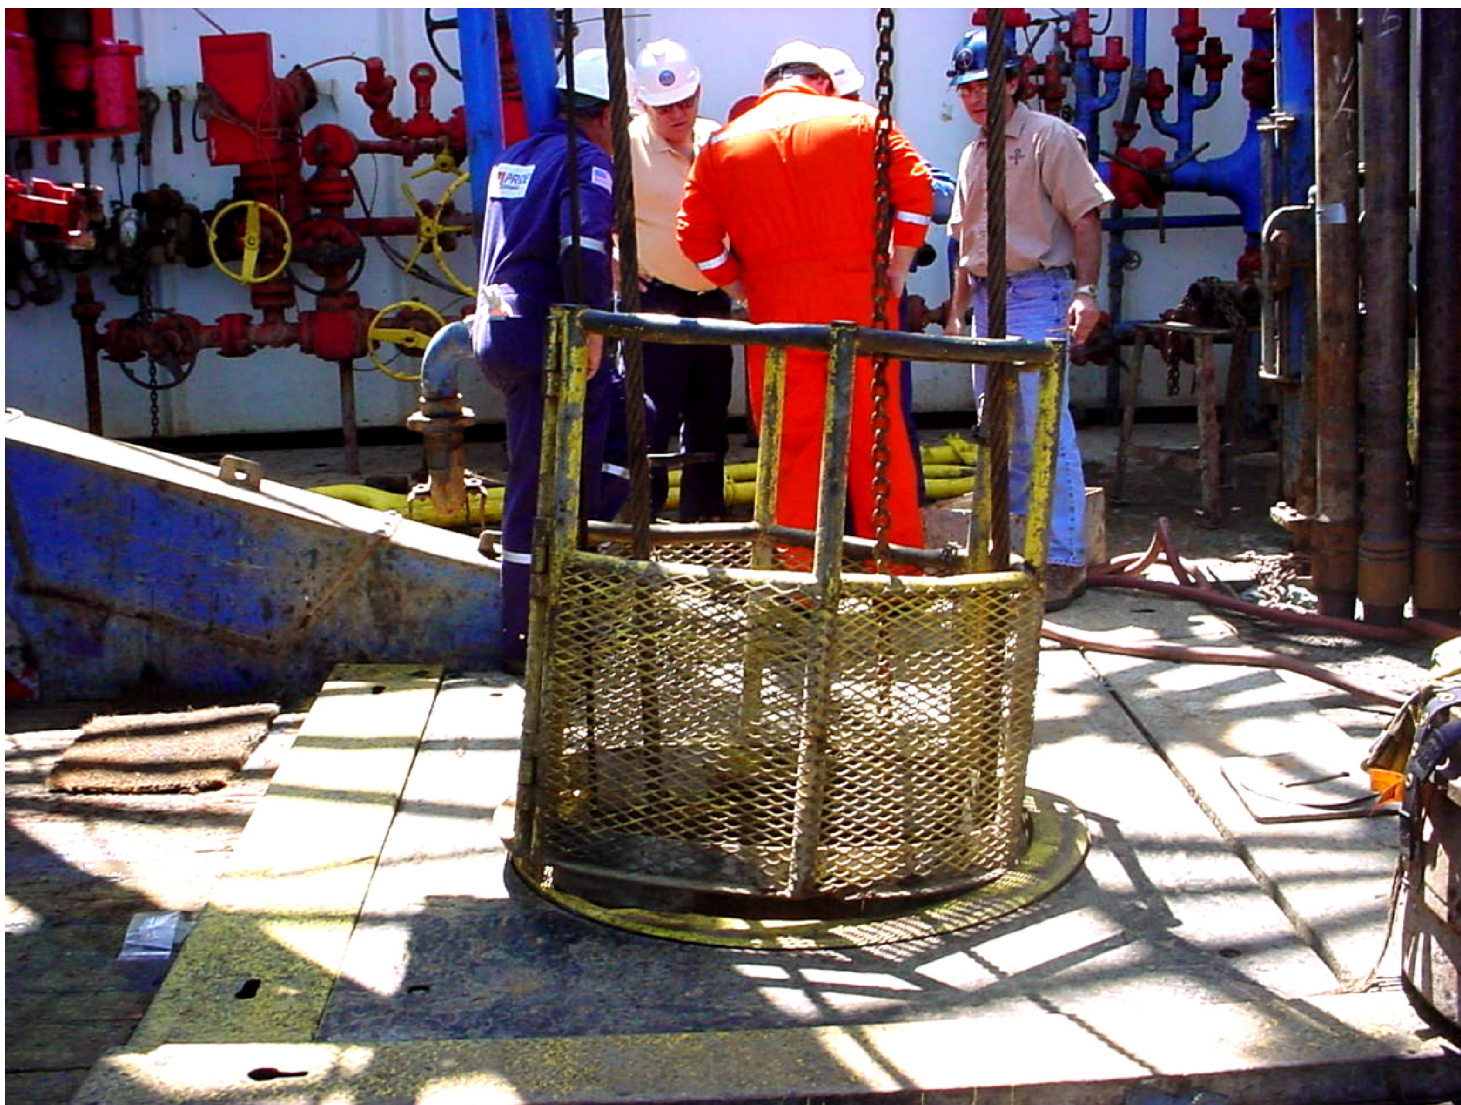
**0130 hrs** – While waiting on cement, the night shift prepared to rig up the diverter system and continued work preparing the blowout preventer (BOP) stack for future use. A decision was made at a JSA meeting to lift personnel into position to install the diverter, using the rig floor hoist system with lift lines run through the rotary. The night shift removed the master bushings in the rotary and installed a Contractor-manufactured rotary barricade (*see Attachment 3*) around the opening in the rotary floor.

The Contractor’s investigators testified that, from the position of the barricade, it is likely that it was lifted and then dislodged, falling and striking the AD. Other post-incident visual evidence was noted by the inspectors. The rotary barricade was found severely deformed with structural failure at welds and it would no longer fit into the rotary table because of distortion. Human tissue and hair resembling that of the AD were collected on the bottom cage of the barricade.

Contractor Manufactured Barricade.

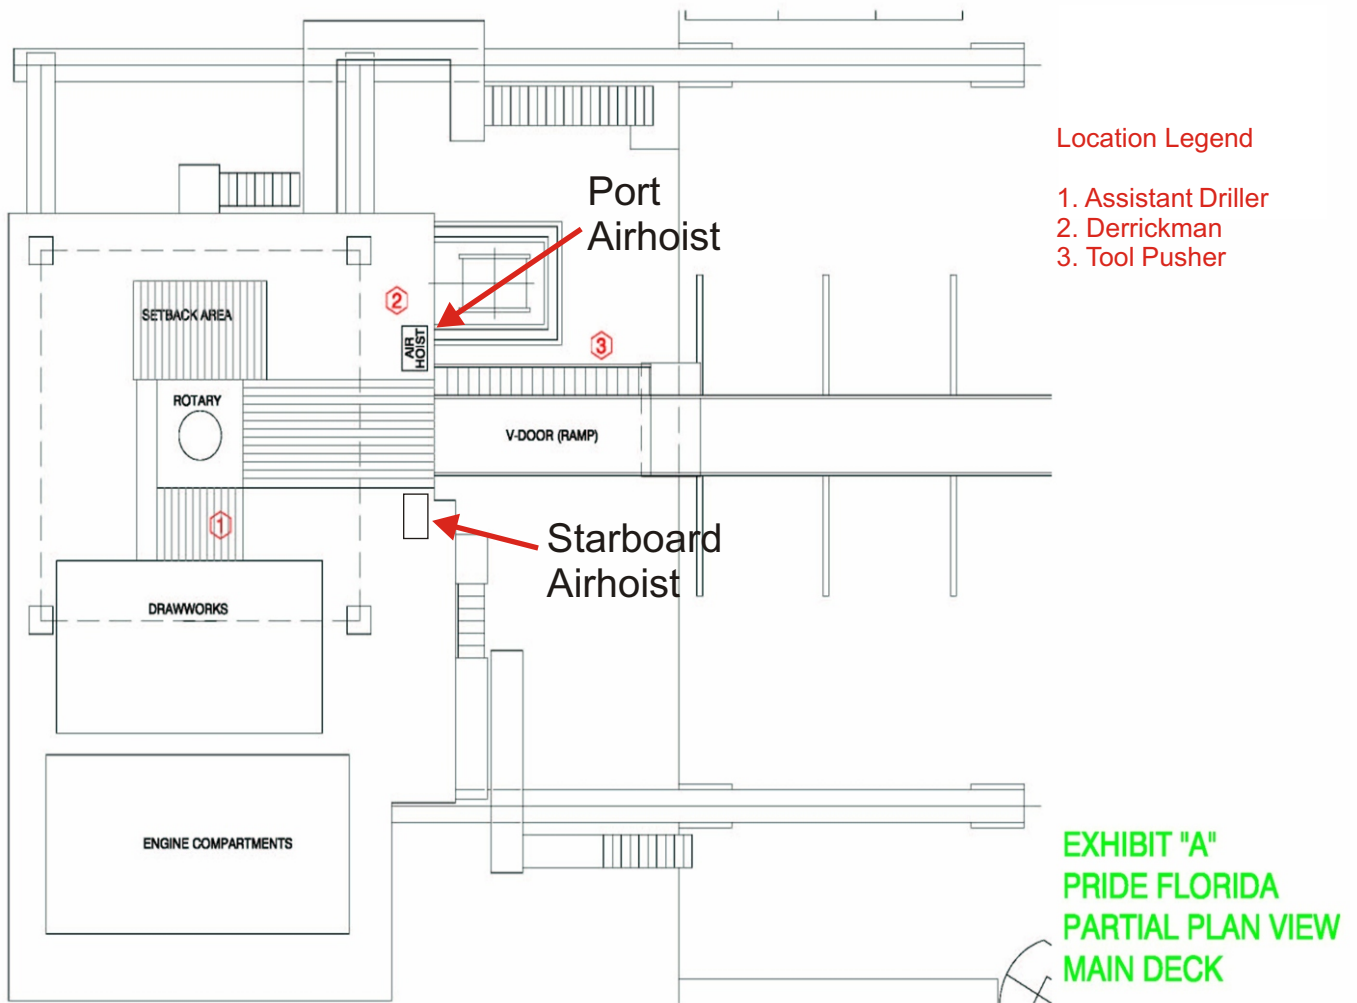
At 0245, from testimony, the derrick man heard a loud noise and hoisting operations were halted. The derrick man then observed the AD lying on his back on the drill floor with his head in the direction of the draw-works and his feet adjacent to the rotary. The derrickman then noticed the rotary barrier had been moved and was now cocked and wedged in the rotary instead of sitting upright, squarely surrounding the opening.

Location of Personnel on Rig Floor at Time of Accident.

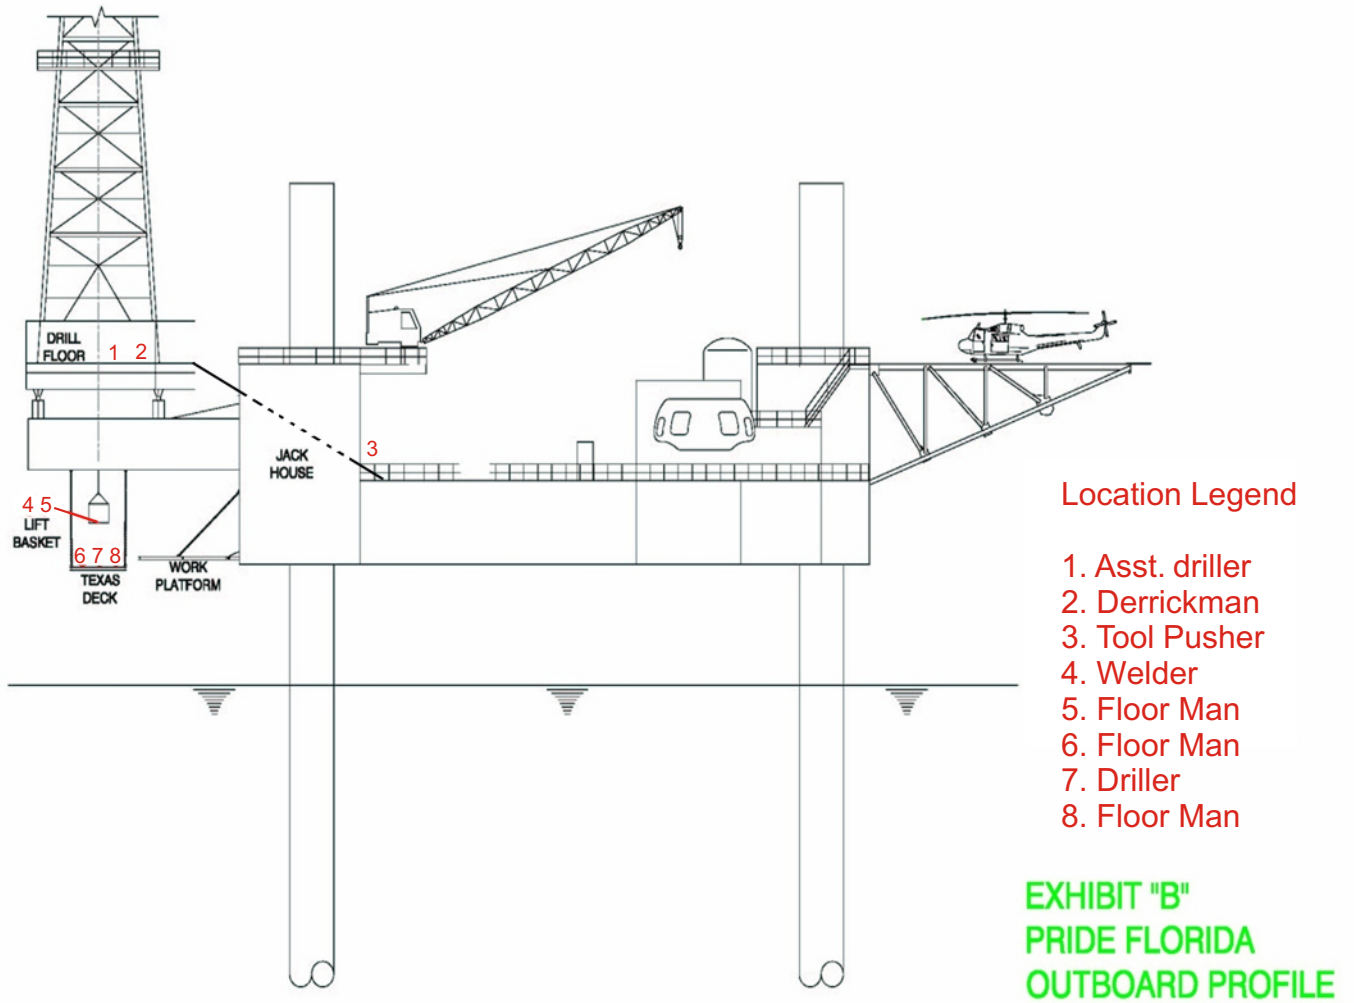
*0245 hrs* – According to testimony, the night tool pusher assigned himself the duty of being the flag man on the main deck, providing line-of-sight between the man-riding work basket beneath the drill floor and the hoist operator located on the drill floor (*see Attachment 6*). The AD was “spotting” above the rotary on the drill floor with the derrick man operating the port side hoist controls, also on the drill floor. The port side hoist was connected through the rotary to the hoist basket on the texas deck.

Location of Personnel on Texas Deck at Time of Accident.

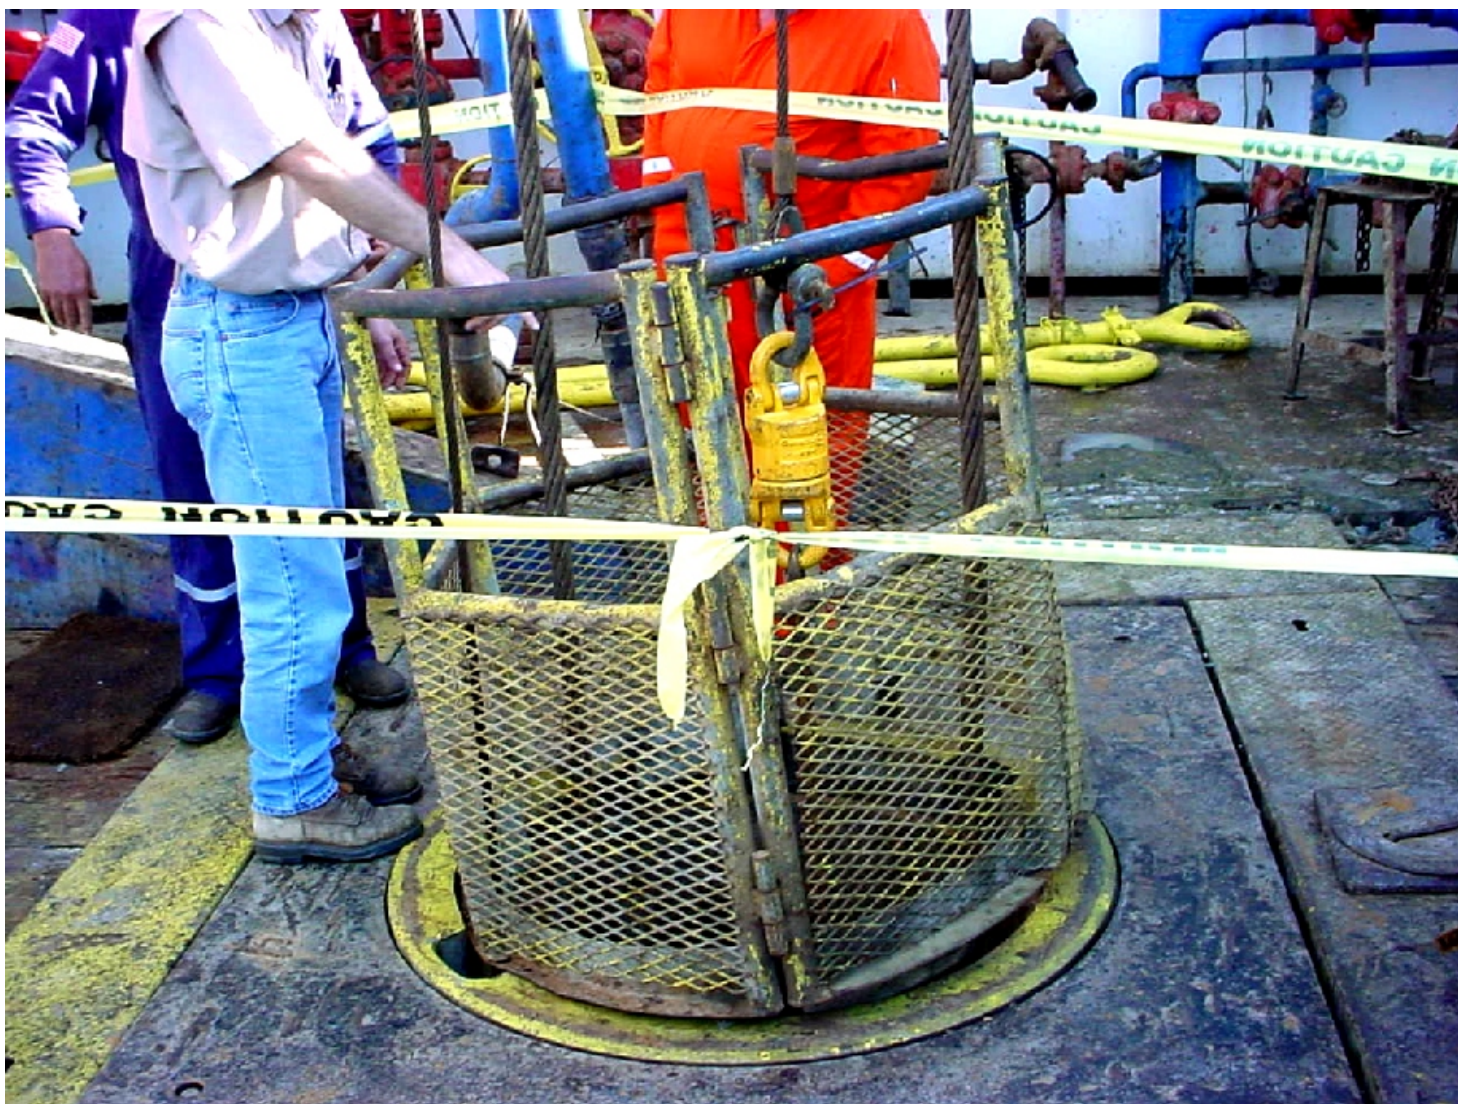
Attempts were made by Contractor personnel, witnessed by MMS inspectors, to re-create the lift operation to confirm the shackle, as installed, could have snagged the barrier. After two simulations with the assumed conditions, it was observed that the shackle did hang up on the hand rail of the rotary barricade as the swivel/shackle was hoisted through the rotary. During the simulation, the barrier remained caught by the shackle and was freely raised from the rig floor (*see Attachments 7, 8, and 9*).

Barricade and Lift Assembly, Start of Reenactment.

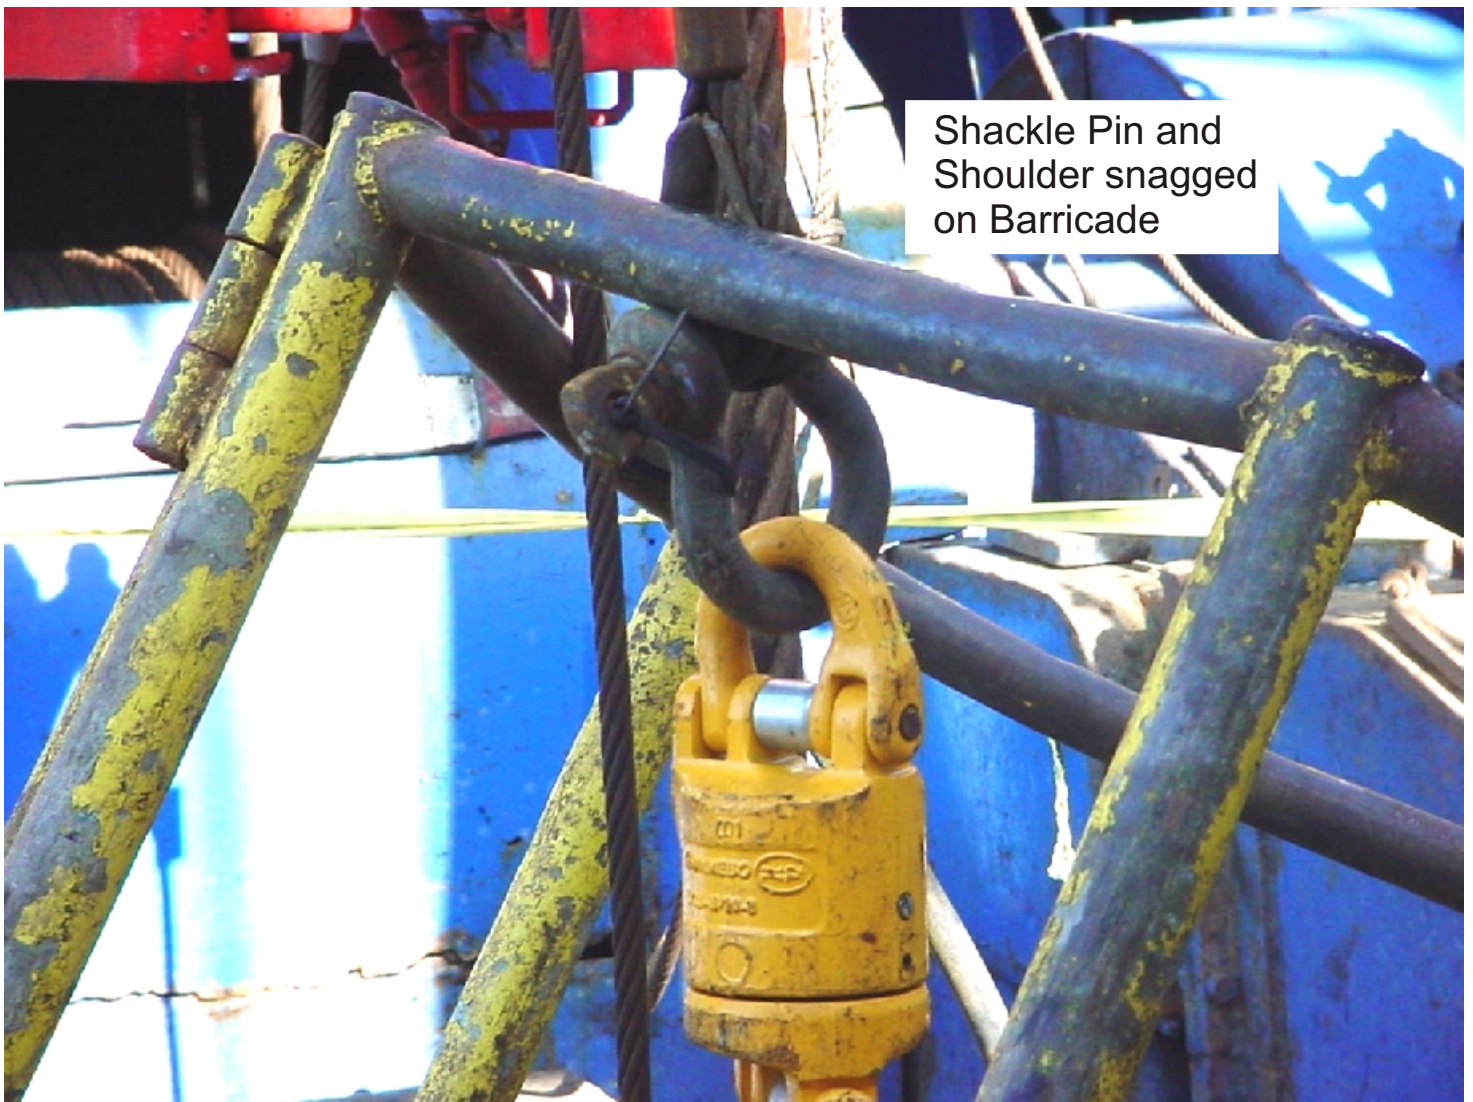
Barricade and Lift Assembly Snagged by Shackle During Hoist, Reenactment.

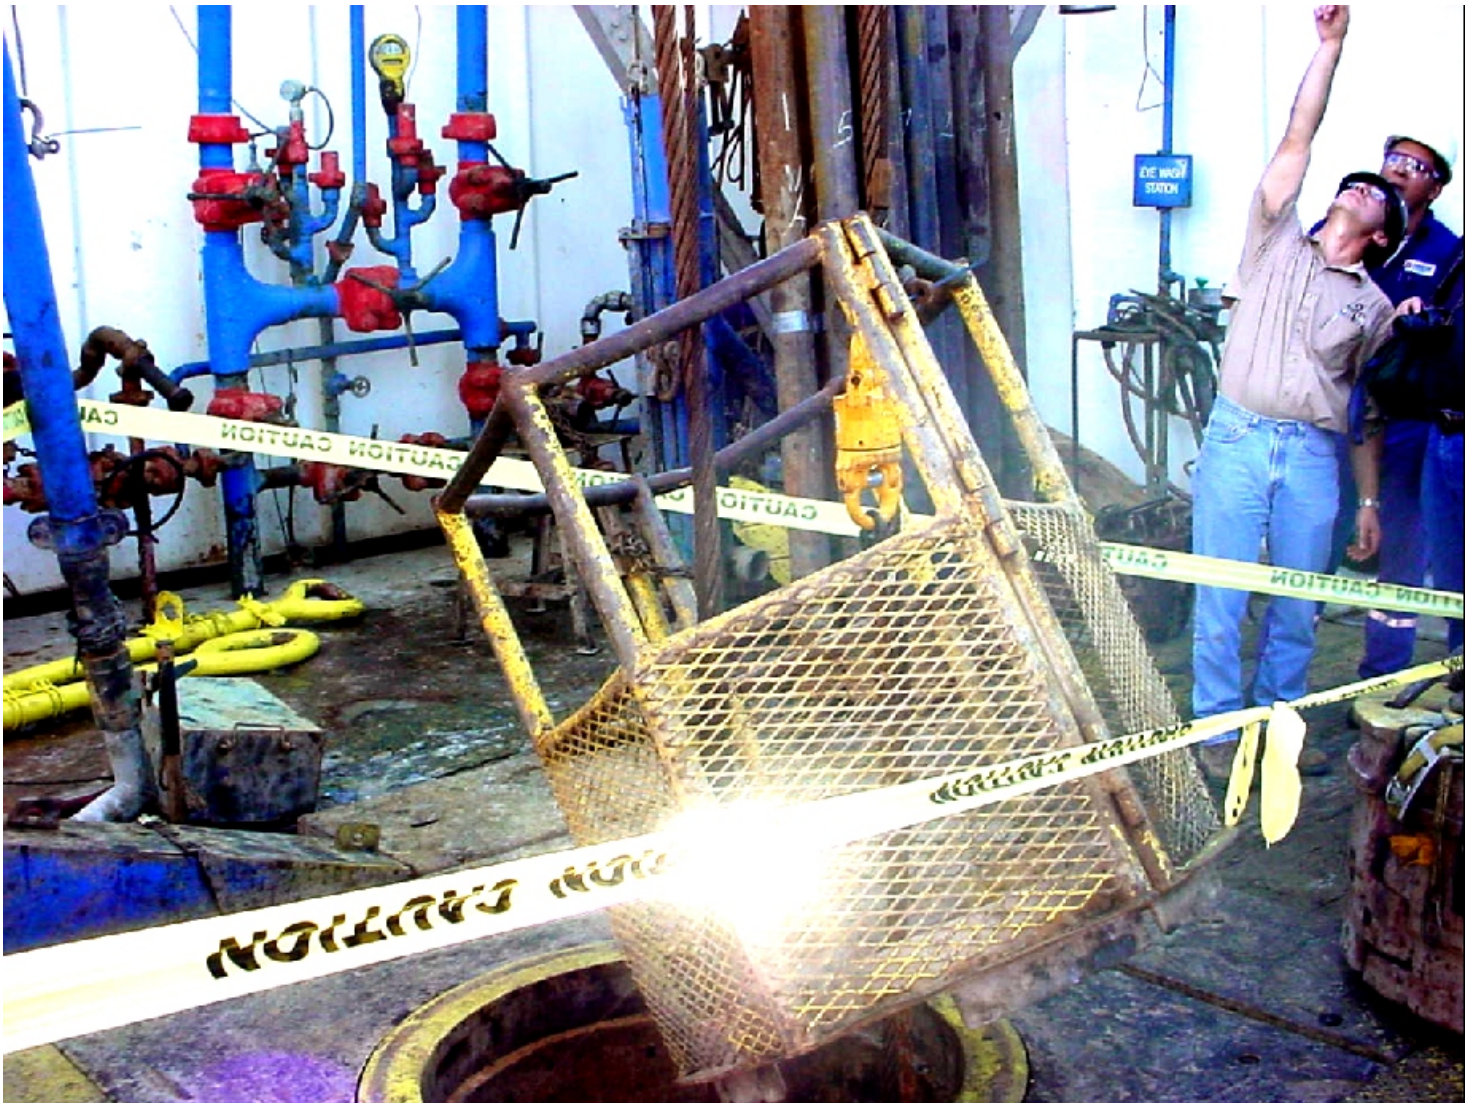
Barricade Lifted by Shackle, Reenactment.

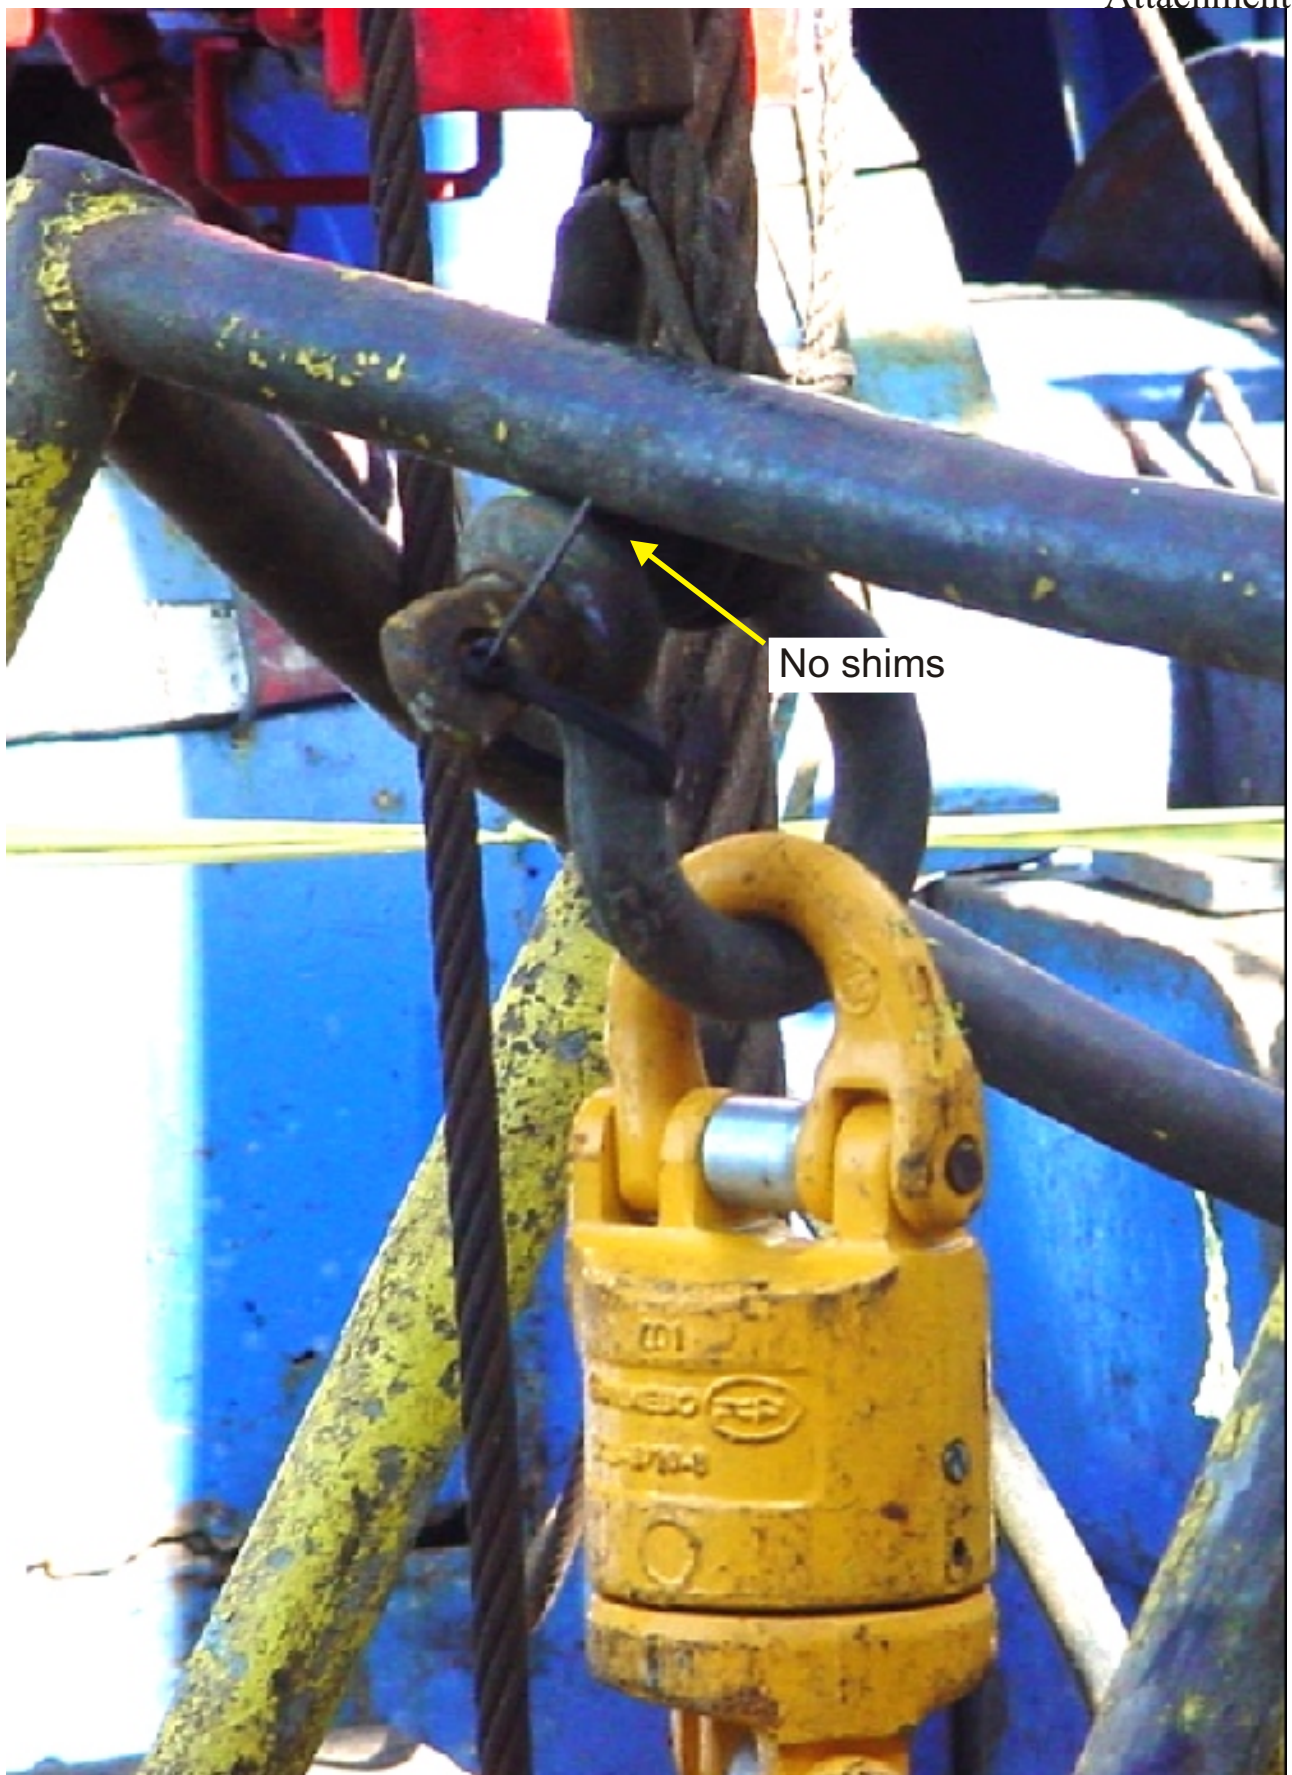
The catalogs of the manufacturer of the shackle were consulted for the manufacturer's recommendations on the use of shackles in a lift assembly. The catalogs recommend that any load on the pin of a shackle be "reasonably centered with shims." A pad eye width of a minimum of 80 percent of the shackle spread is recommended as best practice.

From examination of the shackle and pad eye of the assembly used during the accident, the pad eye was considerably less than 80 percent of the pin and was not shimmed (*see Attachment 10*).

Un-shimmed Shackle Assembly Snagged on Barricade, Reenactment.

It is recommended that MMS issue a Safety Alert warning about the dangers of using an unshimmed shackle in a lift in a configuration and circumstance that allows snagging on other equipment.
