## BASRAH INTERNATIONAL AIRPORT INITIAL AIRPORT MANAGEMENT ASSESSMENT (CLIN 001)

## EXECUTIVE SUMMARY

## 4. CONDITION SURVEY AND OPERATIONAL ASSESSMENT

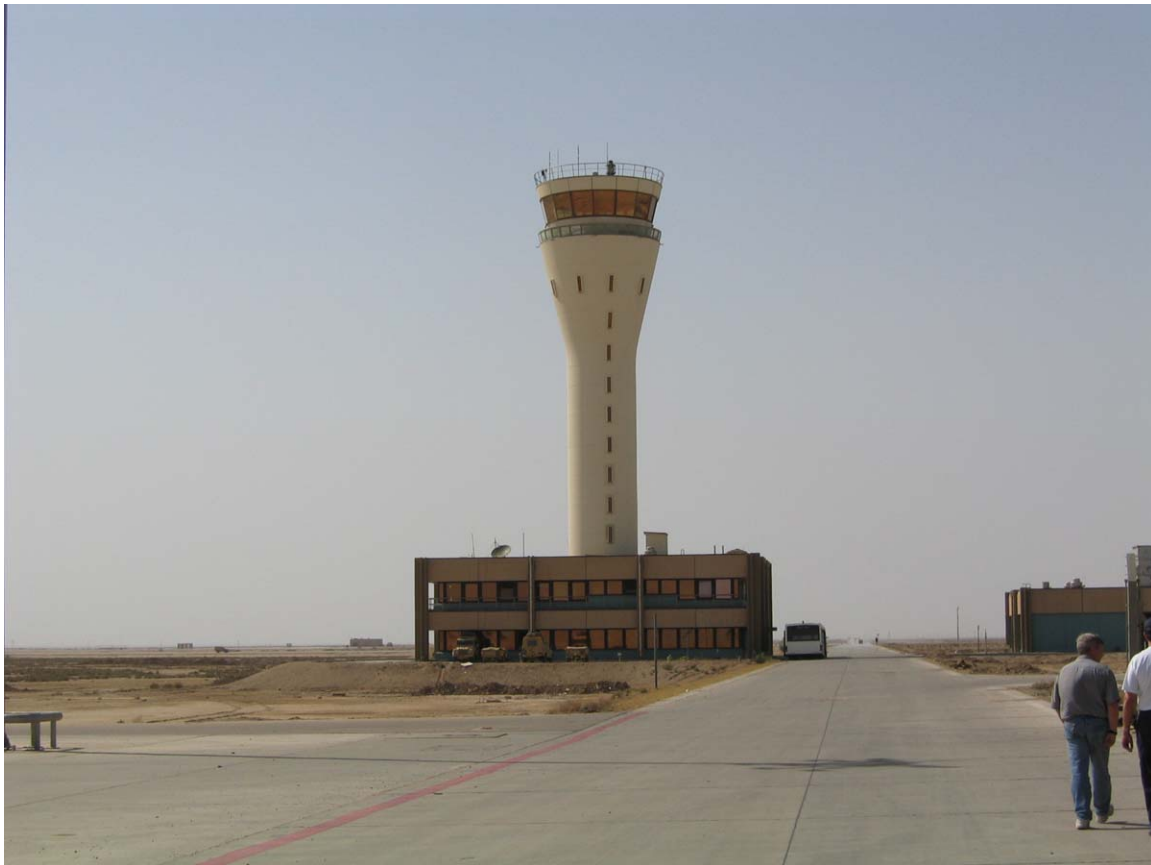
The elevator from the base of the tower to the approach control room is unserviceable and at the moment access to the cab is via a staircase of 220 steps.

Although the structure and the accommodation is in good condition, virtually all equipment is either missing, unserviceable, or obsolete.

*Control tower*

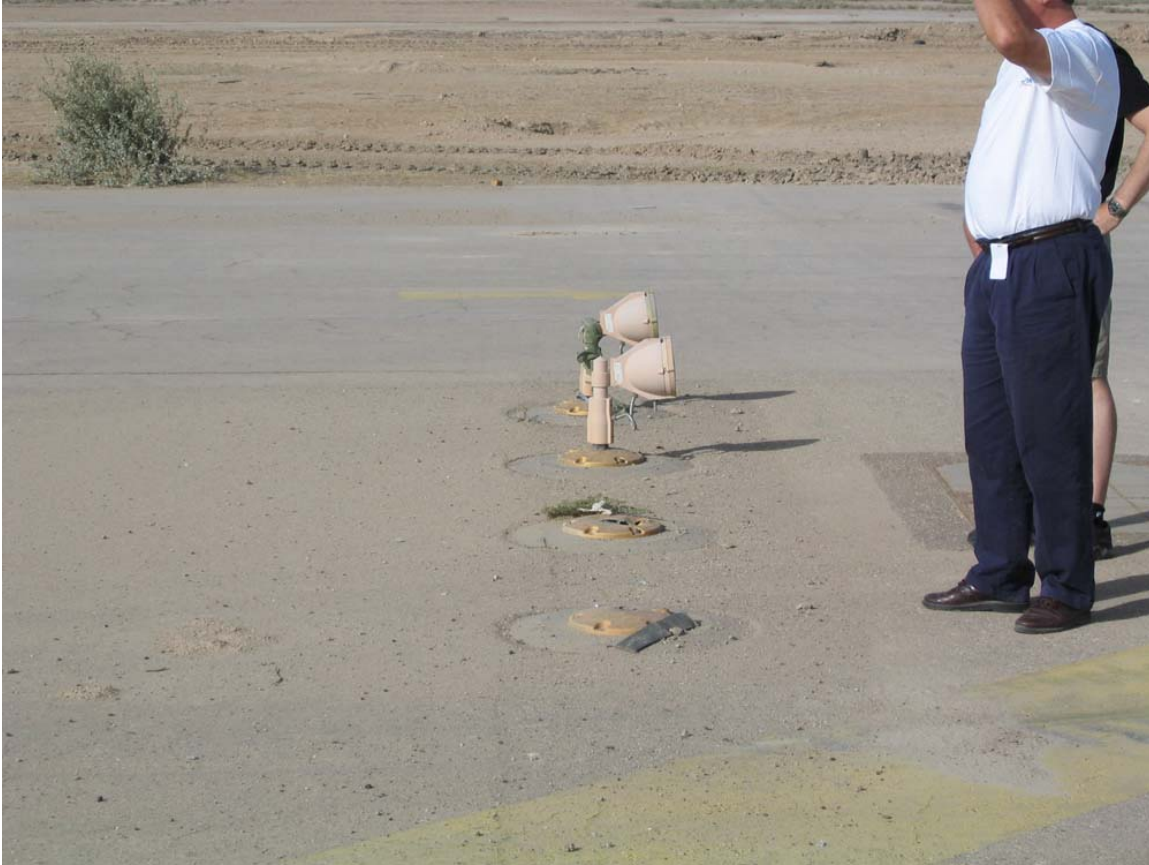
*Damaged approach light fixtures*

- The CAT II approach lighting fixtures and short elevated masts were damaged as a result of tanks and other tracked vehicles running over the fixtures when the Coalition forces entered Basrah International Airport. There are not enough AEG spares in the stores to restore the system and AEG (original manufacturer) no longer exists. The CAT II approach should be replaced at both the 14 and 32 ends.
- The runway edge lights appear in fair condition with some sand scouring on the lenses. The units may be functional but without an energized system, this could not be confirmed. It is recommended that the fixtures be replaced within the existing cans with new units from a supplier that is currently in the business.

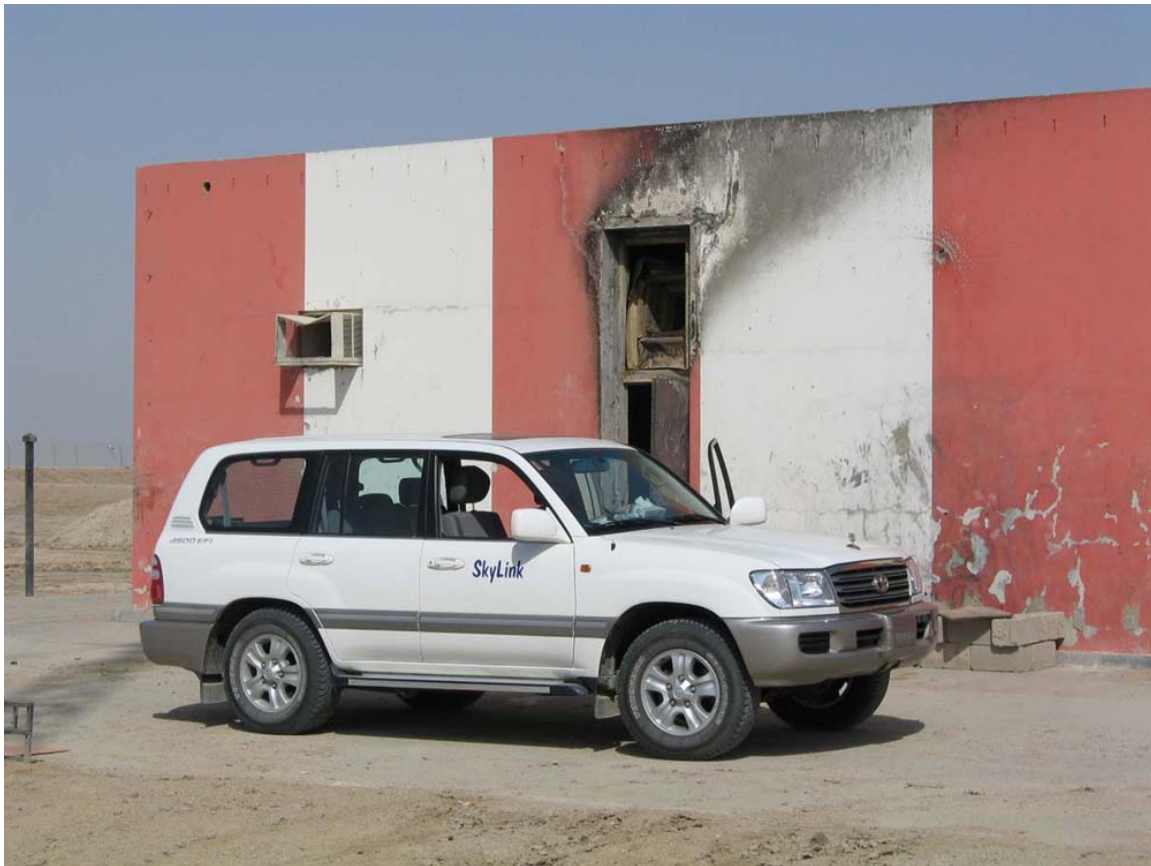
*Damaged transmitter building*

The transmitter and receiver buildings have been completely stripped of equipment, and in the case of the transmitter building the antennae have been destroyed. The transmitters and receivers need to be replaced, although the buildings themselves appear to be reusable.

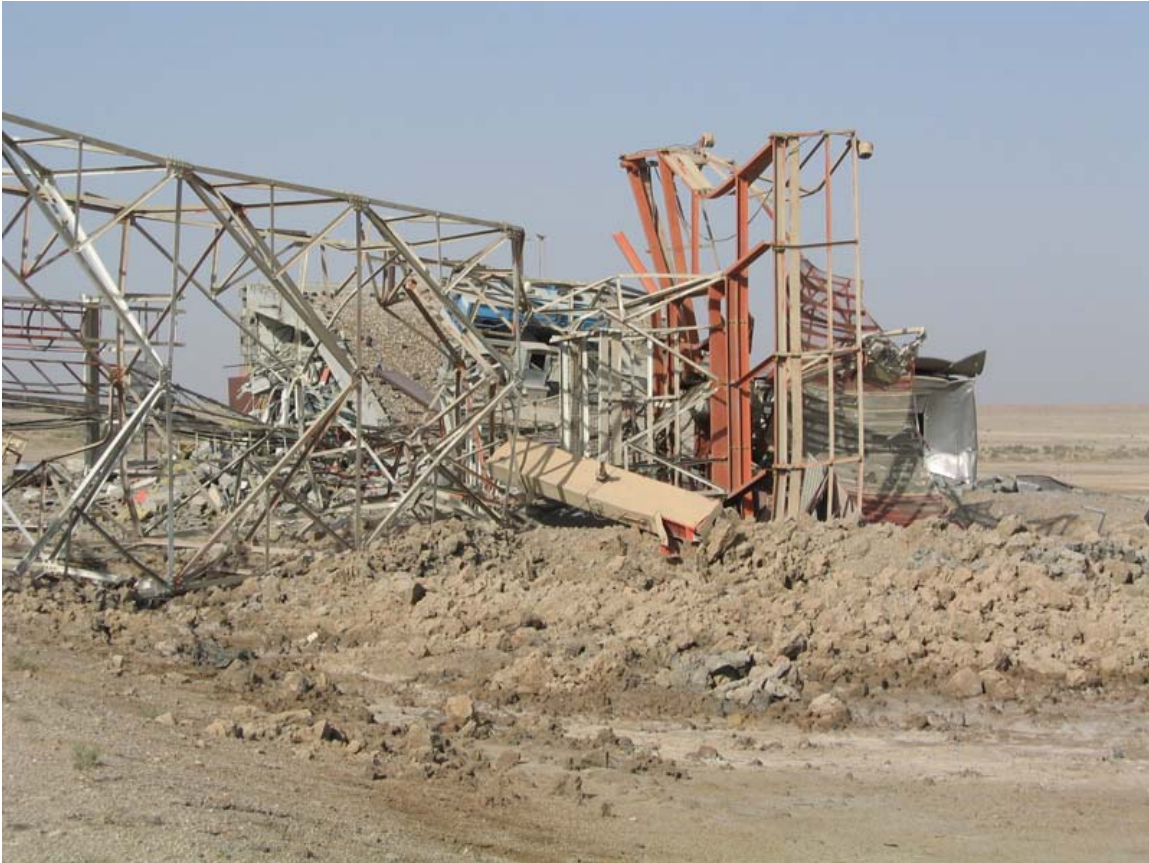
The Secondary Surveillance Radar (SSR) has been completely destroyed, along with its associated building infrastructure.

*Destroyed SSR facility*

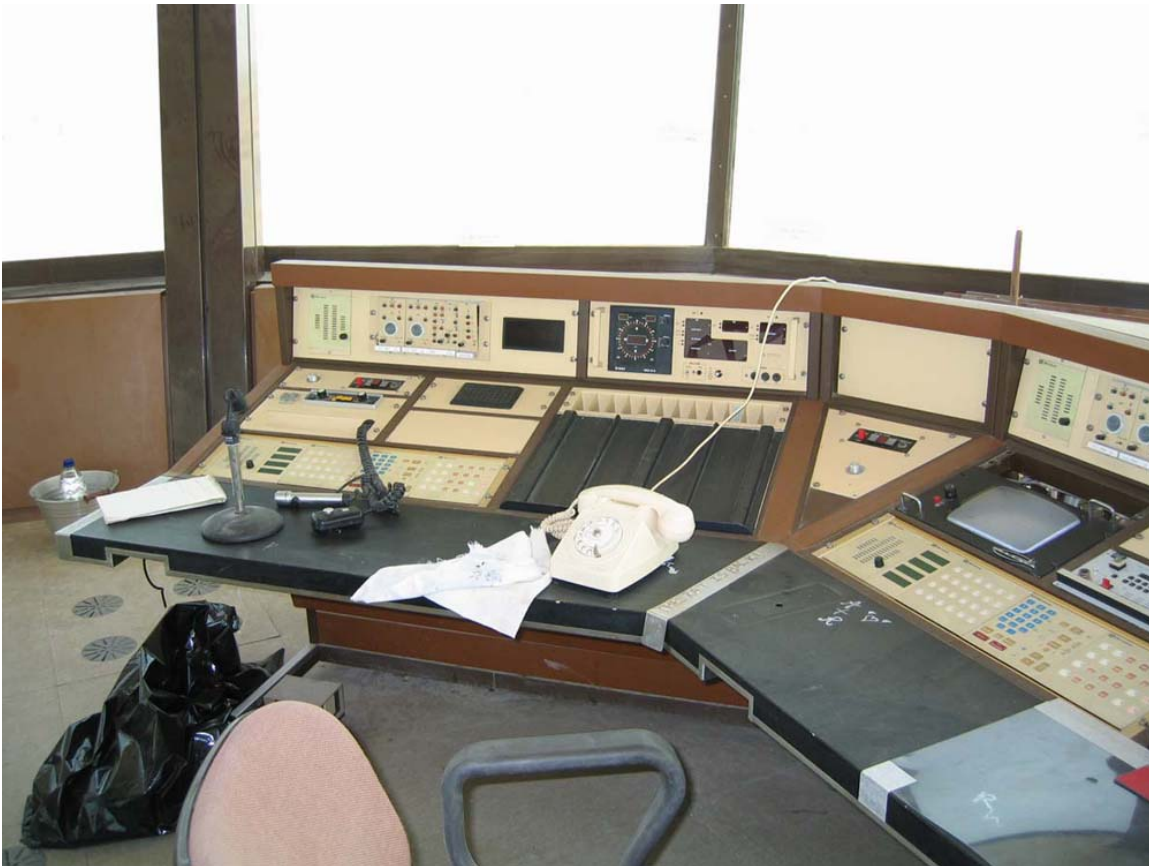
Control tower - consoles

The equipment, including consoles, switches and recorders was assessed as extremely antiquated and all was unserviceable. The Iraqi SATCO who was interviewed during the assessment explained that due to the imposition of sanctions, the majority of the equipment had not been maintained due to an inability to obtain spares.

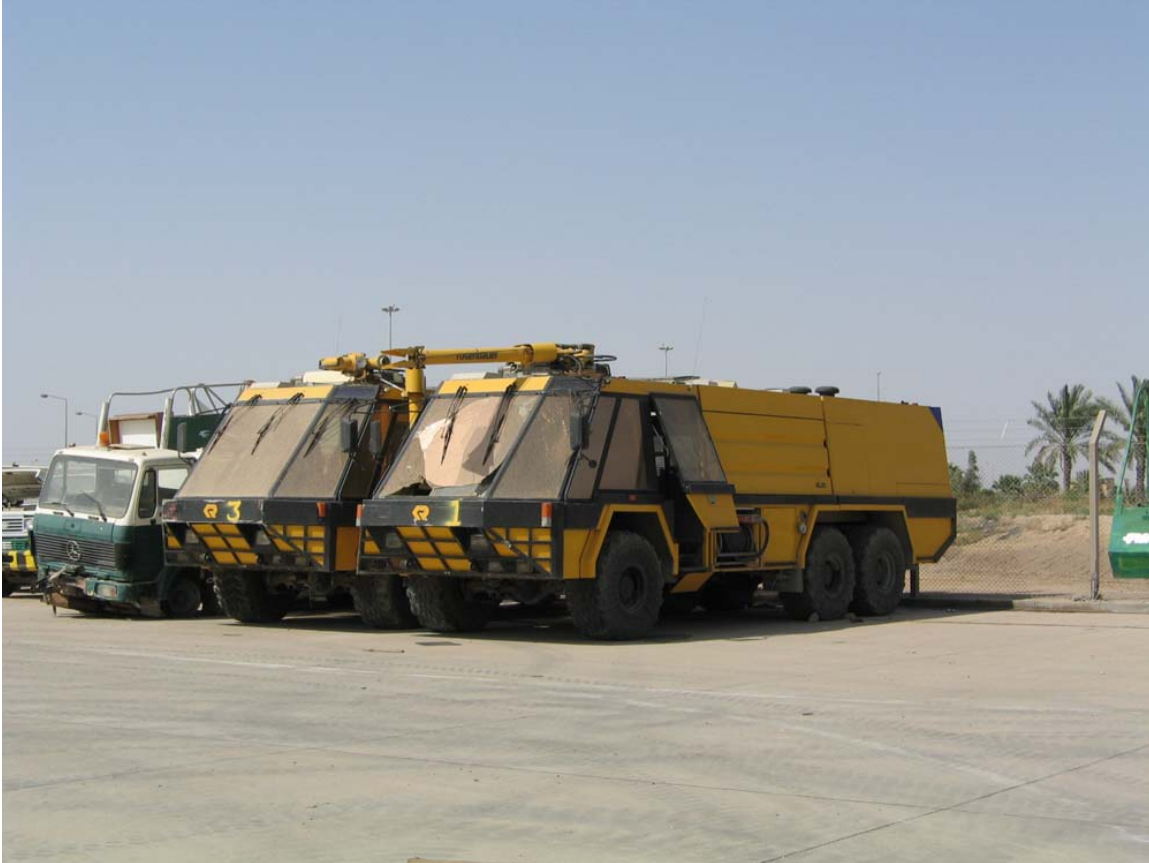
The 5-bay airside firehall located central to all aircraft manoeuvring areas is in excellent structural condition, and all major electrical and mechanical components can be restored to service fairly quickly in terms of the building envelope. The current facilities are being used as dormitories for the British forces, but there is still a significant amount of firefighting apparel located within the building including masks, high-temperature suits, hydrant connections etc. The equipment was scattered in the building and requires a detailed assessment of individual sizes and serviceability. There was no aqueous foam located within the building and this will need to be restocked.

*Unserviceable fire trucks and ground handling equipment*

To repair the three Rosenbauer foam units to a reliable condition, we suggested to the British that they return them on a empty return AN 124, C 17, etc. flight to the manufacturer and after repair, upgrading and certification, ship the units back by any economical means for return to service. The two British units could then be moved to another facility.

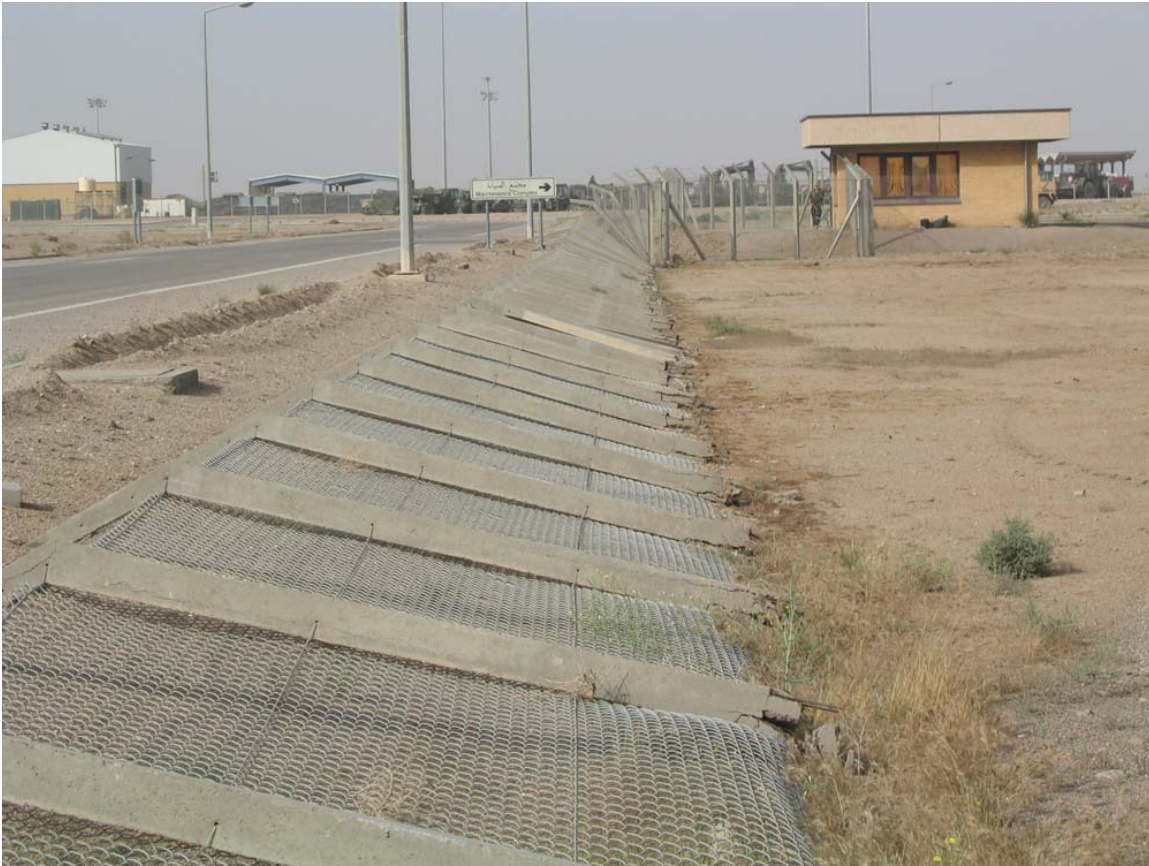
A chain link fence with 3-barbed wire top strands, all supported by reinforced concrete posts provided the airport security. The concrete post reinforcing steel, where buried, has deteriorated from the salts of the original salt marsh to the extent that whole fence runs have collapsed or are in danger of collapsing. To maintain security, the concrete posts will have to be replaced by new posts reinforced by epoxy coated or galvanized reinforcing steel or just galvanized steel pipe posts. The later would be preferable from timing prospective. The top barbed strands could also be supplemented with coiled razor wire to provide better security protection.

*Security fence posts damaged by salt attack*
