AERODROME ASSESSMENT REPORT

BAGHDAD INTERNATIONAL AIRPORT

VERSION: Aerodrome Assessment - Final Report
27-May-03

Prepared by SkyLink Team 2

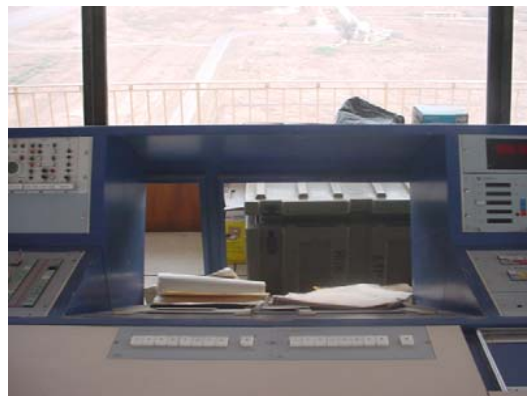
42. **Assessment.** All consoles and associated equipment are unserviceable. The assessment team was unable to determine the reason for the unserviceability and the likelihood of short term repair. The Iraqi maintainers advised that no spares were available and that appropriate spares would be difficult to procure. The assessment team supports this position. Off-field landline communications is unserviceable because the lines were channelled through the destroyed central communications centre in Baghdad.

ATC Consoles – Missing Radar Display

- a. ATC 6 - Assess the feasibility of the short-term repair of equipment.
- b. ATC 7 - Replace consoles and associated inter-face equipment as required in the short term.
- c. ATC 8 - Re-establish landline communications in the short term.

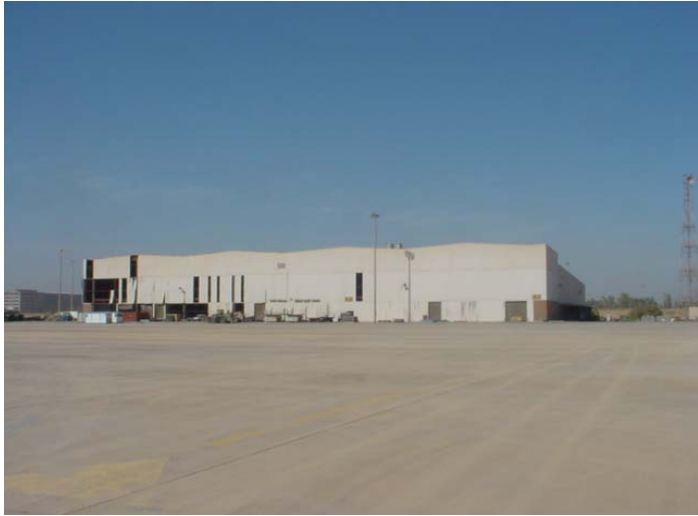
99. **Assessment.** The terminal building is structurally sound but has extensive battle damage to the exterior cladding. There was limited power and no water and sewerage supply to the building. The cold storage areas were not tested but should be functional after servicing. Only one of the many security cameras is serviceable. The fixed fire fighting system requires a complete overhaul. Fire fighting stations were denuded of equipment. The five-tonne scales were not tested, nor have they been calibrated. Although the air conditioning was reported to be working, there were several large leaks in the system. There is no security screening equipment. Although there are no defined Dangerous Goods (DG) and Hazardous Material (HAZMAT) storage areas, there is sufficient space to cater for this requirement. Furthermore there are no

Cargo Terminal

- a. CTML 1 - Install security screening equipment to comply with ICAO Annex 17 – Security in the medium term.
- b. CTML 2 - Establish DG and HAZMAT storage areas and develop handling procedures in accordance with both IATA DG Regulations in the medium term.
- c. CTML 3 - Service and overhaul the following in the short to medium term:
 - i. Power, water and sewerage.
 - ii. Cold storage areas.
 - iii. ETV system.
 - iv. Close circuit security camera system.
 - v. Five tonne scales.
 - vi. Air conditioning.
 - vii. Fixed fire fighting system.

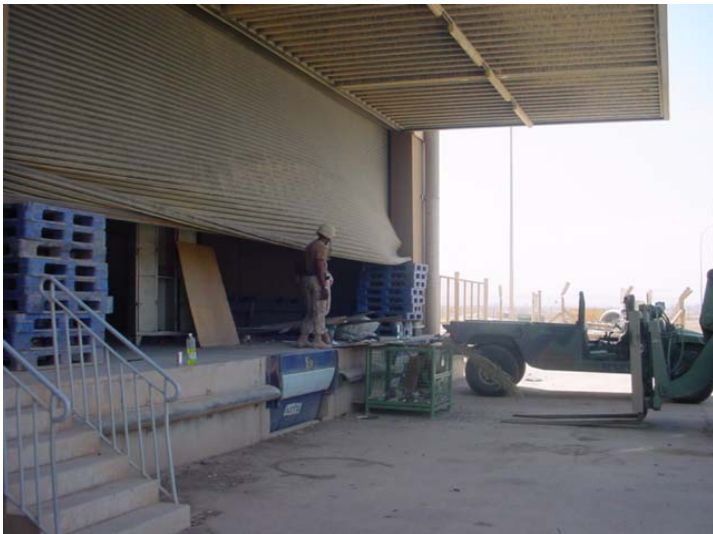
Damaged Roller Doors – Truck Docking Station

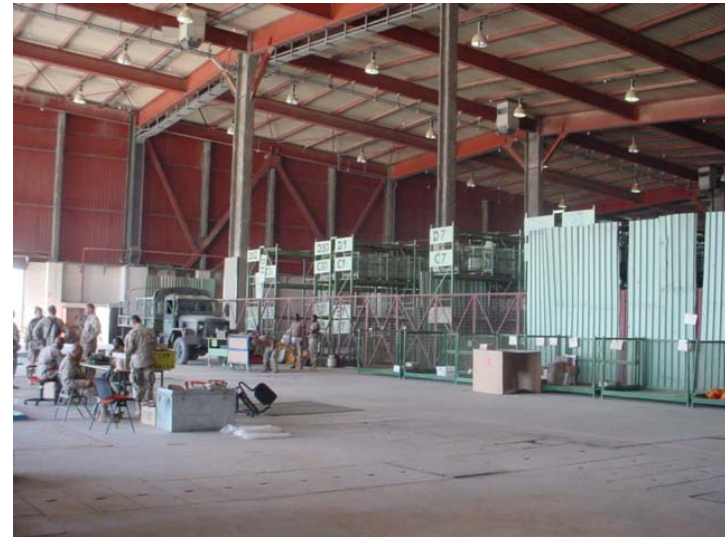
DG and HAZMAT procedures in place. The ETV is unserviceable but the assessment team concludes that it is recoverable after overhaul and maintenance. The storage racks and cages are in good condition.

Storage Racks
