UNITED STATES  
NUCLEAR REGULATORY COMMISSION  
OFFICE OF NUCLEAR REACTOR REGULATION  
WASHINGTON, D.C. 20555

January 21, 2004

NRC INFORMATION NOTICE 2004-01: AUXILIARY FEEDWATER PUMP  
RECIRCULATION LINE ORIFICE FOULING -  
POTENTIAL COMMON CAUSE FAILURE

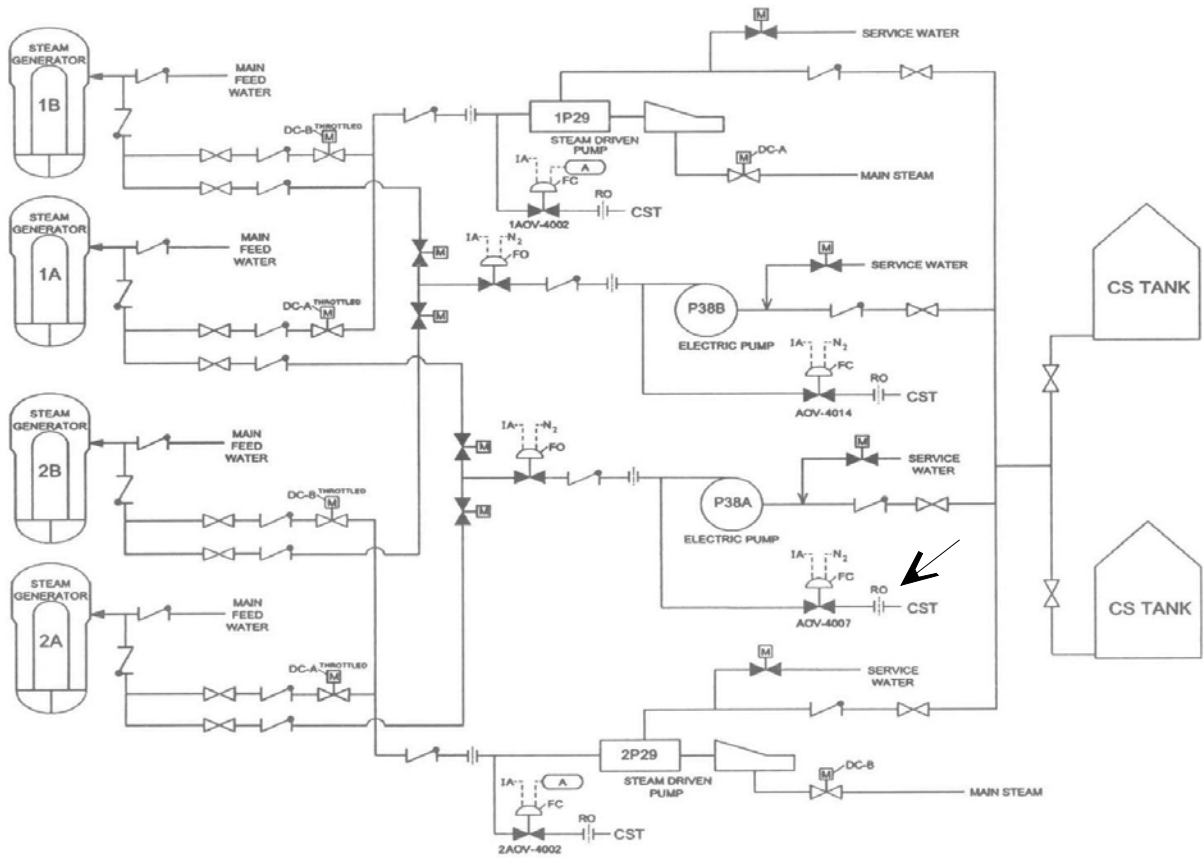
Figure 1. AFW System - Major Flow Paths

Point Beach Nuclear Plant (PBNP) is a two unit site. Each unit has a turbine-driven AFW pump (pumps 1P29 and 2P29) which can supply water to both steam generators. Additionally, the plant has two motor-driven AFW pumps (pumps P38A and P38B) each of which can be aligned to a steam generator in each unit. Each pump has a recirculation line back to the condensate storage tanks (CSTs) to ensure minimum flow to prevent hydraulic instabilities and dissipate pump heat. The recirculation line contained a pressure reducing, flow restricting orifice. An arrow is pointing to the recirculation flow restricting orifice (RO) in the major flow path AFW diagram provided in Figure 1 and a picture of the RO is provided in Figure 2.

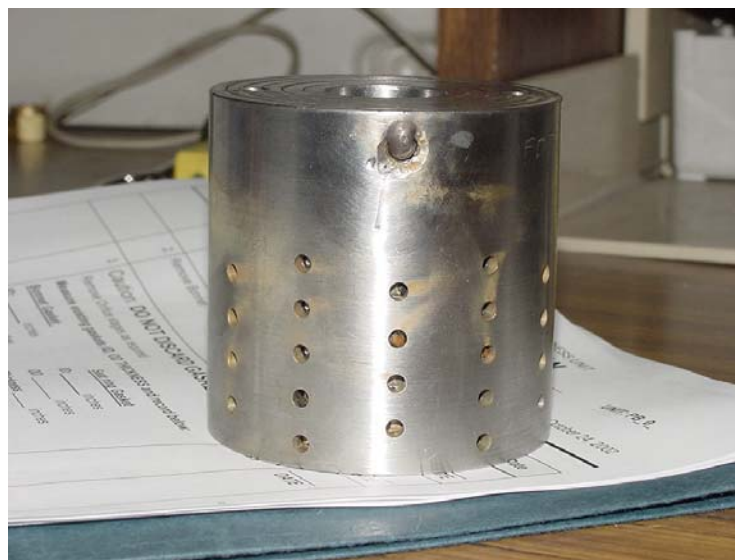
Figure 2. Recirculation Flow Restricting Orifice

The RO used a multi-stage, anti-cavitation trim package installed in the body of a globe valve to limit flow. This style of orifice or flow restrictor was installed in the AFW recirculation lines at PBNP in the past few years to eliminate cavitation caused by the old orifices. This type of flow restrictor used very small channels and holes in each stage combined with a tortuous path to limit flow and prevent cavitation.

After removal of the orifice internals, partial blockage was observed in 24 of the 54 holes in the outermost sleeve. No particles were found on any of the inner sleeves. Samples of the particles removed from the orifice were retained for analysis. A boroscope inspection of the recirculation piping at the orifice location revealed no evidence of debris. Following cleaning and reassembly, the orifice was reinstalled and the P38A AFW pump was successfully retested. Testing was successfully completed on the other three AFW pumps to verify acceptable recirculation flow by October 25, 2002.
