**Ohio Route 50 Joint Sealant Experiment**

*State Job No.: 14668(0)*

**FINAL REPORT**

*April 2002*

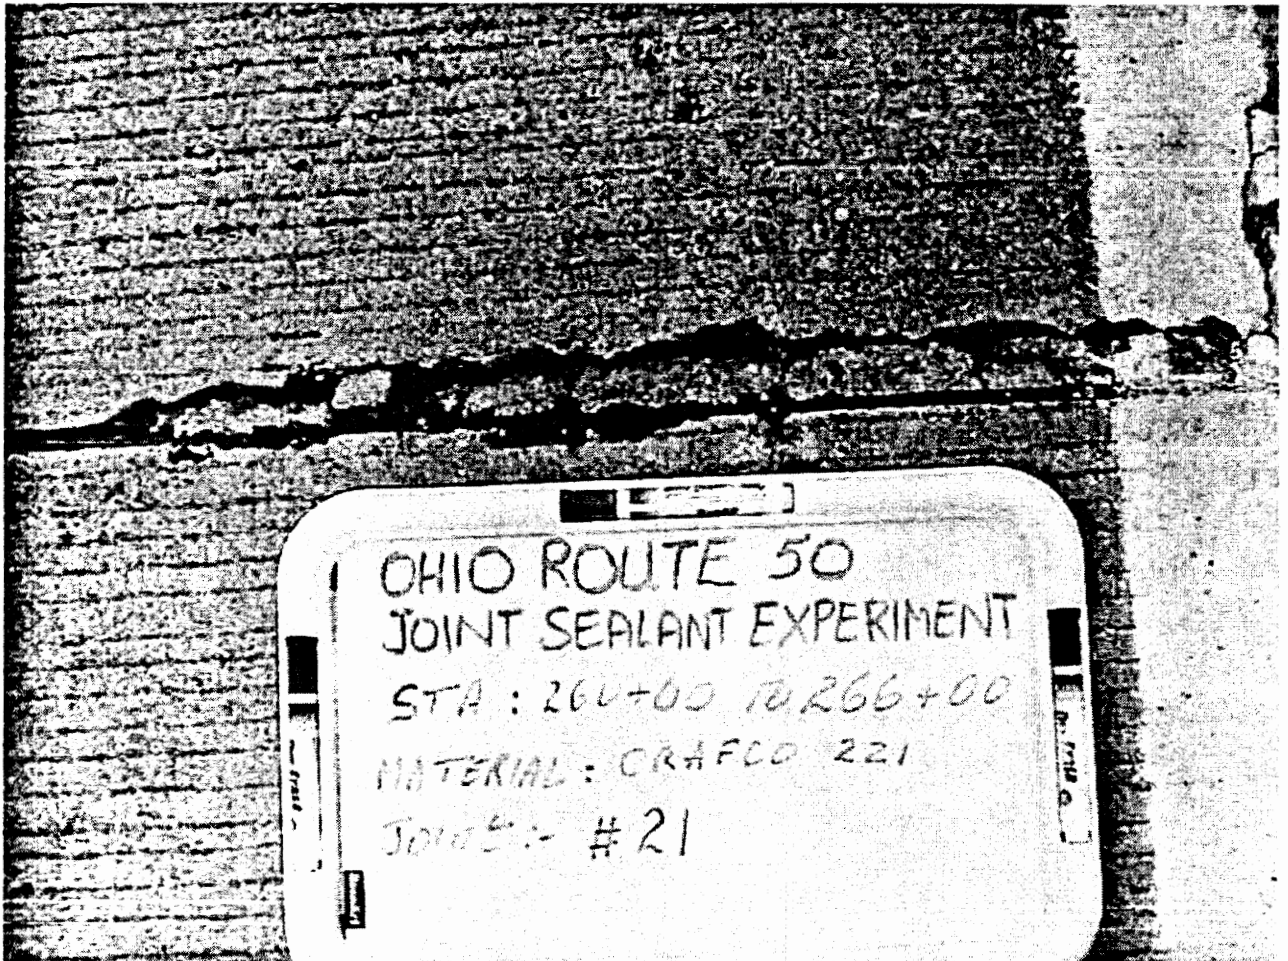
Figure 4.2 Severe cracking and spalling in Joint 21 of the eastbound CrafcO 221 (1) section

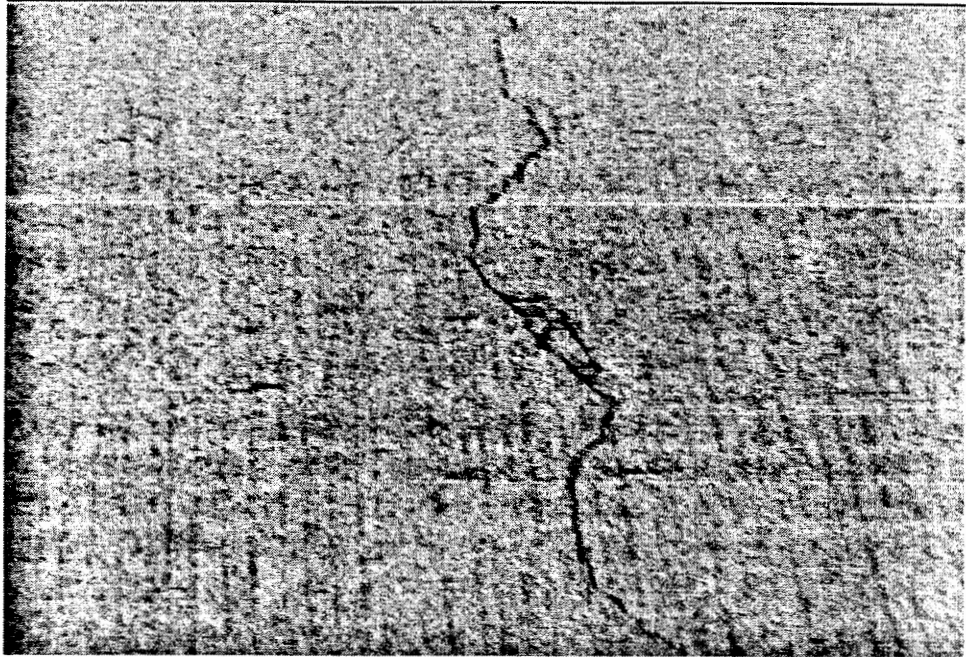
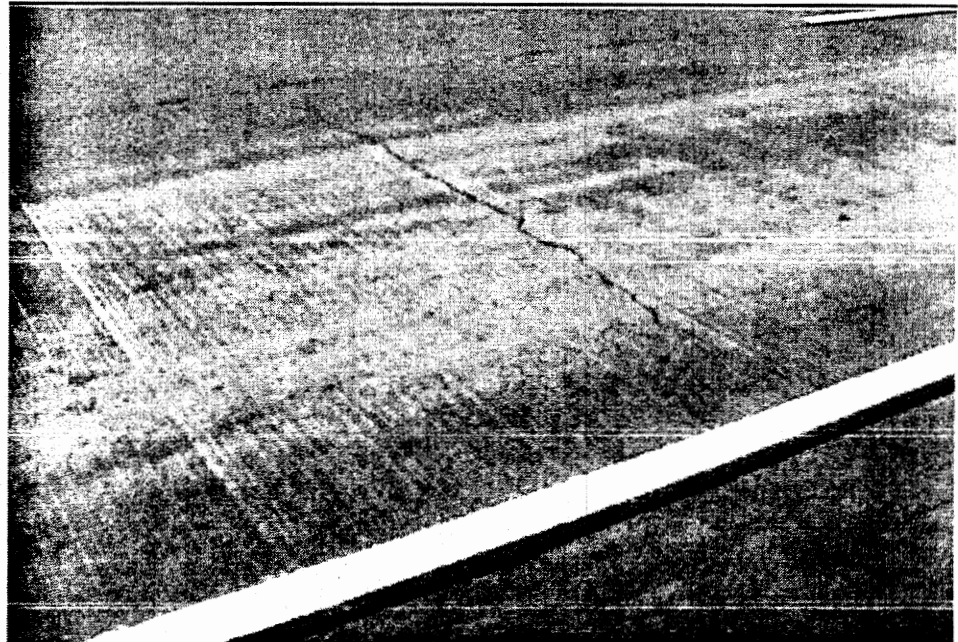
**Figure 5.46** Examples of transverse cracks

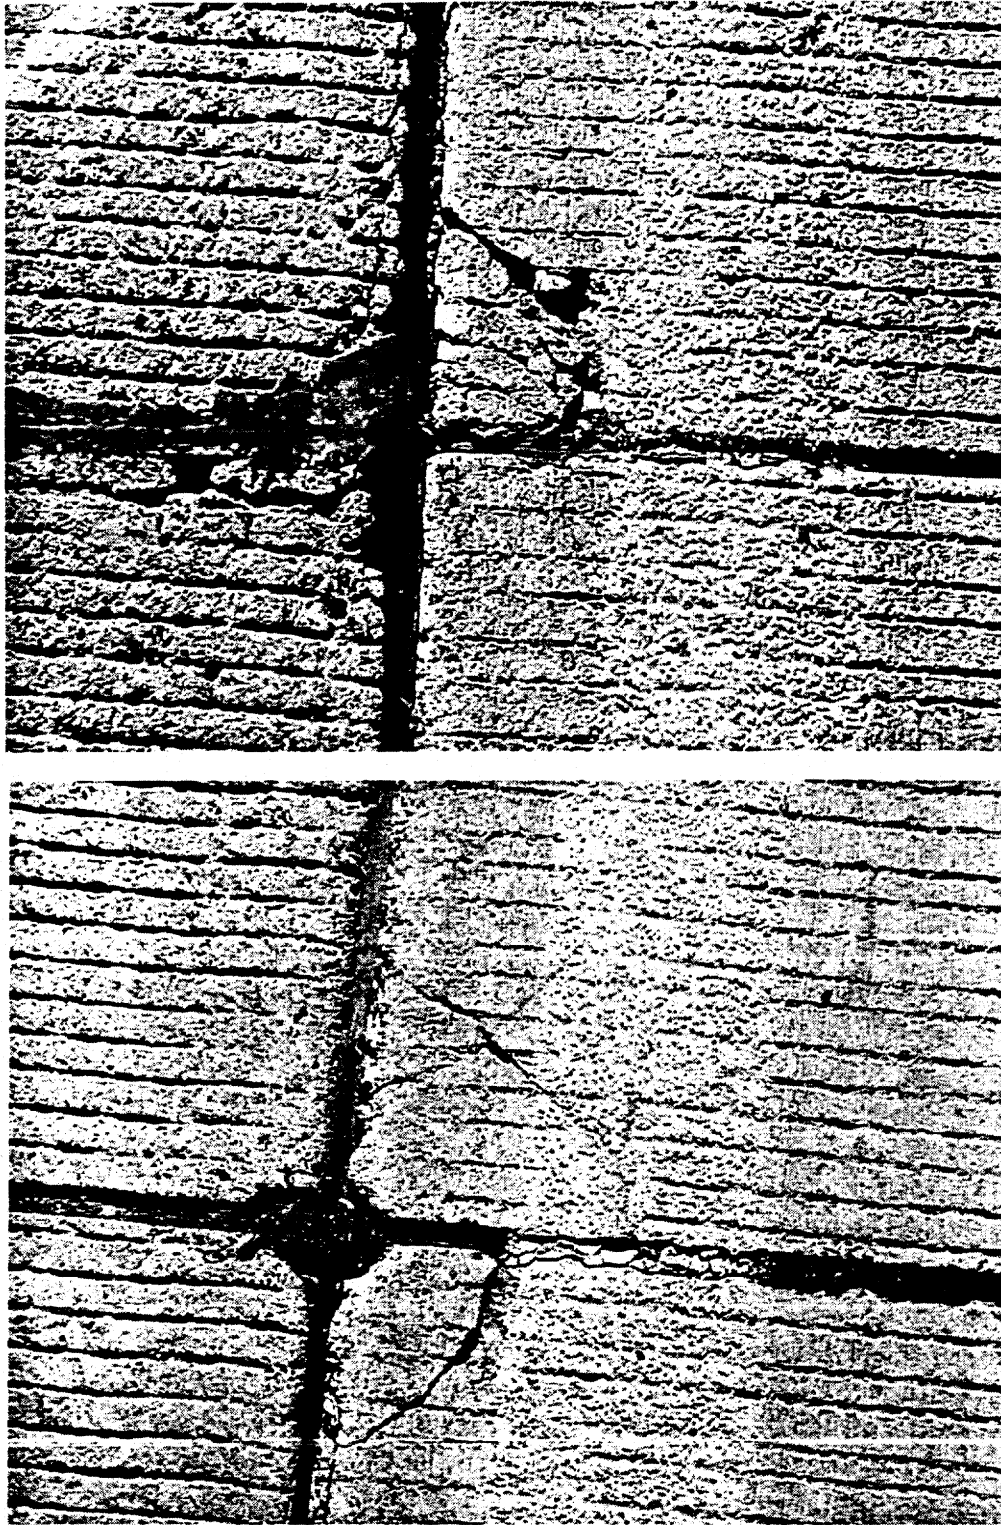
Figure 5.47 Examples of corner breaks

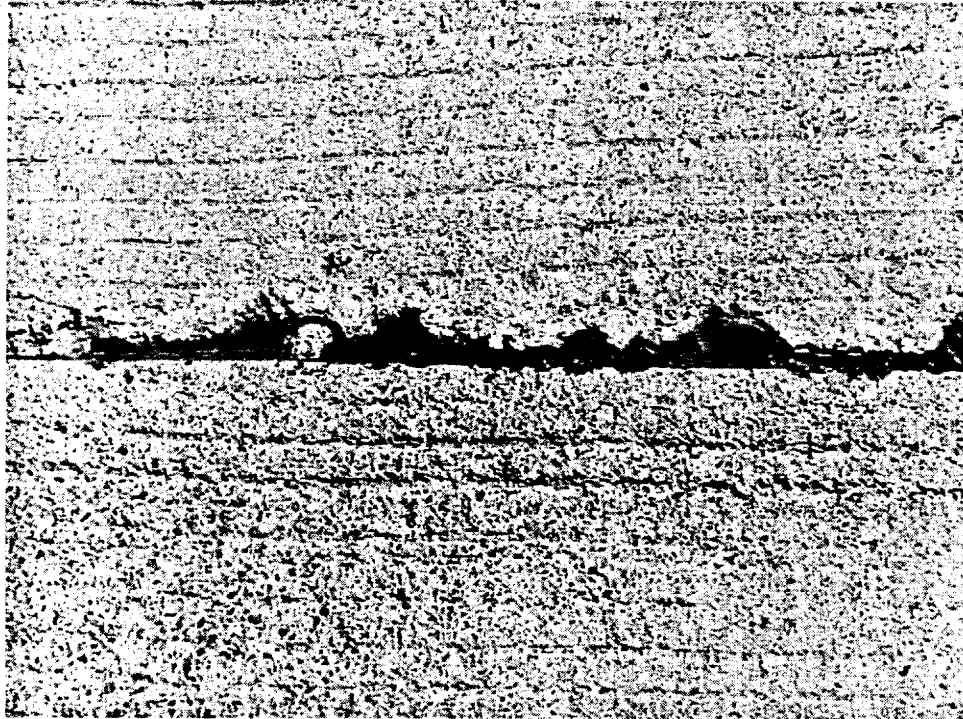
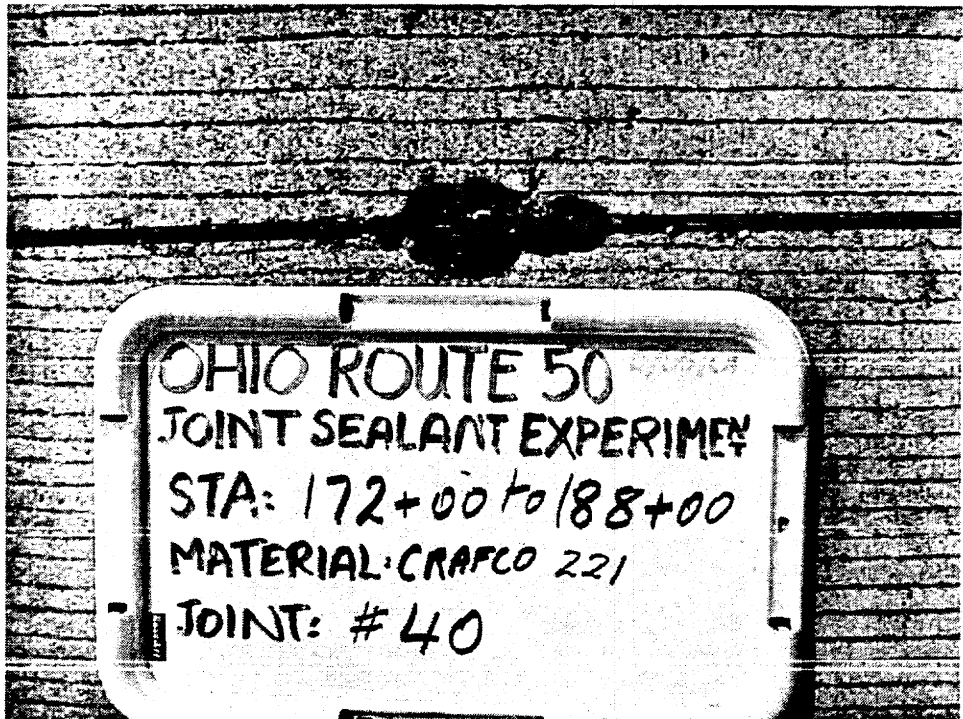
Figure 5.48 Examples of spalling failures

[Top: Joint 7 of WB Dow 890 (4); Bottom: Joint 40 of WB Crafcoc 221 (1); both appear to be created at the time of joint sawing]

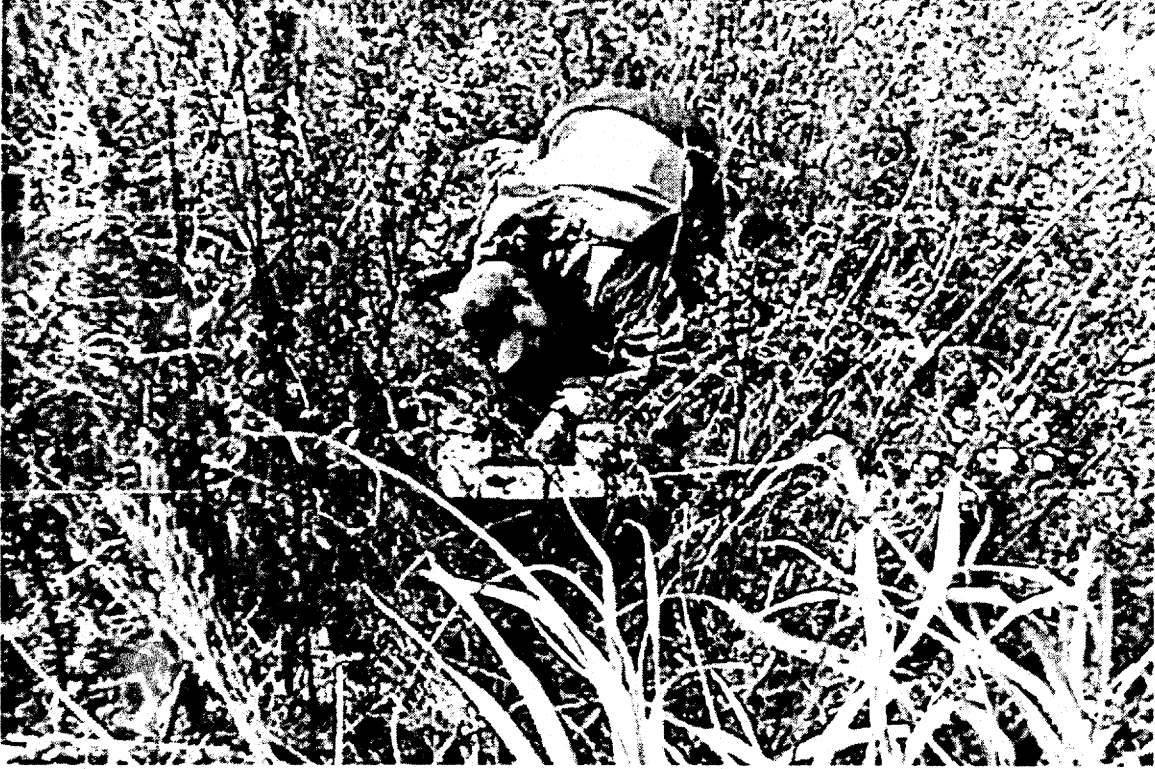
**Figure 6.1** Inspecting the inside of a drain

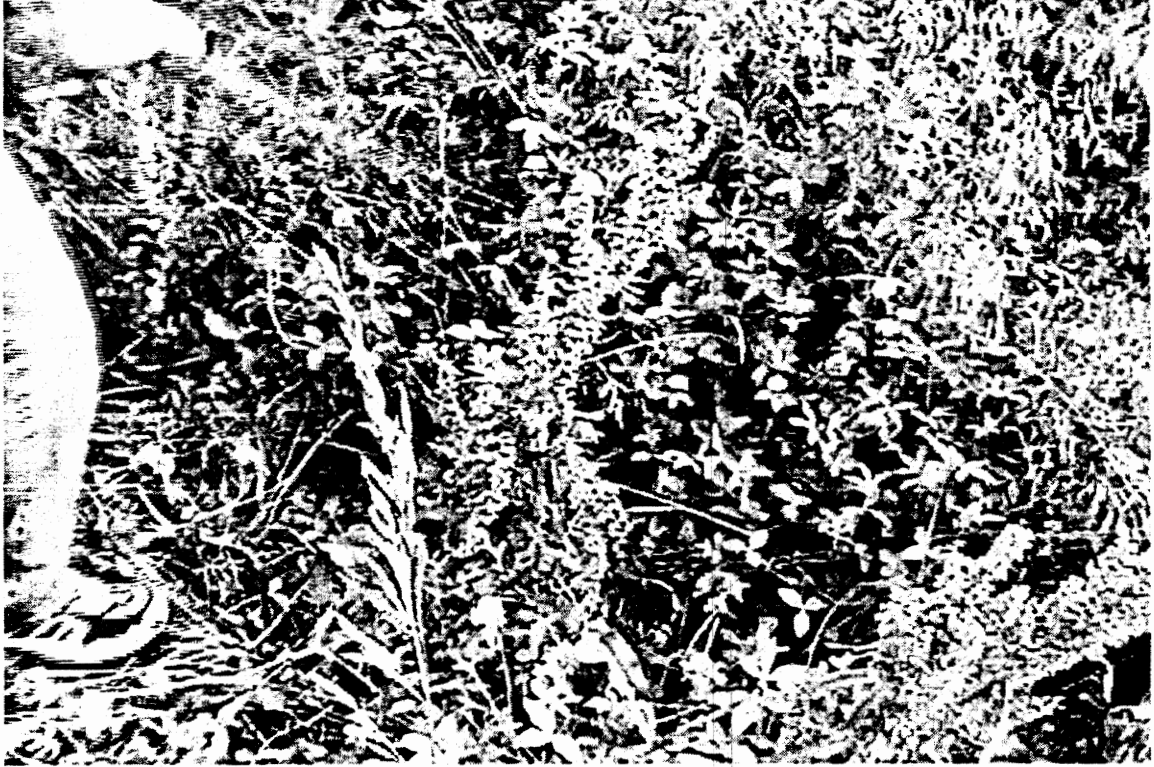
**Figure 6.4** Clearing the growth so that the outlet can be observed

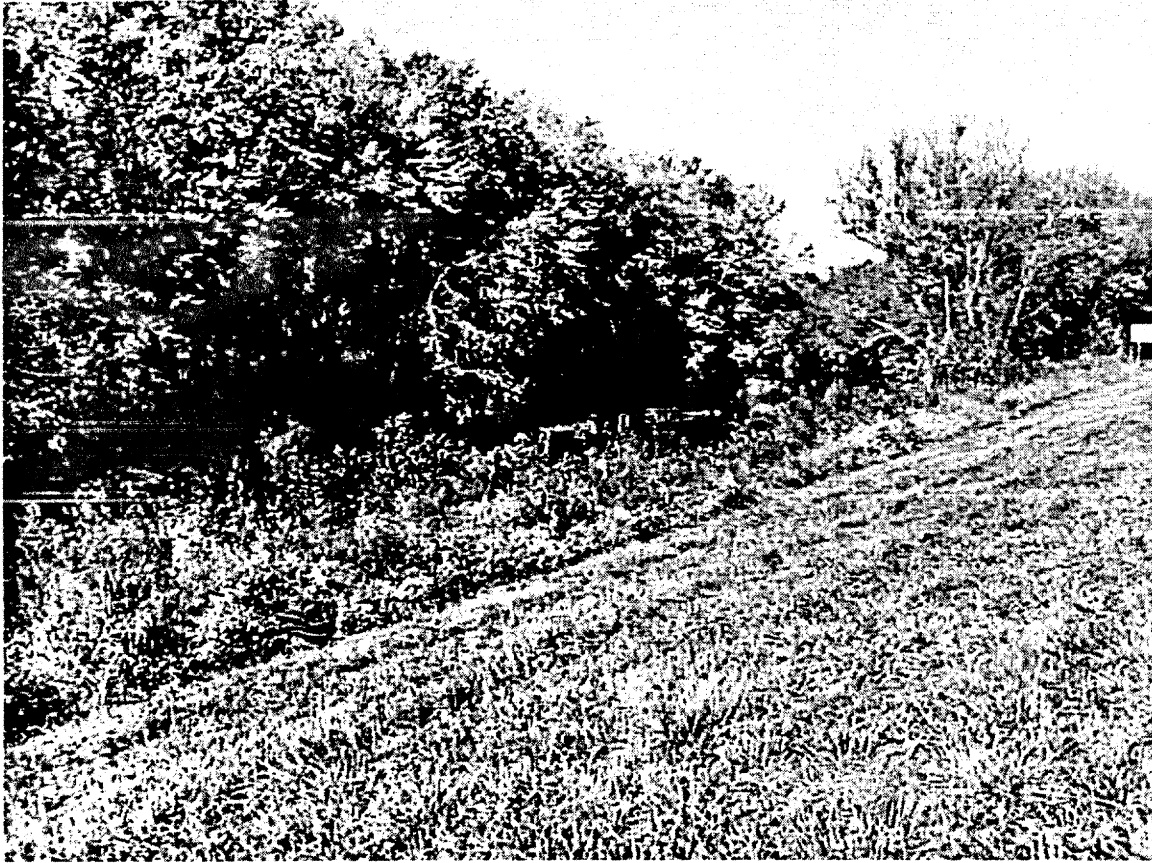
**Figure 6.5** Mowed and unmowed areas

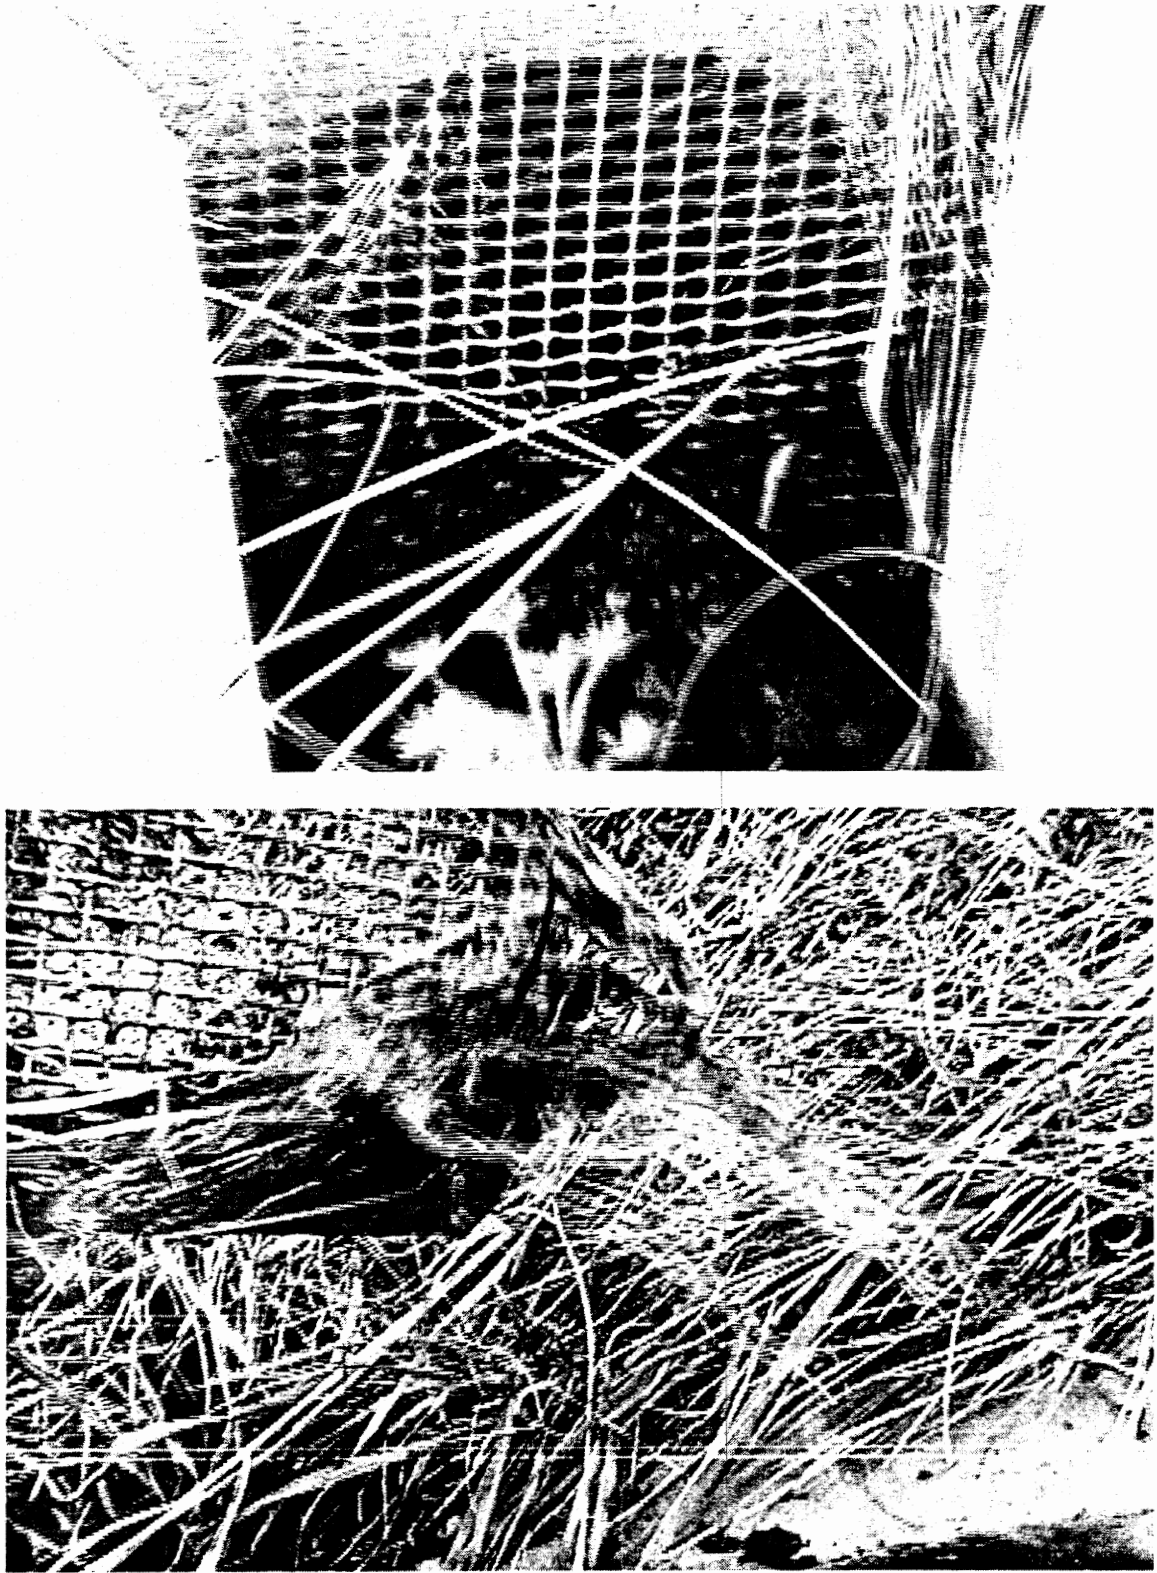
**Figure 6.10** Moss and silt that has gathered on the rodent screen

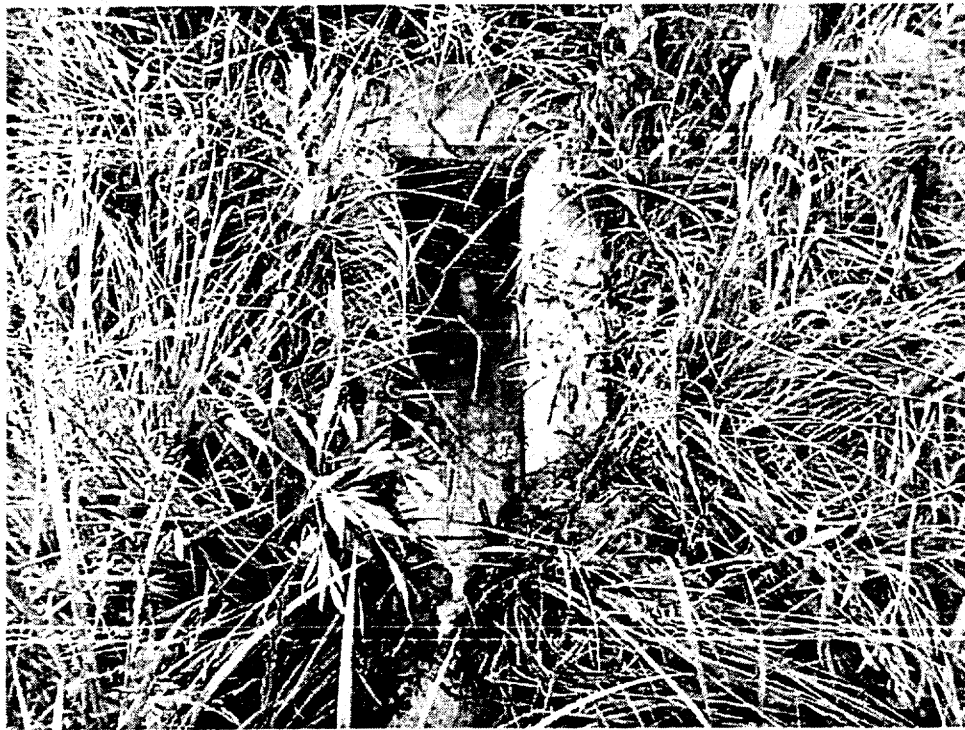
(b)

**Figure 6.13** Typical outlet, as found and after sediments were removed

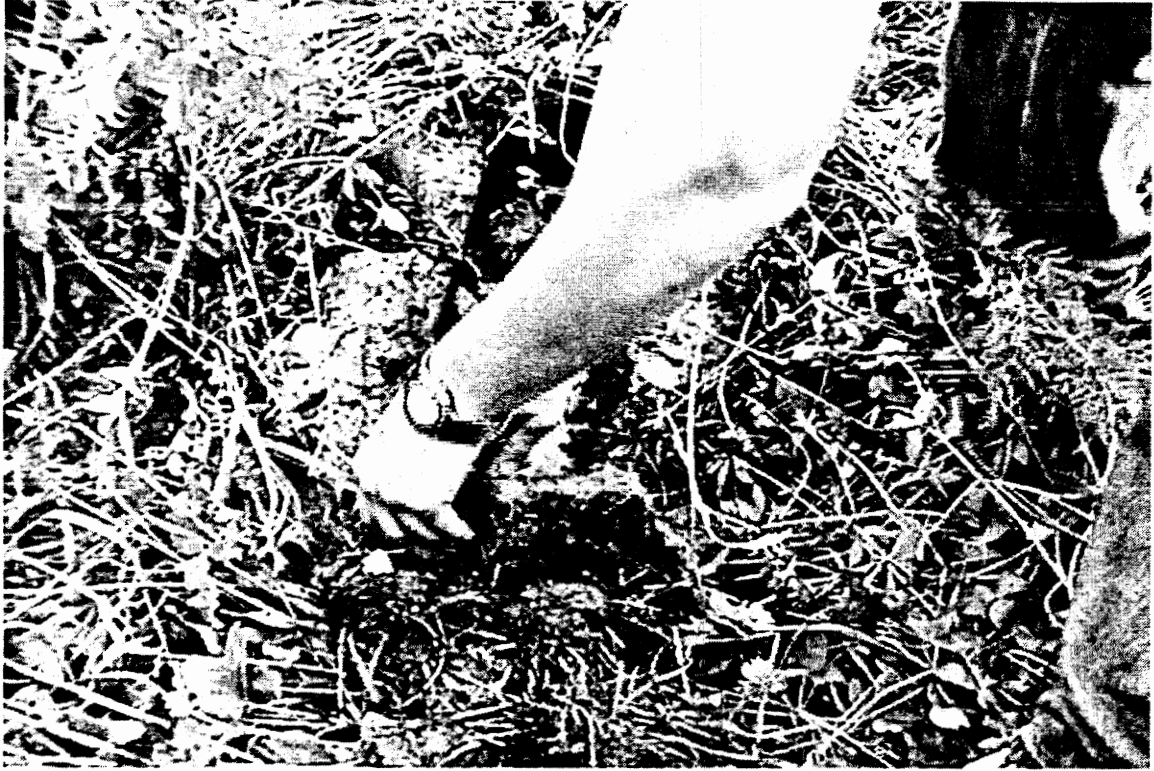
**Figure 6.14** An older concrete outlet, which appears to have been recycled

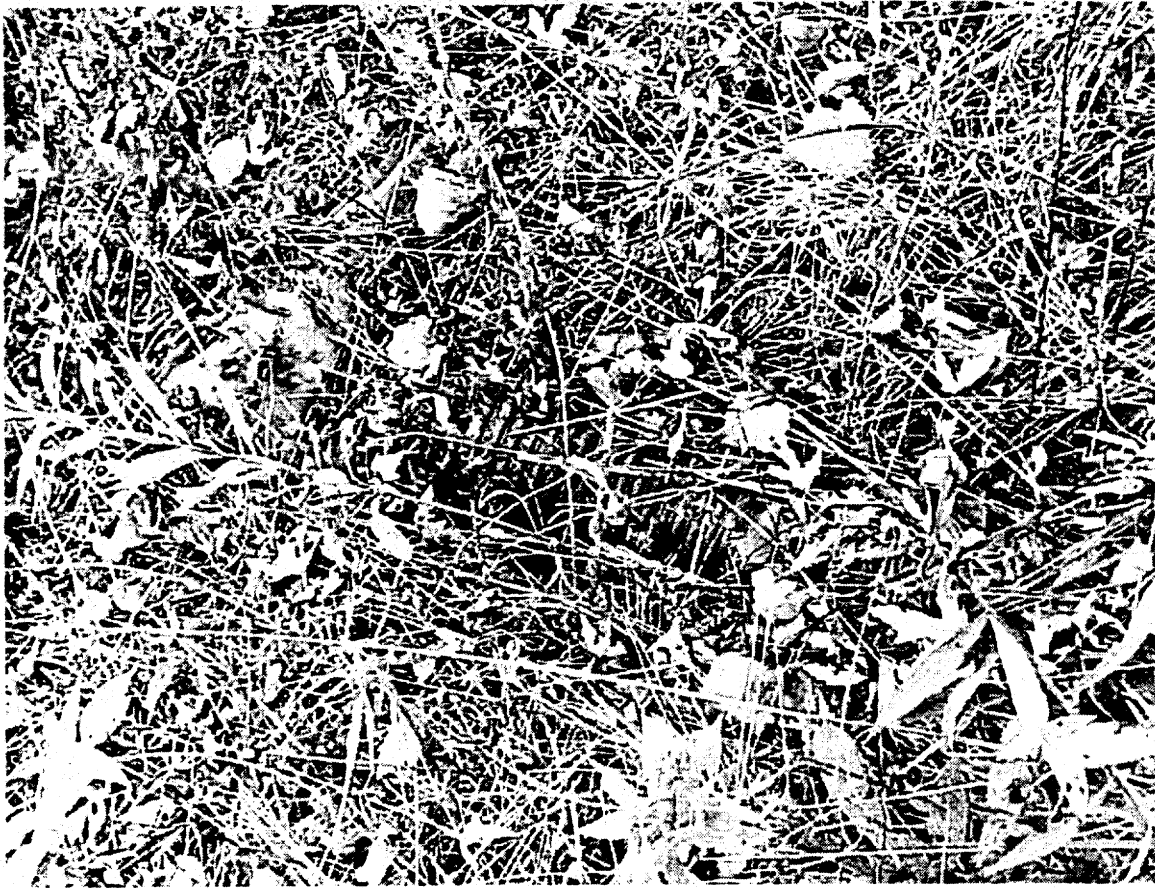
Figure 6.15 A concrete outlet that has slipped down the hillside, exposing the drain
