Highway Concrete Pavement Technology Development and Testing: Volume I— Field Evaluation of Strategic Highway Research Program (SHRP) C-202 Test Sites (Alkali-Silica Reaction (ASR))

PUBLICATION NO. FHWA-RD-02-082

AUGUST 2006

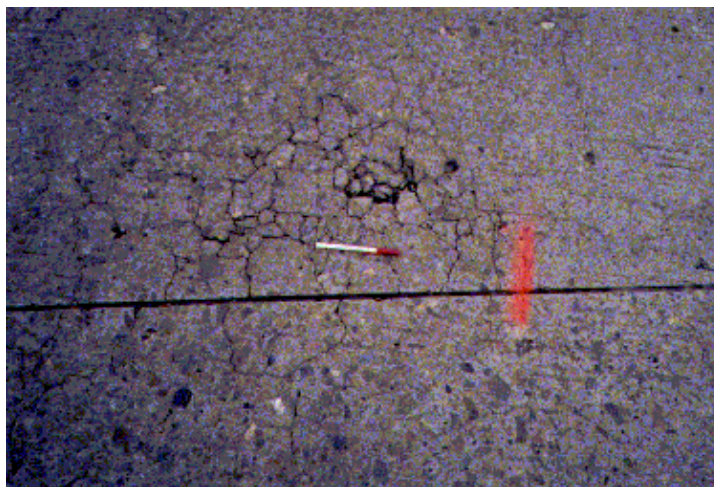
Figure 3 shows an example of joint distress of high severity, and figure 4 shows an example of joint distress of medium severity.

Figure 3. Joint distress of high severity (Winnemucca, NV).

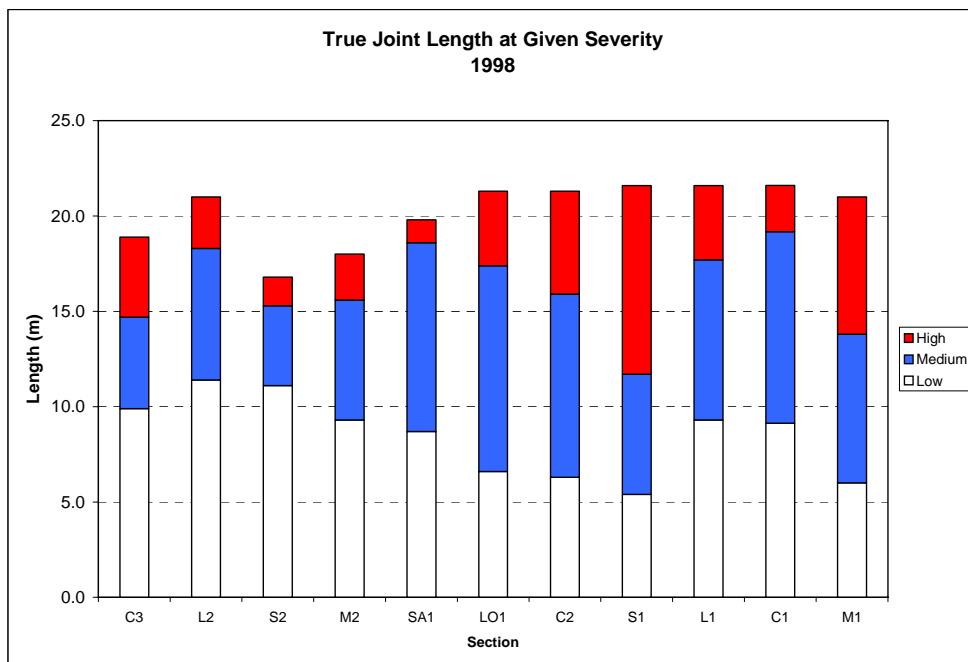
Figure 10 shows the actual measured joint length at each level of severity for all the sections in 1998. If the true joint length at each severity is considered, all sections have some areas of low-severity spalling. The length of high-severity joint spalling per section is less than the length of low- and medium-severity spalling. The section with the most high-severity joint distress is S1. The sections with the least amount of high joint distress are SA1 and S2, but these slabs were in better condition at the start of the study. Of the sections in the same group or beginning condition as S1, the section with least amount of high-severity spalling is section C1 (control). The next best is section L1. In the second group of sections, which were initially in better shape, the one with the most high-severity spalling is C3, followed by section LO1.

Figure 10. Actual joint length of each severity level for each section (Winnemucca, NV, 1998).

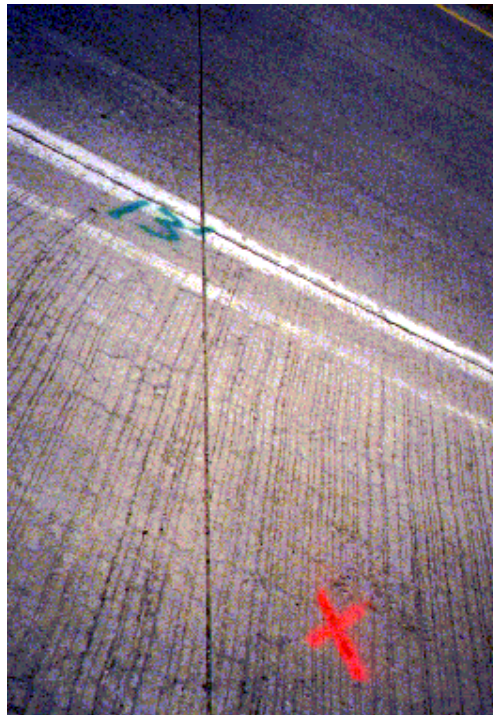
Figure 11. Photograph showing widespread map cracking in shoulder area of Winnemucca test site.

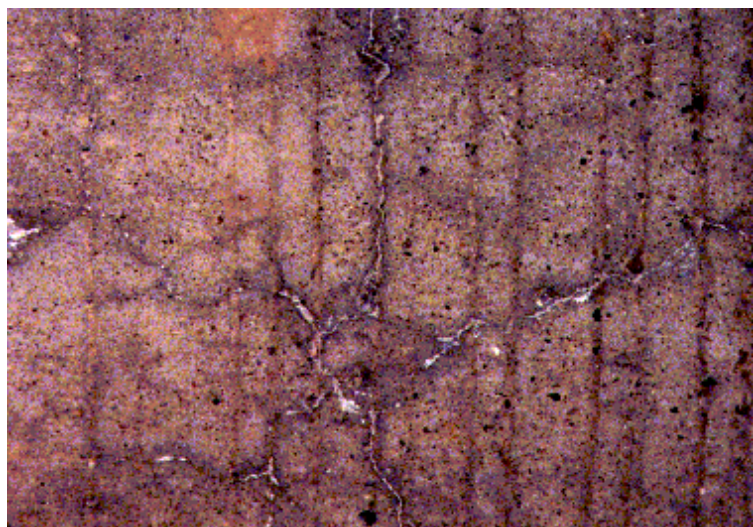
Figure 12. Close-up of map cracking with efflorescence (Winnemucca, NV).

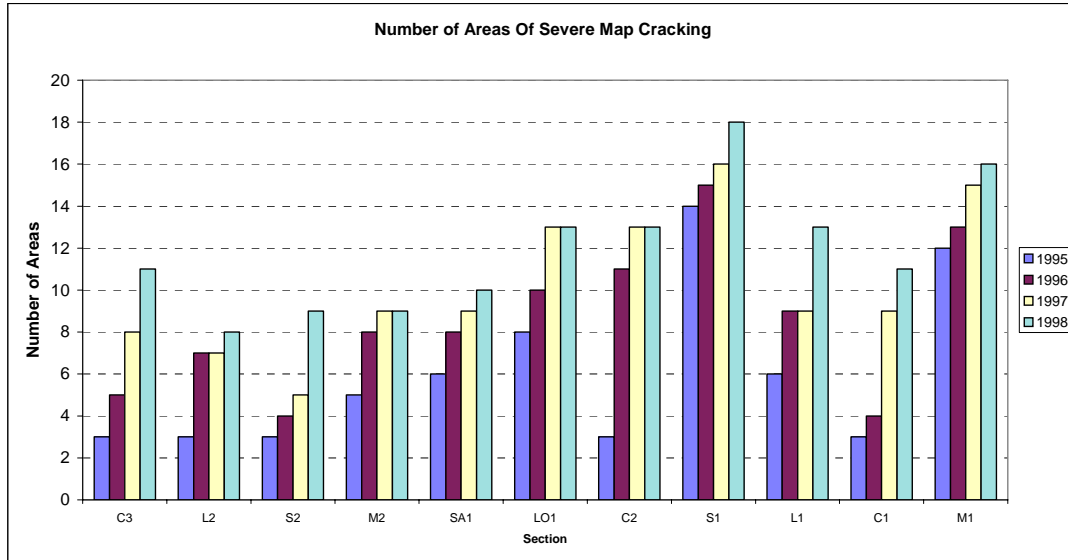
The number of areas of severe map cracking in each section has increased each year over the 4 years. However, sections C2, LO1, and M2 have remained nearly constant for the last 2 years. Figure 13 shows the number of areas of severe map cracking in each section for the years 1995 through 1998. The sections with the most severe map cracking in 1998 are sections M1 and S1 with 16 and 18 areas, respectively. The sections with the least number of areas are sections L2 with eight areas and M2 and S2 with nine areas.

Figure 13. Number of areas of severe map cracking in each section from 1995 through 1998 (Winnemucca, NV).

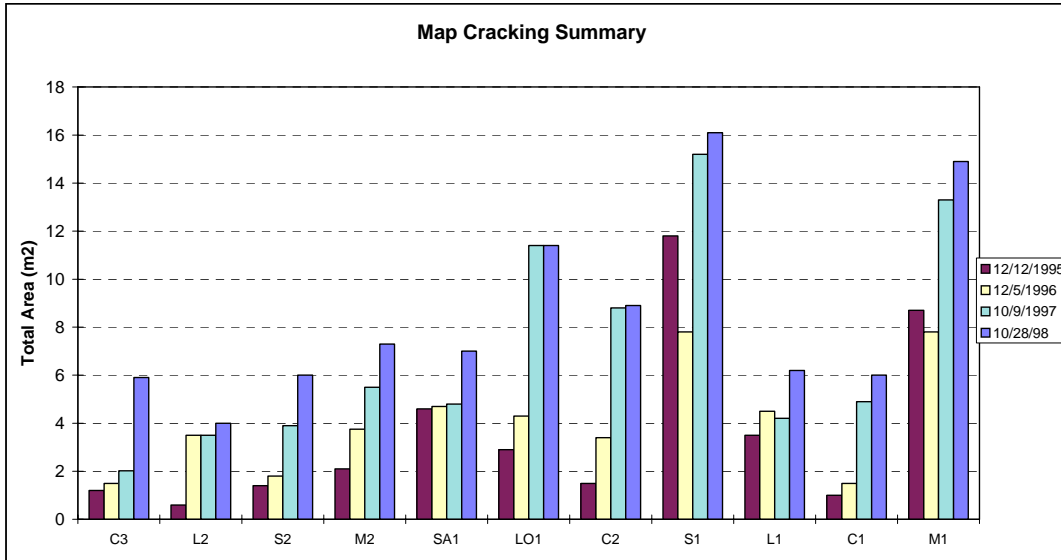
Overall, the only treatment that shows minor improvement in severe map cracking over the control sections is the LiOH (sections L1 and L2). In 1998, section L2 had less area affected than control 3 in the western end of the site. Section L1 in the eastern end had less area affected than control 2 and about the same amount as control 1. In general, all the test sections are performing similar to or worse than the control sections.

Figure 14. Total area of severe map cracking for each section for 1995 through 1998 (Winnemucca, NV).

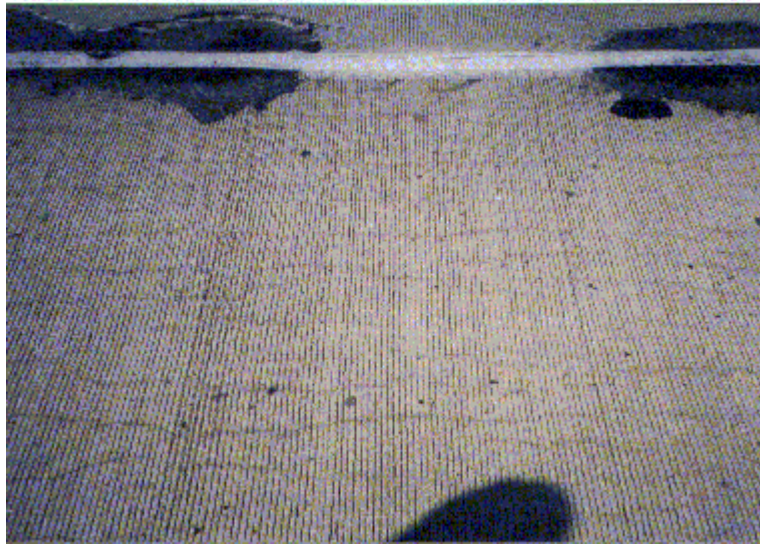
Figure 24. Typical longitudinal cracking and example of asphalt patching along joint between shoulder and travel lane (Newark, DE).

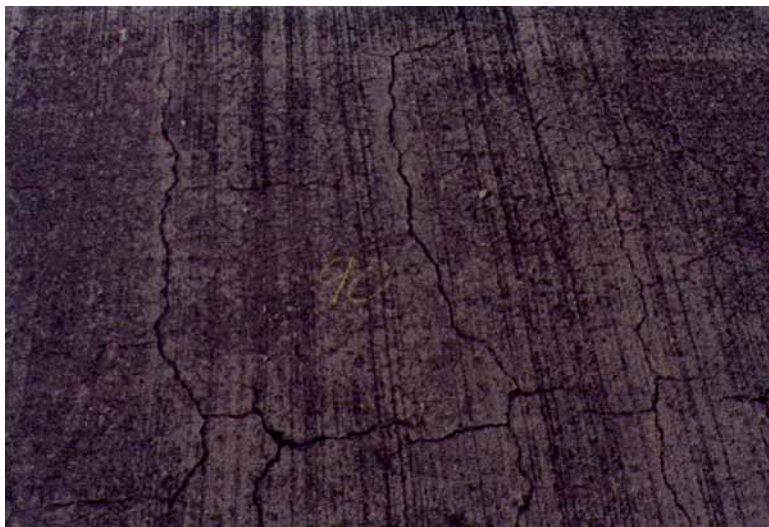
Figure 40. Close-up photograph showing typical map cracking (Boron, CA).

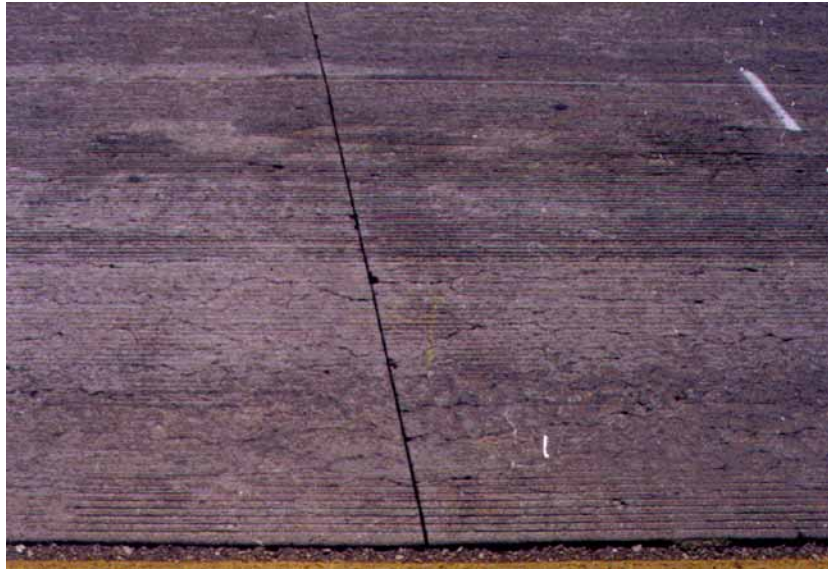
Figure 45. Photograph showing medium-severity joint distress (Boron, CA).

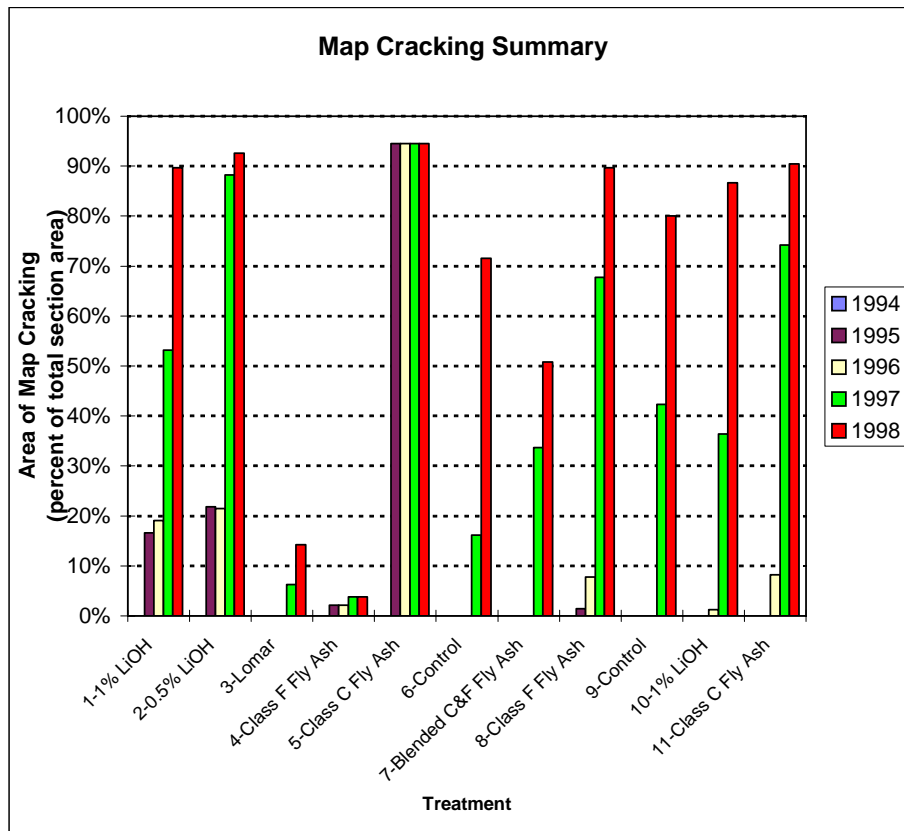
The amount and severity of map cracking is a good early indicator of the extent of ASR occurring in each section. The area of map cracking as a percent of the total area is shown in figure 58. This figure shows that, for most sections, the area of map cracking had increased substantially between 1996 and 1998. The section with Class C fly ash and Shakespeare aggregate had extensive map cracking over the entire test area in 1995, except for a small area along the curb. The section with Class F fly ash and Shakespeare aggregate was performing the best of all the sections, with less than 10 percent of its area covered by map cracking. The Lomar section was the next best with about 15 percent map cracking. Several sections, especially those with Grevey aggregate, had extensive map cracking appear only within the last 2 years of the study.

Figure 58. Area of map cracking as a percentage of the total area (all sections, Albuquerque, NM).
