UNITED STATES OF AMERICA  
NATIONAL TRANSPORTATION SAFETY BOARD  
WASHINGTON, D.C.

SAFETY RECOMMENDATION A-71-18

REPLENISHING AND MAINTENANCE OF OXYGEN SYSTEMS

Notice of Proposed Rule Making

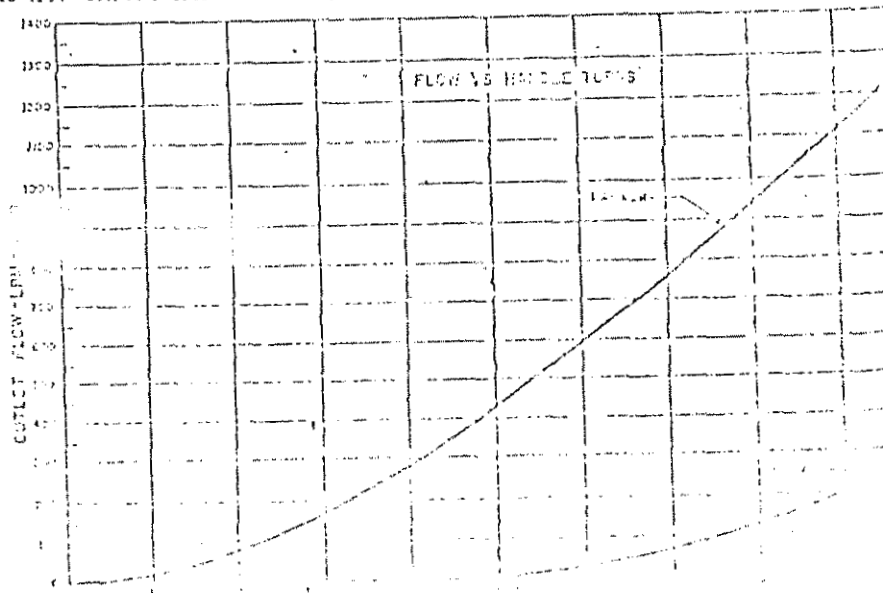
(3) All oxygen supply cylinders installed in the aircraft are equipped with manual slow opening type valves. For purposes of this section a slow opening type valve is defined as a valve in which the flow characteristics for any number

of turns of the valve handle do not exceed the limits shown in the flow chart at any inlet pressures from 0 to 2,150 psig.

Figure 1. Flow characteristics of a slow opening type valve.
