DISASTER FACTS

ACCIDENT REPORT

U.S. Department of Labor • Occupational Safety and Health Administration • Kansas City Region VII No. 22

ACCIDENT SUMMARY

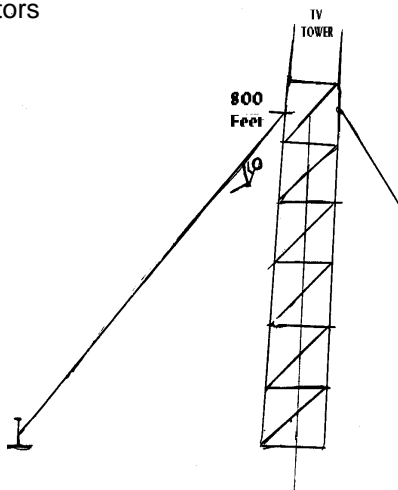
The employee was attaching dampners (weights approximately ten feet from the tower on the guy wire) to the guy wires. Employee would attach a body belt with a seat attachment to the guy wire with pelican hooks. Next he would attach a lanyard from the tower to the body belt. Employee would then slide down the guy wire to the specified length and attach the dampner. This was done at the 1000 foot guy wire, but on the 800 foot wire the employee did not properly attach the belt to the lanyard and when the specified length was reached, the lanyard fell back to the tower as employee lowered himself down the wire. The employee was able to hold his position for a few minutes while rescue was attempted, but then he lost his grip and slid down the entire length to the ground.

1. Provide tower length safety lines and provide employees with rope grabs and harnesses for additional fall protection.
2. Include construction methods that eliminate the need for climbing onto the guy wire.

3. Train employees in proper fall protection procedures.
