National Transportation Safety Board

Washington, D.C. 20594
Safety Recommendation

Date: January 15, 1998
In reply refer to: A-97-126 through -128

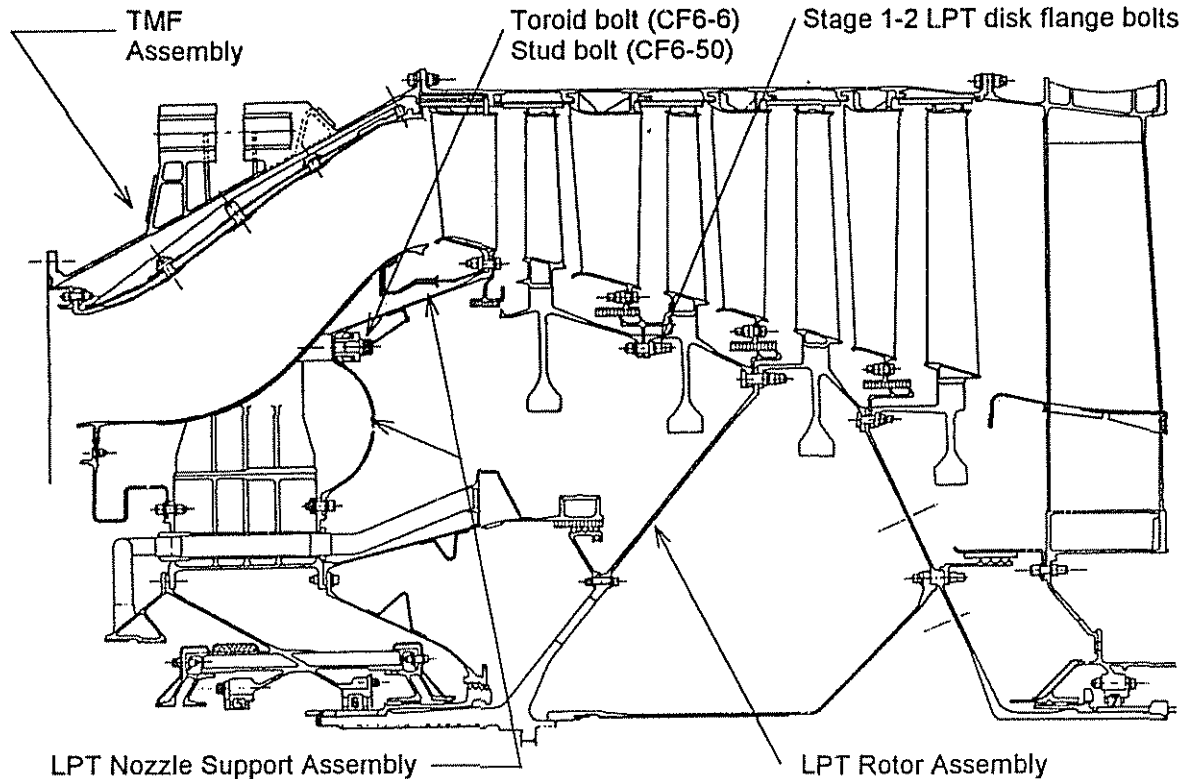
Figure 1. Cross section of low pressure turbine assembly

The toroid bolts used in the CF6-6 and the stud bolts used in CF6-50 secure the LPT nozzle support assembly to the TMF (see the cross section of the low pressure turbine shown in Figure 1).

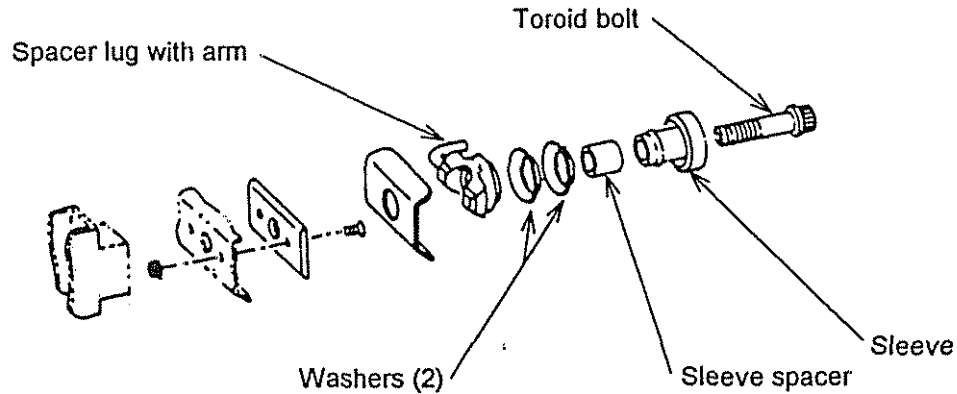
Figure 2. Exploded view of toroid bolt and associated hardware

In the CF6-6 engine, there are eight $\frac{3}{8}$ -inch double hex head machine toroid bolts installed in threaded holes of the TMF. The bolt passes through a sleeve, sleeve spacer, two shim washers, and a spacer lug. As a result of two CF6-6 engine-contained LPT failures, in which the failure of the toroid bolt safety wire permitted the bolts to back out of the holes and damage the TMF LPT cavity, GEAE issued Service Bulletin (SB) 72-533 on August 27, 1975. The SB added an arm to the spacer lug to attach a second strand of safety wire to the toroid bolt to prevent the bolt from becoming loose (see the exploded view shown in Figure 2). The spacer lug and all of the associated hardware from the toroid bolt, which was found battered in the TMF LPT cavity of the United Airlines CF6-6 engine that failed at O'Hare, could not be identified among the debris that was found in the cavity. An examination of the seven remaining spacer lugs on this engine showed that they had the safety wire arms added, indicating that SB 72-533 had been accomplished.

Require General Electric Aircraft Engine (GEAE) to revise the CF6-6 engine manual to include an inspection of the toroid bolts and associated hardware, retorquing of the toroid bolts, and replacement of the safety wire that should be accomplished at each maintenance exposure. Further, require GEAE to revise the CF6-50 engine manual to include an inspection of the stud bolt and associated

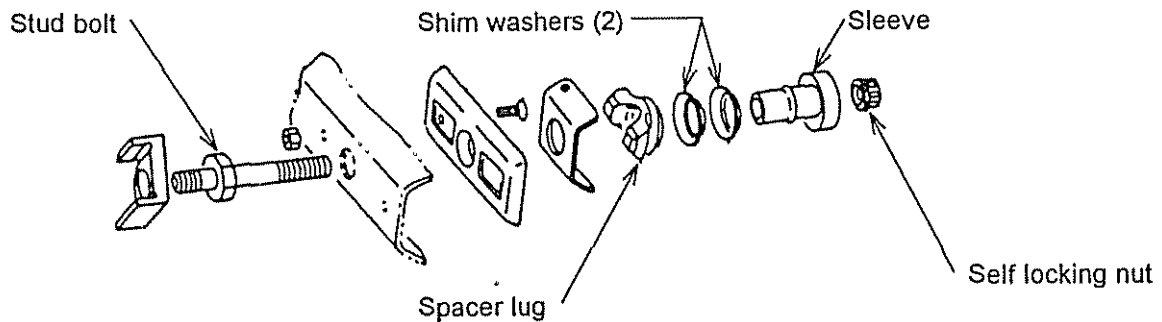
Figure 3. Exploded view of stud bolt and associated hardware

The $\frac{3}{8}$ -inch shouldered stud bolt is also installed into a hole in the TMF in a CF6-50 engine, with the shoulder of the bolt welded to the front side of the TMF. As with the toroid bolt on the CF6-6 engines, the stud bolt contains a similar stack of parts consisting of a sleeve, two shim washers, and the spacer lug; all of these parts are held in place with a self-locking nut. According to GEAE, the stud bolt design used in the CF6-50 engine TMFs was intended to be an improvement over the toroid bolt design for the CF6-6 engine (see the exploded view shown in Figure 3).
