# National Transportation Safety Board

Washington, D.C. 20594  
**Safety Recommendation**

**Date:** October 27, 1995

**In reply refer to:** A-95-101 through -102

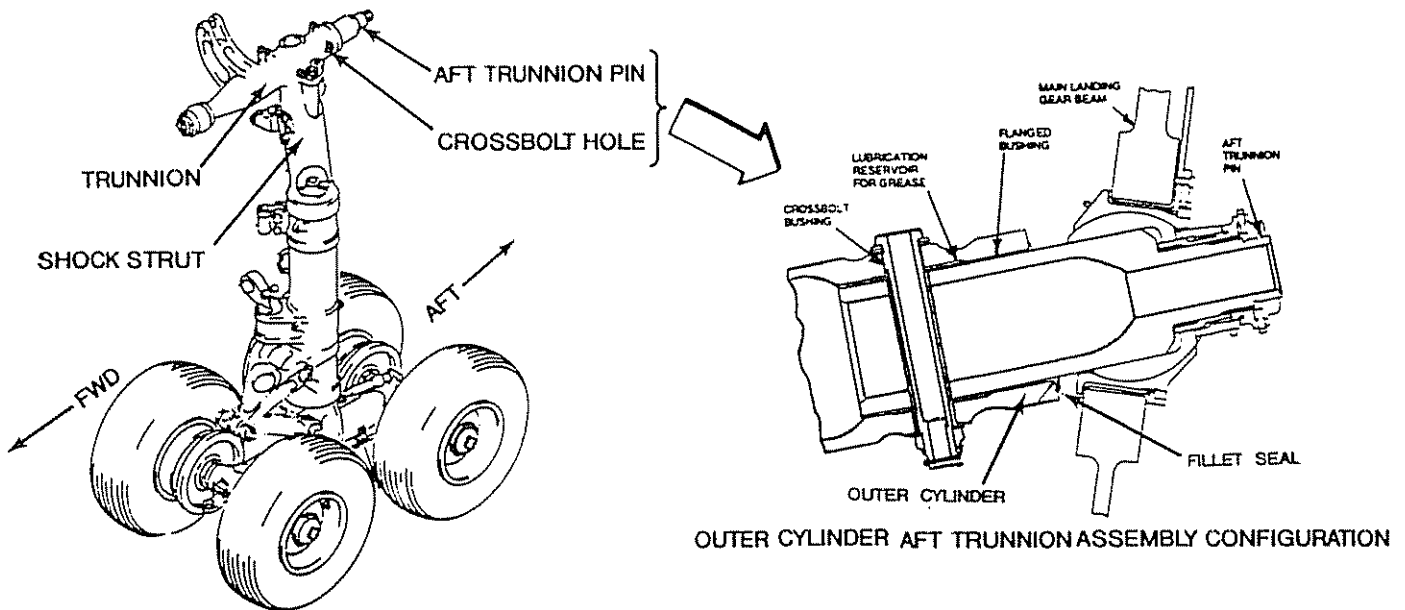
(Figure 1.) BOEING 767 MAIN LANDING GEAR ASSEMBLY

The B-767 MLG is a conventional, four-wheel, dual tandem gear that has a metering pin orifice shock strut (see Figure 1). The gear has four support points: the forward trunnion, which attaches to a fitting on the wing rear spar; the aft trunnion, which attaches to the landing gear beam; the drag brace, which attaches to a fitting on the rear spar; and the side strut, which ties to a fitting at the outboard end of the landing gear beam. The outer cylinder of the MLG assembly transfers operational loads from the truck assembly (the wheels and tires) to the four support points. The aft trunnion support point is a pin-in-socket design in which the pin is held inside the trunnion by a crossbolt. The trunnion pin connects the outer cylinder to the MLG beam. The trunnion pin is housed inside the upper aft end of the outer cylinder and bears against a flanged bushing that is installed in the outer cylinder using temperature differential shrink fit. The outer edges of the bushing flange and the cylinder are covered by a putty-like flexible fillet seal, which prevents moisture from entering under the bushing flange and cylinder chamfer area. The trunnion cylinder bore has a 5-inch-wide increased diameter section along the inner circumference of the cylinder that serves as a lubrication reservoir.

According to the Boeing Commercial Airplane Group, a lack of lubrication and/or insufficient interference between the trunnion cylinder and the trunnion pin may cause the bushing to move under loading. This results in the cracking of the fillet seal, allowing moisture to seep into and become trapped under the bushing flange and cause subsequent corrosion.
