# National Transportation Safety Board

## Safety Recommendation

In reply refer to: A-95-151

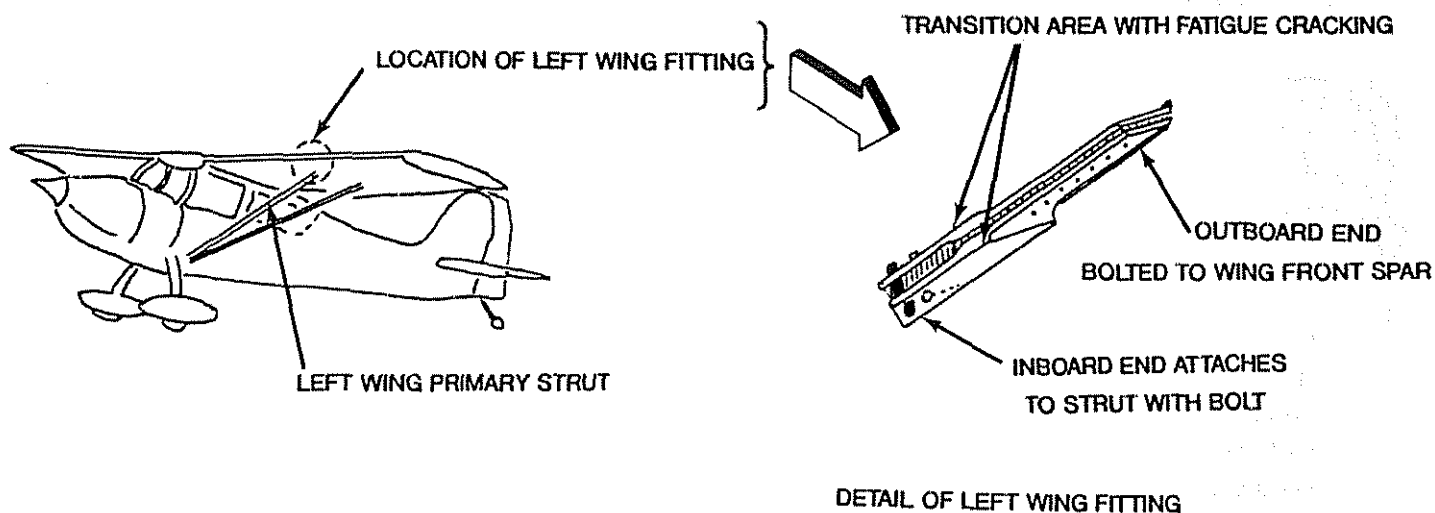
The aft wing fitting for the left wing primary strut separated in overstress. The forward fitting fractured through the transition area, approximately in the center of the length of the fitting. In the area of the separation, the fitting consists of an aft leg (assembled against the forward face of the wing spar web) and a forward leg.

**Figure 1. Location of fatigue cracking on the wing fitting for the left wing primary strut.**

Examination of the fractures through the two legs of the forward fitting showed that fatigue cracking progressed almost all of the way through the aft leg and about 25 percent of the way through the forward leg. The Safety Board's investigation revealed two factors that contributed to the initiation of the fatigue cracking: scratches in the forward fitting and operation of the airplane in an abusive manner.

Initiation of the fatigue cracking in the wing fitting was from multiple locations in one of a series of small, sharp scratches in the forward edge of the shorter portion of the aft leg, in the area where the leg begins the transition to the inboard configuration. The scratches were about 0.010 inch deep and were oriented vertically across the thickness of the shorter portion of the leg. Independent secondary cracks were found in three of these scratches. The Safety Board has not determined the source of the scratches, but they may have been created during the manufacturing process. The area that contained the scratches was in the transition area of the fitting, an area that is blended after removal of excessive material. It is possible that the scratches were not entirely removed during final sanding and polishing of the surface at this time. Other manufacturers have previously made the same models now made by American Champion. However, the previous manufacturers only made these airplanes with wooden spars and different (steel) wing fittings for the lift strut. For this reason, wing fittings on airplanes made by previous manufacturers are not of concern.

Because scratches in the wing fittings could facilitate initiation of fatigue cracking and precipitate another serious accident, the Safety Board is concerned that American Champion 8KCAB airplanes that have accumulated sufficient hours of operation may have fatigue cracks in the wing fittings for the primary struts. The Safety Board therefore believes that the wing fittings of these higher-time 8KCAB model airplanes should be subjected to an immediate, one-time inspection for scratches, using magnified visual examination, and for cracking, using an appropriate nondestructive inspection method such as dye penetrant inspection.

Notify operators of the American Champion 8KCAB airplanes of the circumstances of this accident and warn them of the possible adverse consequences of flying aerobatic airplanes in a manner for which the airplane was not certificated; for example, exceeding  $V_{ne}$  or using full or abrupt control movements above  $V_a$ . (Class I, Urgent Action) (A-95-151)
