NATIONAL TRANSPORTATION SAFETY BOARD  
WASHINGTON, D.C.

SAFETY RECOMMENDATION(S)

A-82-52

On January 27, 1982, a Bell UH-1B military surplus helicopter crashed into Kent Lake, California, killing the pilot, the only person onboard. The helicopter was performing sling operations at the time of the accident and had 656.2 hours of civilian use.

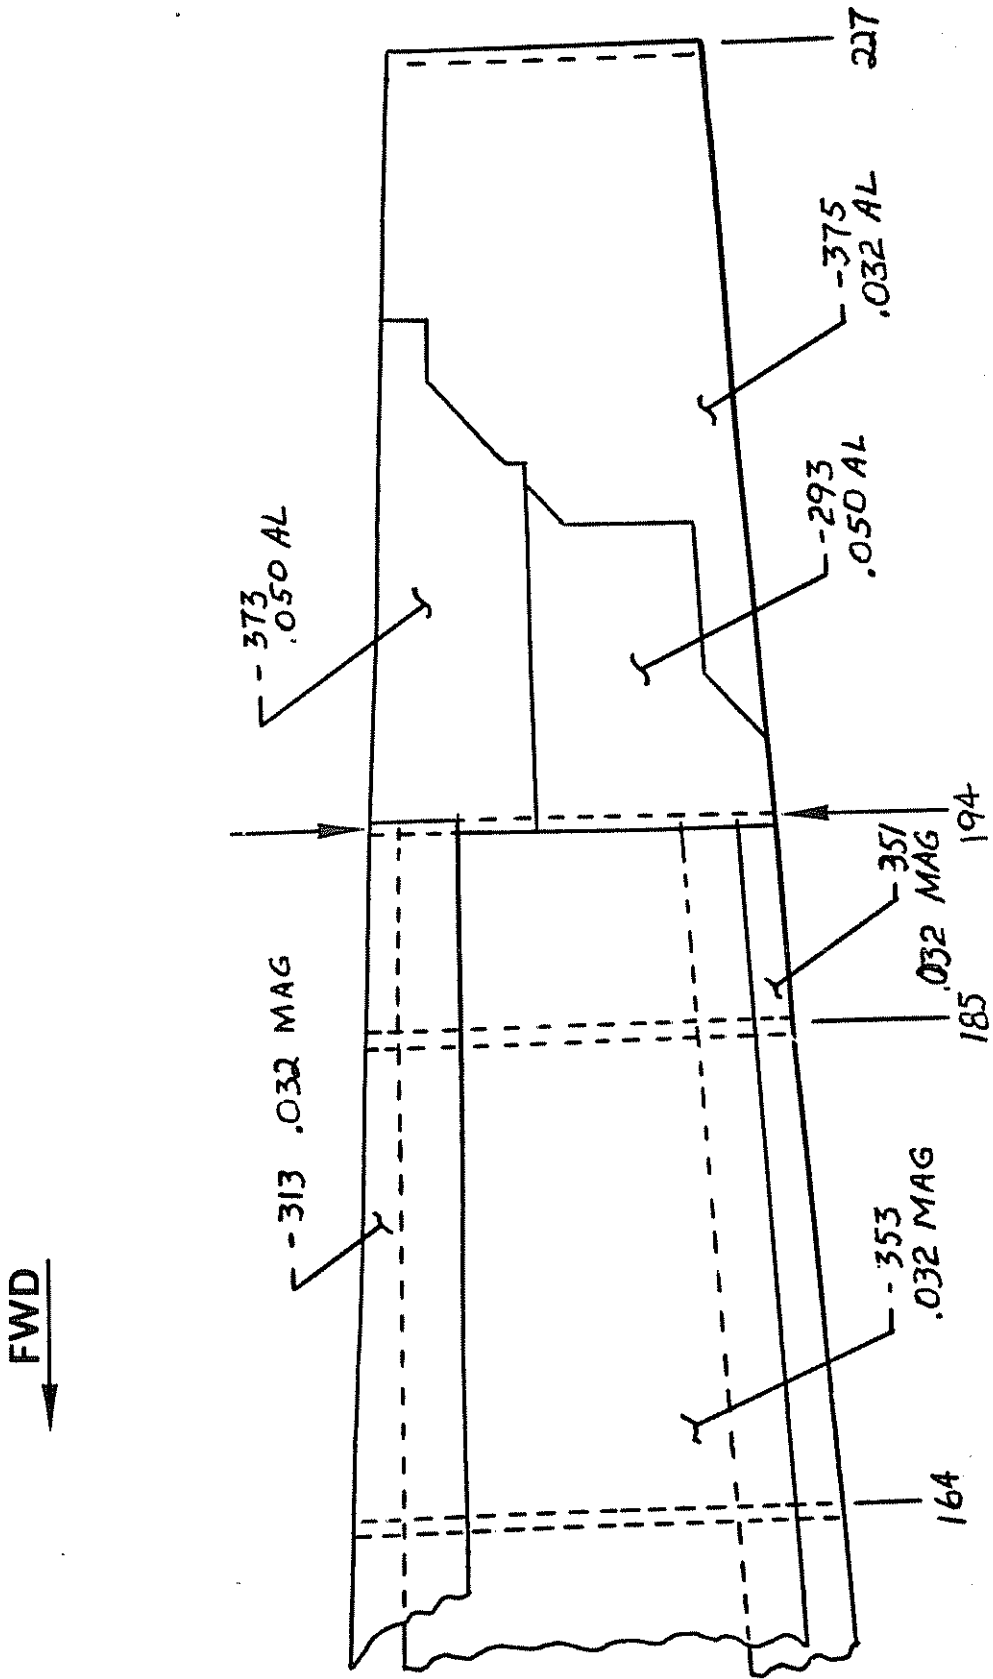
The National Transportation Safety Board performed a metallurgical examination of portions of the tail boom and vertical fin assemblies at its laboratory in Washington, D. C. This examination revealed extensive fatigue cracking in the magnesium alloy skin panels of the tail boom at station 194. The fatigue began from multiple rivet holes in the circumferential rivet pattern at station 194. Areas of fatigue were found from the bottom center rivet position, up the left side of the boom, and halfway across the skin at the top of the boom. The area where fatigue first started is believed to be near the lower left corner of the tail boom.

The tail boom of this aircraft is constructed with magnesium alloy skin forward of station 194 and aluminum alloy skin aft of this position. The skin panels were joined at station 194, with the side and lower magnesium alloy skin panels sandwiched between a bulkhead and the aluminum alloy skin panels. Thus, visual detection of cracking in these magnesium alloy skin panels along the station 194 rivet line would be difficult.

Figure 1. Sketch of the skin panels on the left side of the tail boom of the UH-1B from station 164 to station 227. Part number, thickness and alloy of the various skin pieces are indicated. For example, "-353 .032 mag" indicates that this skin piece is P/N 204-030-800-369-353 and is a magnesium alloy sheet with an 0.032 inch thickness. Arrows indicate the station 194 fracture location.

Issue an Airworthiness Directive to require (1) that all military surplus Bell UH-1B and UH-1D model helicopters and Bell 204B model helicopters be visually inspected before further flight and at appropriate time intervals thereafter for evidence of fretting on or adjacent to the tail boom aft access panel and the tail boom skin and rivets at station 194, (2) that aircraft found to have fretting or cracking be X-ray inspected before further flight for cracks in the magnesium alloy skin beneath the outer aluminum alloy skin on the left side (180°) of the tail boom at the station 194 rivets and also in the left side angle of the vertical fin front spar along a 1-inch-long area near the top of the spar where the angle first contacts the forward edge of the housing to which the 90° gear box is attached, (3) that aircraft in which the X-ray inspection discloses cracks be repaired before further flight, and (4) that at appropriate time intervals X-ray reinspection to detect newly developing cracks be made of aircraft on which the initial X-ray inspection disclosed no evidence of cracking. (Class II, Priority Action) (A-82-52)
