NATIONAL TRANSPORTATION SAFETY BOARD  
WASHINGTON, D.C.

ISSUED: 6/14/82

SAFETY RECOMMENDATION(S)  
H-82-16

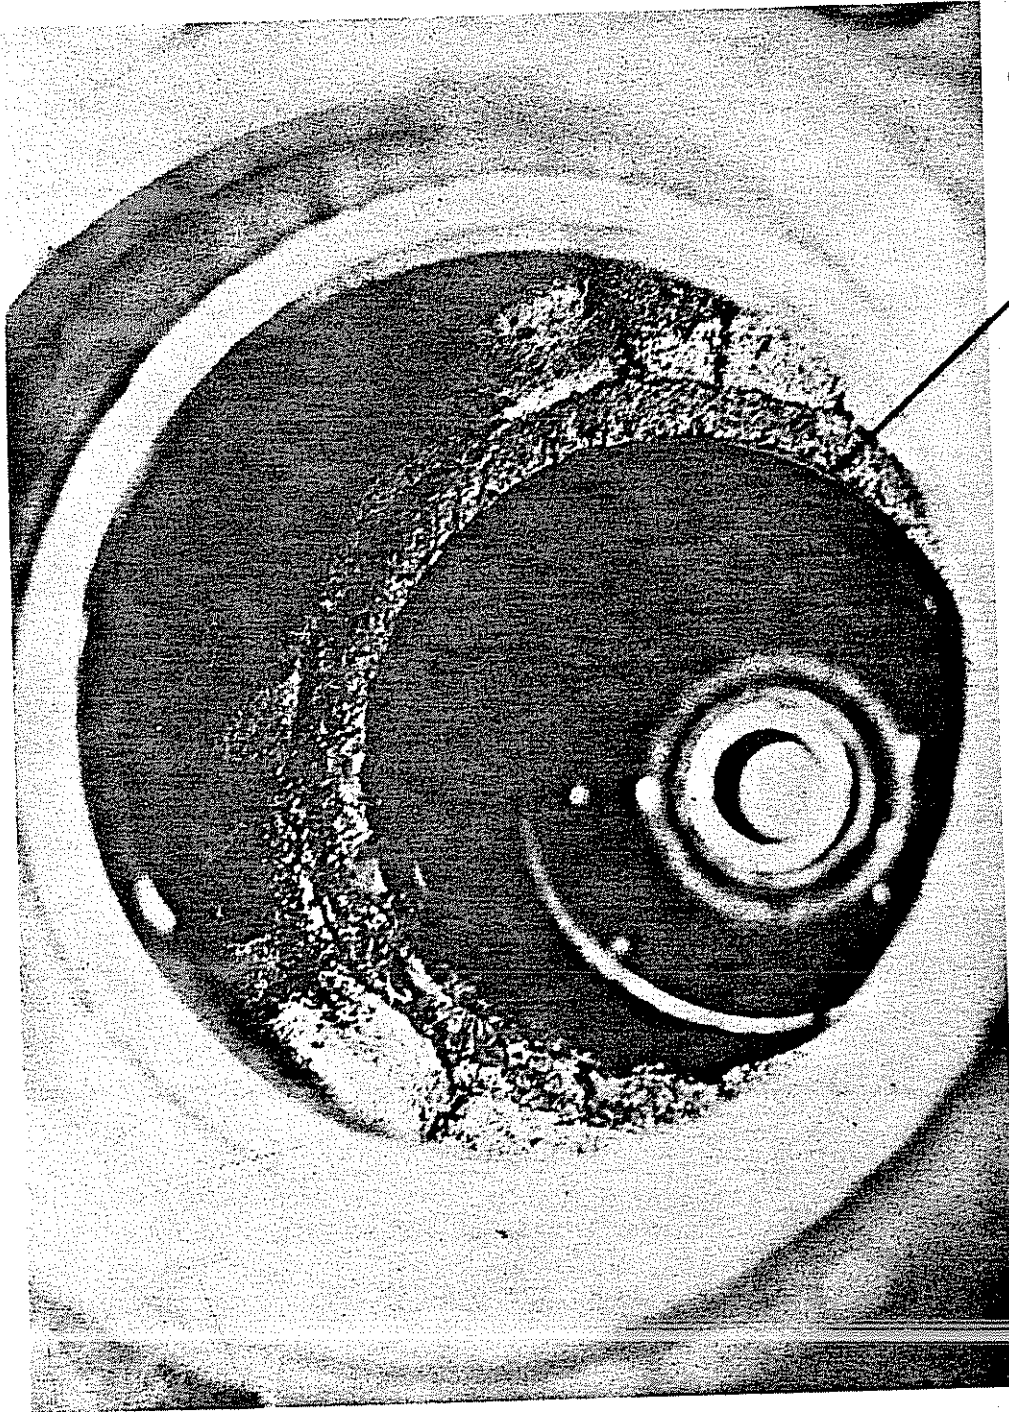
Figure 1.--Left front hub.

A postimpact inspection and laboratory analysis by the California Department of Transportation revealed that the left front aluminum wheel hub of the tractor had failed circumferentially through the outer spindle bearing cup retainer flange. (See figure 1.) Figure 2 is a schematic of the aluminum wheel hub and attached spindle bearings. The failure permitted excessive lateral and vertical movement of the aluminum wheel hub about the spindle.

The failure was probably caused by the improper installation of the outer bearing cup into the wheel hub compounded by the repeated tightening of the spindle adjustment nut against the bearing. The maintenance-induced failure would have eventually resulted in critical steering control problems for the driver, especially when the vehicle was being steered around right-hand curves. However, there were no reports of steering problems with the vehicle before this accident.

Missing Outer  
Bearing Flange

Left Front Hub

Issue an On Guard Bulletin to advise commercial vehicle owners, operators, and maintenance personnel of the correct procedures for installing spindle bearing cups into aluminum wheel hubs. State in the Bulletin that failure to follow the manufacturers' prescribed procedures could damage the aluminum wheel hub and result in critical steering control problems for drivers. (Class II, Priority Action) (H-82-16)

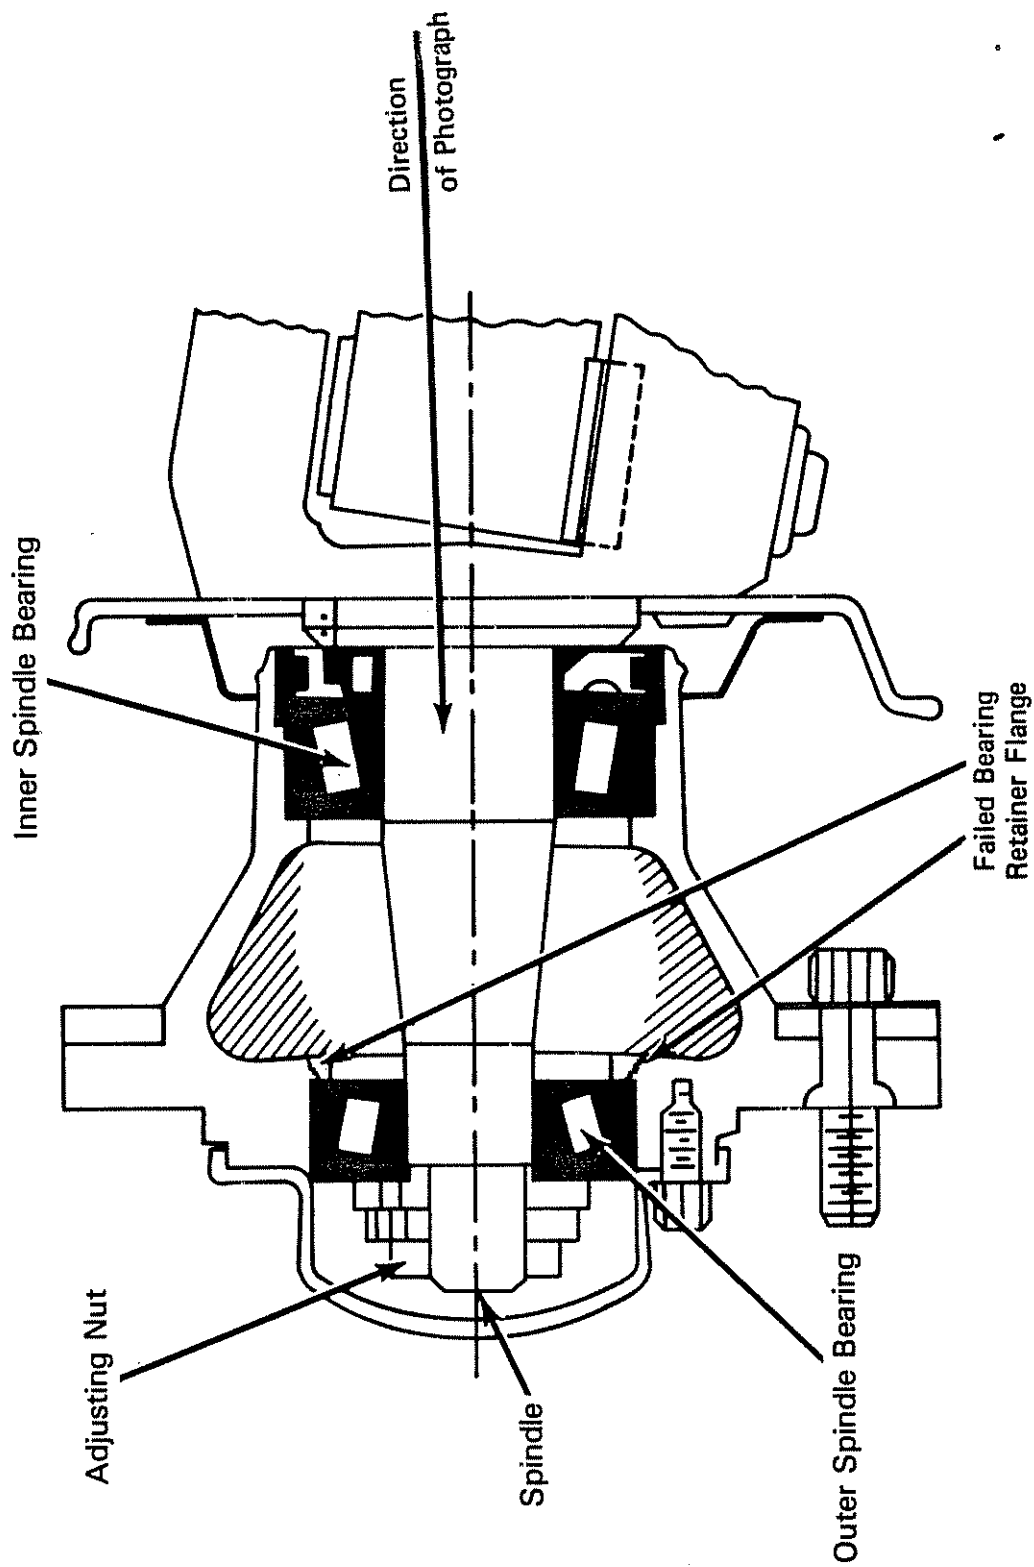
Figure 2.--Section of left front aluminum wheel hub.

# Section of Left Front Aluminum Wheel Hub
