NATIONAL TRANSPORTATION SAFETY BOARD  
WASHINGTON, D.C.

SAFETY RECOMMENDATION(S)  
H-82-17

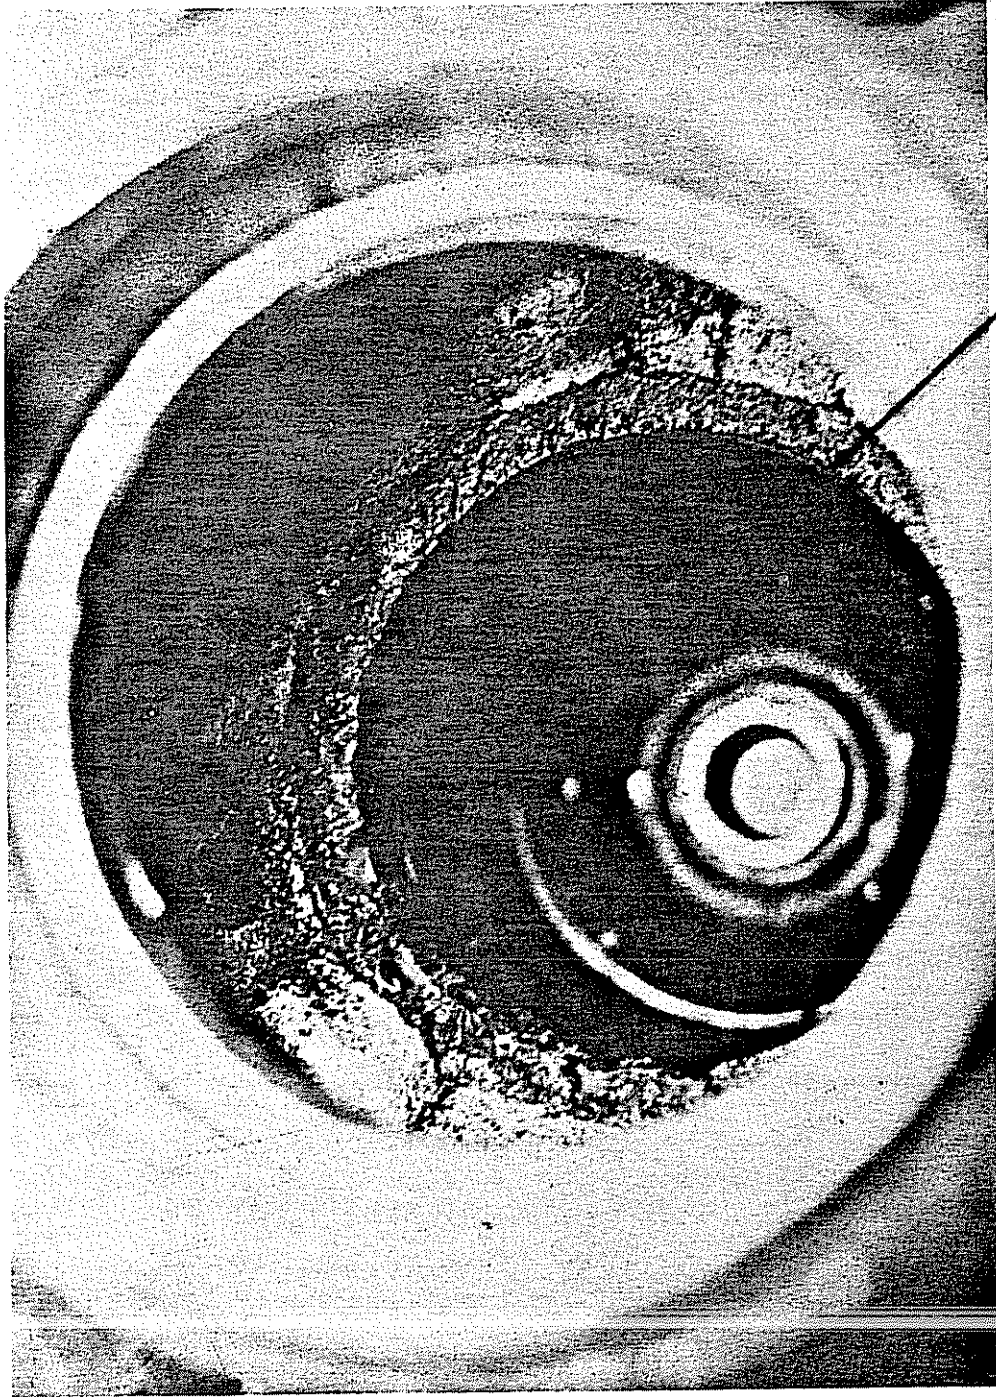
Figure 1.--Left front hub.

A postimpact inspection and laboratory analysis by the California Department of Transportation revealed that the left front aluminum wheel hub of the tractor had failed circumferentially through the outer spindle bearing cup retainer flange. (See figure 1.) Figure 2 is a schematic of the aluminum wheel hub and attached spindle bearings. The failure permitted excessive lateral and vertical movement of the aluminum wheel hub about the spindle.

The failure was probably caused by the improper installation of the outer bearing cup into the wheel hub compounded by the repeated tightening of the spindle adjustment nut against the bearing. The maintenance-induced failure would have eventually resulted in critical steering control problems for the driver, especially when the vehicle was being steered around right-hand curves. However, there were no reports of steering problems with the vehicle before this accident.

Missing Outer  
Bearing Flange

Left Front Hub

Disseminate to its membership and related organizations information concerning the correct procedures for installing spindle bearing cups into aluminum wheel hubs, the improper performance of which could damage the aluminum wheel hubs, consequently, resulting in critical steering control problems for drivers. (Class II, Priority Action) (H-82-17)
