NATIONAL TRANSPORTATION SAFETY BOARD
WASHINGTON, D.C.

SAFETY RECOMMENDATION(S)

I-82-1 through -4

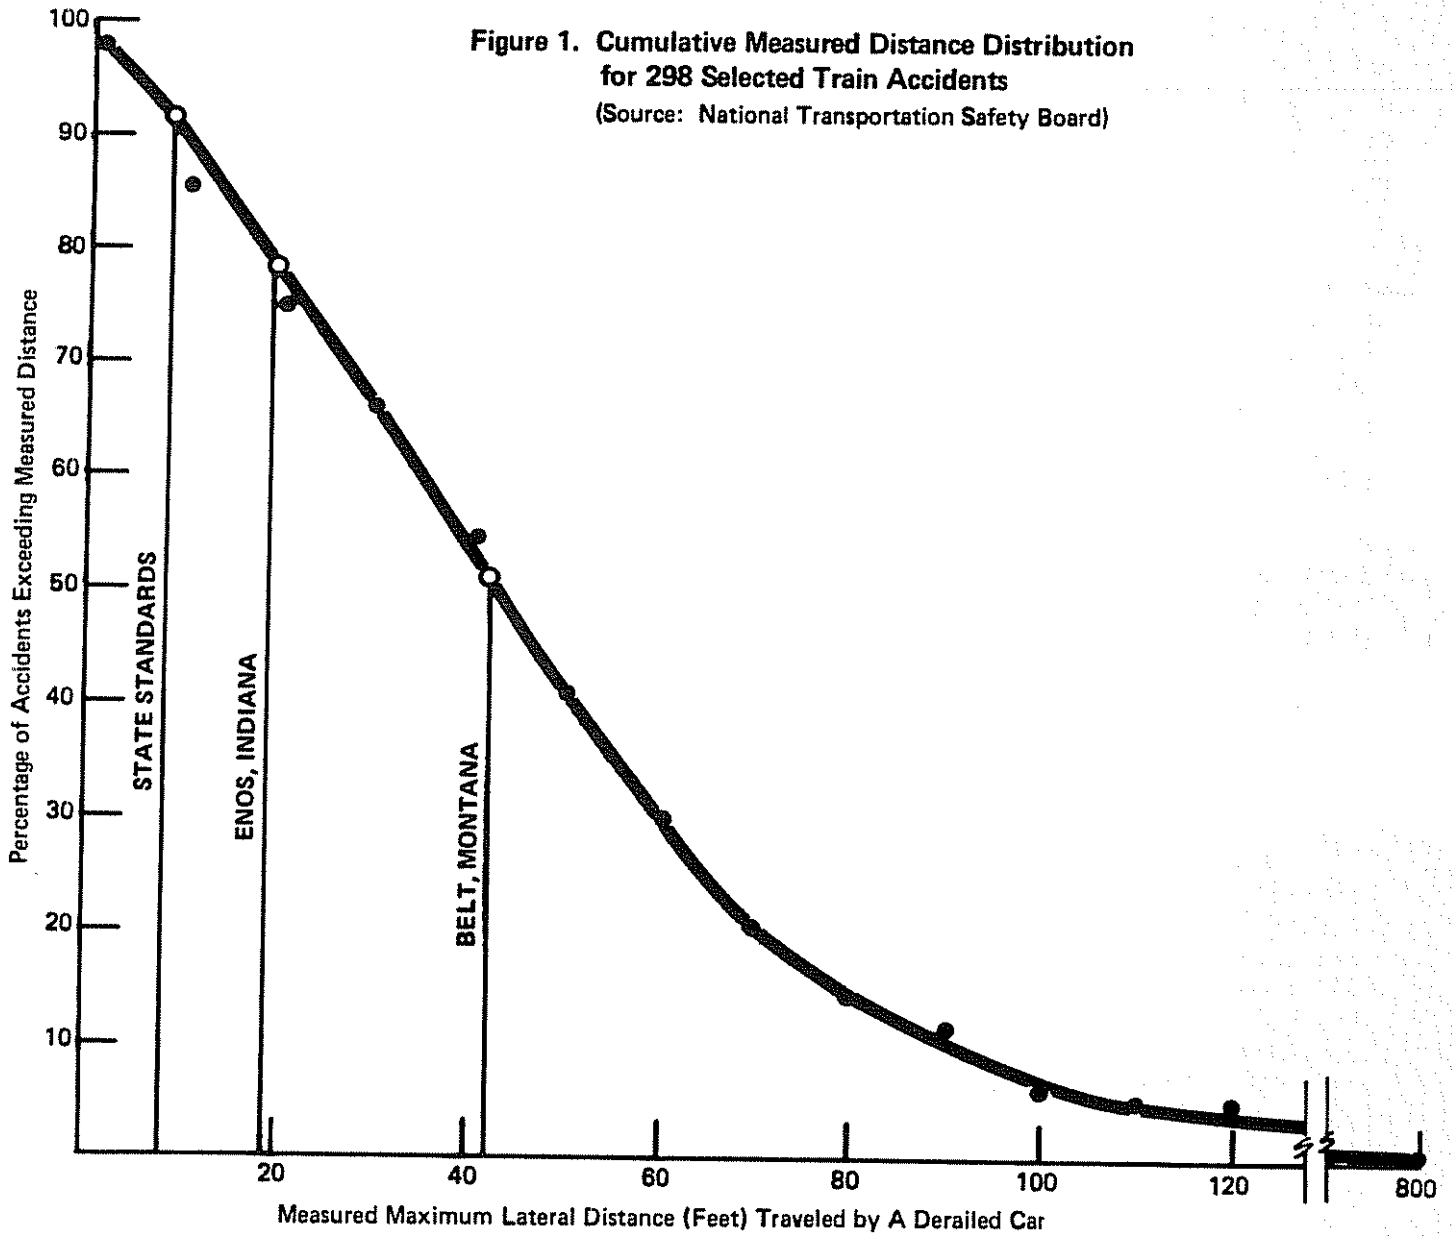
Figure 1. Cumulative Measured Distance Distribution for 298 Selected Train Accidents
(Source: National Transportation Safety Board)

Based on the Safety Board's measurements, in more than half of these derailments hazardous materials placed as close to the tracks as the hazardous materials in Belt could have been struck. Had hazardous materials been placed as close as those at Enos, they could have been struck by derailed cars in three-fourths of the accidents. Storage tanks 8 feet from tracks would have been vulnerable to damage by derailed cars in over 90 percent of the 298 accidents investigated by the Safety Board. (See figure 1.)
