National Transportation Safety Board

Safety Recommendation

In Reply Refer To: R-92-09

About 8 a.m. on September 17, 1991, Norfolk Southern (NS) train 277, en route west from Fort Wayne, Indiana, to Chicago, Illinois, struck eastbound train 629 head-on at milepost (MP) 455.1 near Knox, Indiana. The accident occurred on the main track west of the Knox siding. One locomotive and four cars of train 277 and three locomotives and five cars of train 629 derailed. The engineer of train 277 was killed, and the conductor sustained serious injuries. The student engineer of train 277 and all three crewmembers on train 629 sustained minor injuries.¹

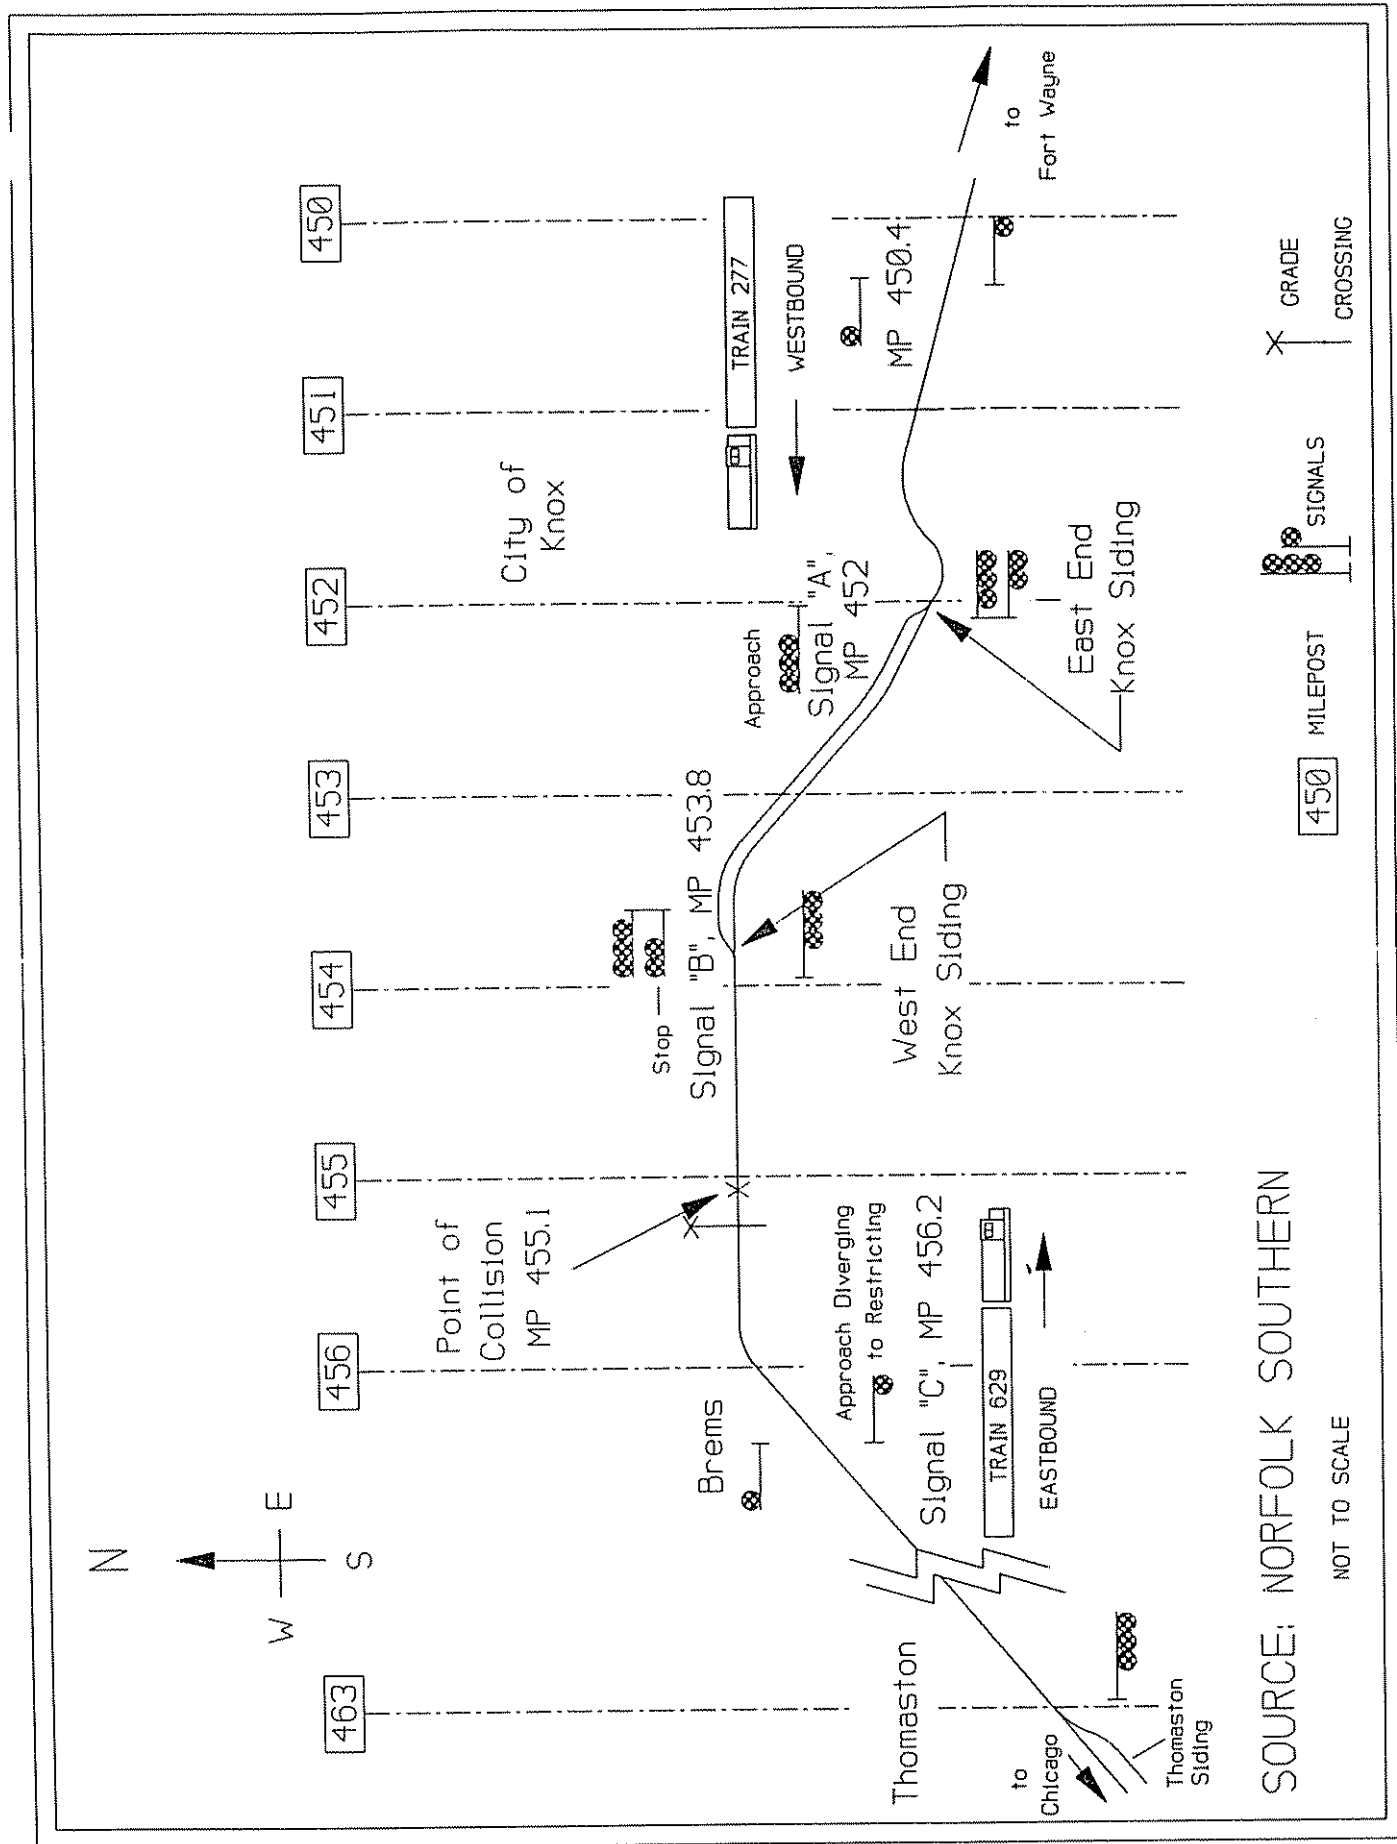
Figure 1.-- Knox siding.

The student engineer said that he saw signal A (MP 452; see figure 1), the "approach" signal for the east end of the Knox siding, and thought it was clear; he did not describe the combination of colors that the signal showed. He also said he assumed the engineer saw the signal because the engineer was standing behind him. According to the student engineer, neither he nor the engineer called out the signal as required by operating rule 34. The student engineer stated that "as far as I know" (but he was not sure), the conductor called the signal clear.

Signal B (MP 453.8), the signal for the west end of the Knox siding, was clear, according to the student engineer. The investigation showed, however, that signal B, which is a "remote control" signal controlled by the dispatcher, displayed a "stop" signal. Train 277 should have stopped at signal B, which governs movement of trains on the main track at the west end of the siding. The student engineer stated that he observed "green over red" (the color combination that signifies clear) on the left column of signal lights. He said that neither he nor the engineer, who was in the middle of the cab at the time, called the signal. The conductor had moved from the rear seat to the front seat on the left side, and he called "clear," according to the student engineer, who said the signal was clear as the train passed it. The student engineer reported that he did not notice which way the switch was lined (whether it was set to allow train 277 to proceed on the main track or to allow train 629 to enter the siding). He estimated the train's speed at 35 mph and increasing when the locomotive passed the signal and switch.

Safety Board sight-distance tests indicated that the student engineer, who was sitting on the right, could have seen signal A, but only for 934 feet. It was not possible for the conductor or the engineer of train 277 to see signal A from the left side of the locomotive. According to the TC log, the train's average speed was 29 mph, or 42.5 feet per second, on the main track from the east to the west end of the Knox siding. At this speed, the student engineer, as well as anyone standing behind him, would have had approximately 22 seconds to see the signal before going past it.

After the train passed signal A, signal B would have been visible to anyone sitting on the left side for 3,600 feet, or 90 seconds, and to anyone sitting on the right side for 2,400 feet, or 55 seconds.

Review and revise your programs for traincrew supervision, locomotive cab discipline, and training of student engineers in light of the circumstances of this accident, and make necessary improvements. (Class II, Priority Action) (R-92-09)
