National Transportation Safety Board

Safety Recommendation

In reply refer to: A-06-24 through -26

The National Transportation Safety Board is currently investigating two accidents involving fractures of tension-torsion (T-T) straps in MD Helicopters, Inc. (MDHI), model MD900 helicopters. Thirteen T-T straps are part of the anti-torque fan assembly in the no tail rotor (NOTAR[®]) systems in the MD900 helicopter. Fracture of a T-T strap results in failure of the anti-torque fan and loss of thrust for yaw control.

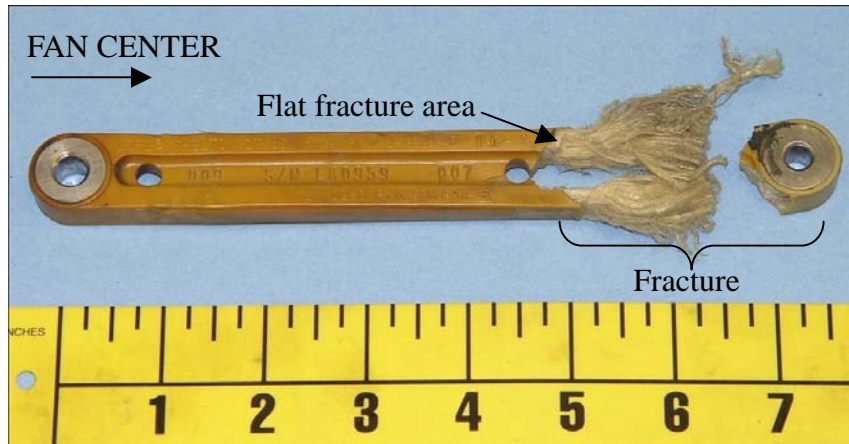
Post-accident inspections of the accident helicopters revealed that in each case, 1 of the 13 T-T straps in the anti-torque fan had fractured. The fractured strap for N9016W failed after 1,694 hours time in service (TIS) and for JA6757, after 1,724 hours TIS. These fractures resulted in liberation of anti-torque fan blades from the anti-torque fan and a loss of thrust for helicopter yaw control. Figure 1 shows one of the fractured straps. All 26 of the straps from both accident helicopters were sent to the Safety Board's Materials Laboratory for examination.

Figure 1. View of the fractured strap from one of the accident helicopters showing the side with identifying markings.

The Safety Board's examination showed that both of the broken straps fractured because of progressive transverse cracking through the fiber-reinforced region of the composite straps, which gradually degraded the strength of the straps until they could no longer support the expected in-service tensile loads. If an overstress fracture of the entire fiber-reinforced area of the straps had occurred under the tension loads that would have been acting on the accident straps at the time they failed, an irregular and frayed appearance of the fibers would be expected throughout the fracture surface. However, portions of the fractures in the failed straps were on a flat transverse plane, and likely existed prior to the final fracture of the straps. Upon further examination, other intact straps also had fiber fractures on a flat transverse plane. The locations and shapes of the flat areas were consistent with damage associated with torsion (twist) loading.⁴ Transverse cracks like those indicated in the polished cross-section of an intact spool area shown in figure 4 were associated with kinked fibers, a feature that is consistent with longitudinal compression and/or

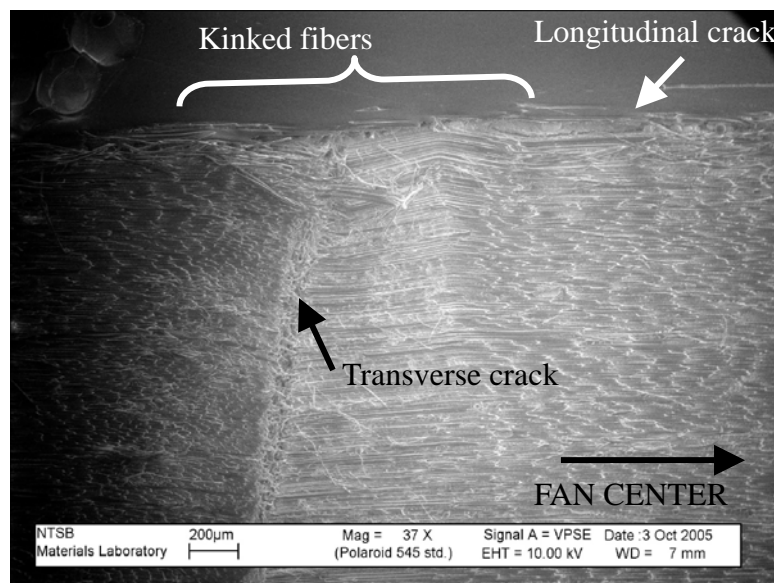
Figure 4. Scanning electron microscope view of fiber kinking and cracks in a polished cross-section of an intact spool area of one strap.

transverse shear stresses at that location. Kevlar[®] fibers, which are relatively weak in compression and transverse shear when compared to other structural composite fibers like glass or carbon, will buckle or kink at relatively low strains.⁵

The finite element analysis indicated that twist loads that occur without applied CF loads comprise an important and potentially critical load case that should be included in the fatigue testing and analysis of these straps. The stresses associated with this load case were consistent with the fiber kinking and associated cracking observed in the accident straps. As further discussed below, the manufacturer's certification testing did not include this potentially critical load case, which could be routinely imposed in service.

Require MD Helicopters, Inc. (MDHI), to conduct additional tests to enable the full analysis of all critical load cases for tension-torsion straps installed in the anti-torque fan of MDHI model 500N series, 600N, and MD900 helicopters, including load cases that create regions of transverse shear or compression in the fiber-reinforced areas of the straps. (A-06-24)

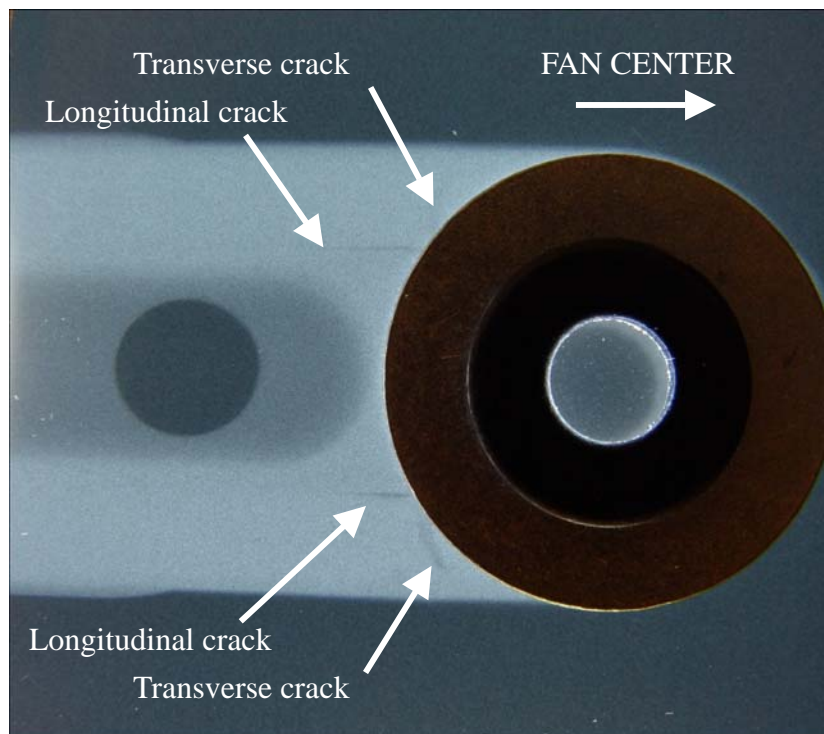
All straps from the two accident helicopters were x-ray inspected after the accidents, and the resulting radiographs were examined in the Board's Materials Laboratory. Among the 24 intact inner spool areas and 26 intact outer spool areas, identifiable transverse crack indications were observed emanating from the inner spool of one strap. Figure 5 shows the x-ray radiograph for this spool with the transverse crack indications on each side of the inner spool. When several intact strap ends were sectioned and polished, nearly all of them had some amount of fiber fracture on a transverse plane. For the strap spool area shown in figure 5, the transverse cracks that were visible in the radiograph were gaped open in the polished cross-sections.⁶ In

Figure 5. Photograph of an x-ray radiograph of the inner spool area of an intact strap from one of the accident helicopters. Transverse and longitudinal crack indications were visible in the radiograph.

The radiographs showed that most of the straps had longitudinal crack indications that in many cases were more visible than the transverse crack indications in the same strap. These longitudinal crack indications (see figure 5) corresponded to longitudinal separations that ran approximately along the boundary between the fiber-reinforced region and the polyurethane-only region. Based on observations of the strap cross-sections, longitudinal crack indications detectable in the radiographs appeared to correlate strongly to the presence of significant fiber kinking and to the progression of fiber fracture on a transverse plane. Such longitudinal crack indications are an indicator of a damaged strap with transverse cracking, even if transverse crack indications are not present on a radiograph. Because the longitudinal indications are more readily visible on the radiographs, they may provide an earlier warning that transverse cracking is progressing. To improve the safety of continued operation after x-ray inspection of the straps, the Safety Board therefore recommends that, during the non-destructive inspections of T-T straps installed in anti-torque fans in MDHI model MD900 helicopters and any other models requiring x-ray inspections, require that the x-ray film be examined for indications of both progressive fiber fractures and for longitudinal cracks in the T-T straps, and require that any T-T straps in which progressive fiber fractures or longitudinal cracks are found be removed from service.

During the non-destructive inspections of tension-torsion (T-T) straps installed in anti-torque fans in MD Helicopters, Inc., model MD900 helicopters and any other models requiring x-ray inspections, require that the x-ray film be examined for indications of both progressive fiber fractures and for longitudinal cracks in the

T-T straps, and require that any T-T straps in which progressive fiber fractures or longitudinal cracks are found be removed from service. (A-06-26)
