# National Transportation Safety Board

## Safety Recommendation

**In reply refer to:** A-06-29 through -35

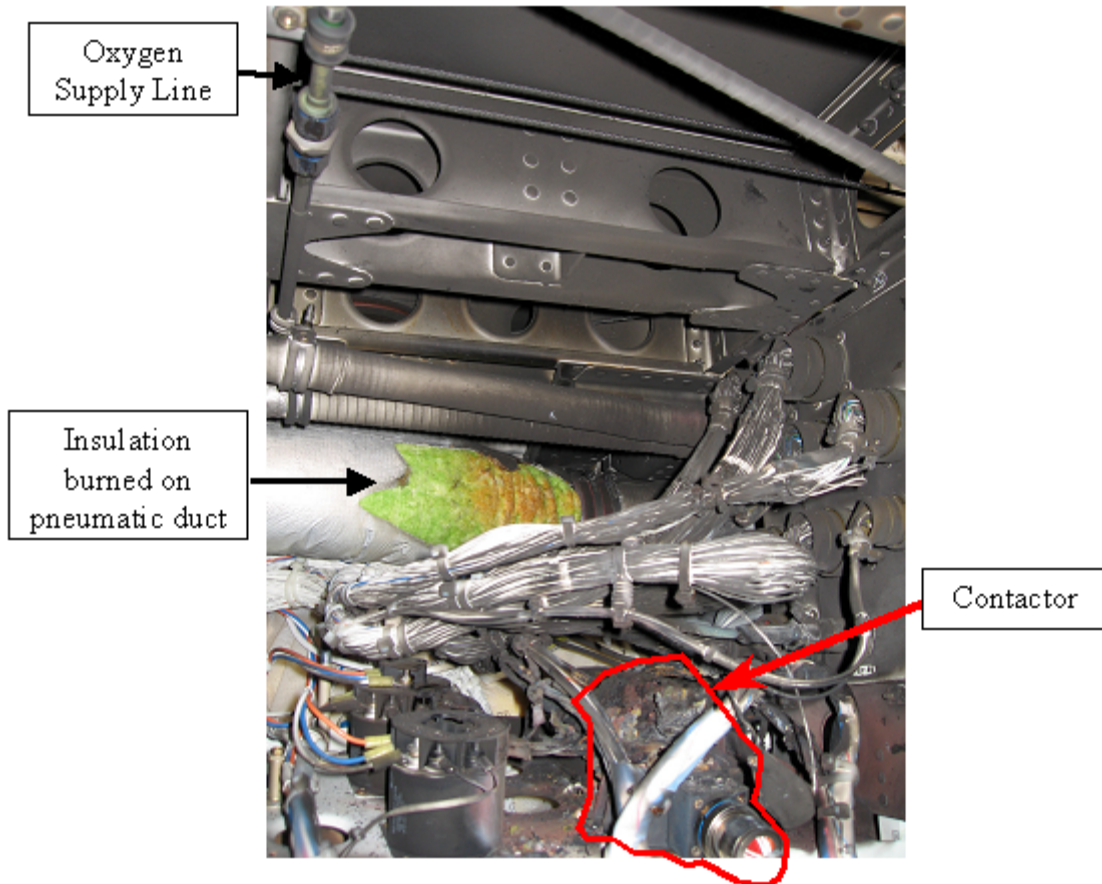
Postincident inspection found that a fire had originated at the Ultem 2200<sup>1</sup> base terminal portion of the 1K4XD electrical contactor,<sup>2</sup> manufactured by Tyco Hartman, and spread throughout that portion of the avionics compartment. The contactor was located in the avionics compartment beneath the floor, slightly aft of the captain's seat, and beneath the wall separating the cockpit from the passenger cabin. The fire extensively damaged wire bundles for power supply and airplane systems, caused external damage to other electrical components, and blackened the supply line to the captain's oxygen mask. If the fire had penetrated the oxygen line or if there were leakage from this line, the fire could have been substantially worse.

On December 14, 2005, the pilots of Atlantic Southeast Airlines (ASA) CRJ-200 flight 5029 declared an emergency while descending through 24,000 feet into Hartsfield-Jackson Atlanta International Airport, Atlanta, Georgia, when a fire broke out at the 1K4XD contactor in the avionics compartment (see figure 1). The cockpit voice recorder (CVR) transcript revealed that the flight crew was confronted with a cascade of failure events as electrical power from the left, and then right, generator was lost, the smell of electrical smoke entered the cockpit, all EFIS displays were temporarily lost, the cabin temperature temporarily became hot, and the air-driven

**Figure 1.** Burned area beneath the left forward cabin floor of the ASA CRJ-200.

Immediately require operators to provide separation of electrical power sources in CRJ-200 airplanes to prevent the potential loss of electronic flight instrument system displays that may result from contactor failures. (A-06-29) Urgent

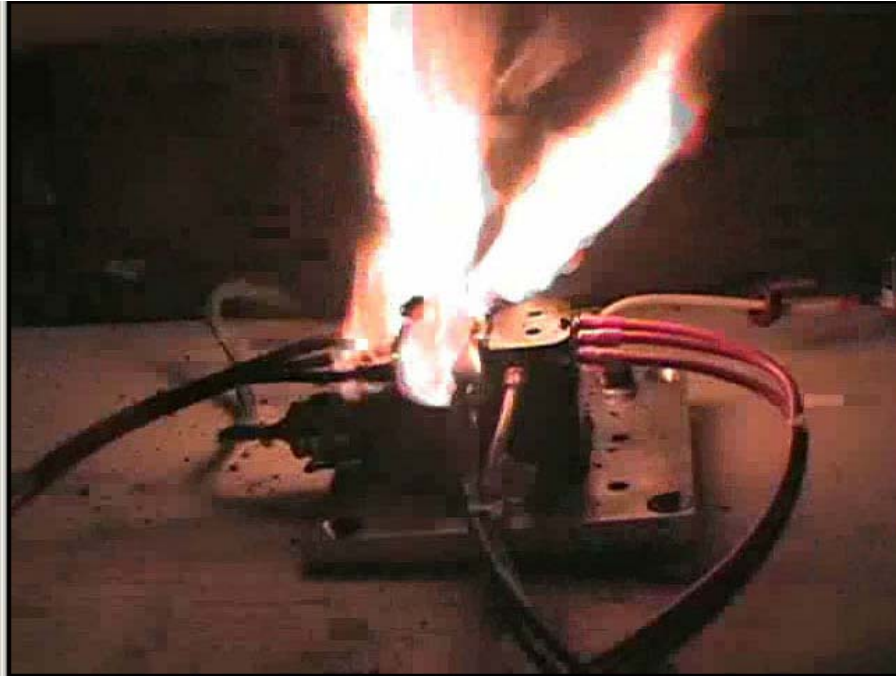
Two versions of the 1K4XD contactors are approved to be installed on in-service CRJ-200 airplanes: the originally certified version, which uses NP509 woven glass fabric, melamine resin laminate (also known as G-9) as an insulator for the contactor's plastic base and a newer version (approved for use on March 16, 2000, by Tyco Hartman<sup>5</sup>), which uses the Ultem 2200 material. Safety Board investigators conducted tests at Tyco Hartman on both versions of the contactor in February 2006. The tests revealed that when drops of water were placed on the contactor that contained the Ultem 2200 material to bridge the electrical terminals, the Ultem 2200 material gradually turned to a carbon char for the duration of power application. After the water evaporated due to the short circuit, the carbon char provided a semiconductive path between terminals, and intense flames and arcing extended more than a foot from the contactor (see figure 2). The duration of the breakdown of the base material, short-circuiting, and fire lasted for more than 100 seconds in one test before a wire fell away, disconnecting the power supply. Similar tests on the contactor containing the melamine insulator material resulted in the water steaming off with no material breakdown and no fire.

**Figure 2.** Arcing and flames rising from the contactor base with the Ultem 2200 material after water bridged two electrical terminals. Continuous short-circuiting and fire, along with occasional arcs, such as shown above, lasted for 100 seconds in this test.

Immediately require Bombardier to develop a means of protecting electrical terminals on Tyco Hartman 1K4XD contactors fitted with Ultem 2200 (polyetherimide) terminal bases from moisture-induced short circuits. (A-06-30) Urgent

Require Bombardier to expedite the replacement of 1K4XD contactors on CRJ-200s with contactors that are not susceptible to short circuit. (A-06-32)
