National Transportation Safety Board

Safety Recommendation

Date: August 25, 2006

In reply refer to: A-06-56 through -59

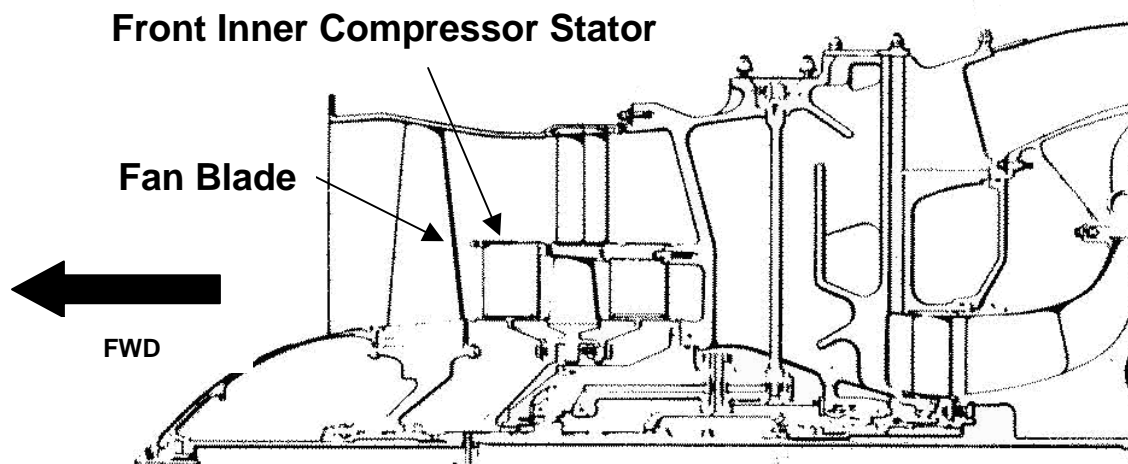
Following the Sarasota and Jacksonville events, P&WC accomplished a study to determine if it was possible for high-altitude ice crystals to adhere to and build up inside the JT15D-5 engine to the point that the engine would flame out. The analysis revealed that with the engine anti-ice turned off it was possible for ice crystals to build up on the leading edges of the JT15D-5 engine's front inner compressor stator¹⁴ (see figure 1) and that the buildup could lead to a compressor surge and/or flameout. The study results suggest that the ice crystals melt as they pass through the fan section (due to an increase in temperature from air being compressed) then adhere to and refreeze on the front inner compressor stator leading edges.

Figure 1. View of forward half of JT15D-5 engine showing front inner compressor stator

¹⁴ The JT15D-5 engine low pressure compressor rotor consists of the fan and booster stages. On the front and rear sides of the booster stage are the front and rear inner compressor stators, respectively. When engine anti-ice is activated, the engine's front and rear inner compressor stators as well as the inlet cone are heated with warm air from the high pressure compressor to prevent ice formation. The lip of the airplane's inlet duct is also heated when engine anti-ice is activated.

Immediately require Beechjet 400 pilots to activate the engine ignition and anti-ice systems at high altitude whenever they are in or near visible moisture, or near convective storm activity, or before any power reduction unless the pilots can verify that the airplane is not in or near visible moisture or near convective storm activity. (A-06-56) Urgent
