UNITED STATES
DEPARTMENT OF LABOR
MINE SAFETY AND HEALTH ADMINISTRATION

REPORT OF INVESTIGATION

Surface Coal Mine
Fatal Fall of Highwall
April 17, 2007

Job #3
Tri-Star Mining, Inc.
Barton, Allegany County, Maryland
MSHA I.D. No. 18-00713

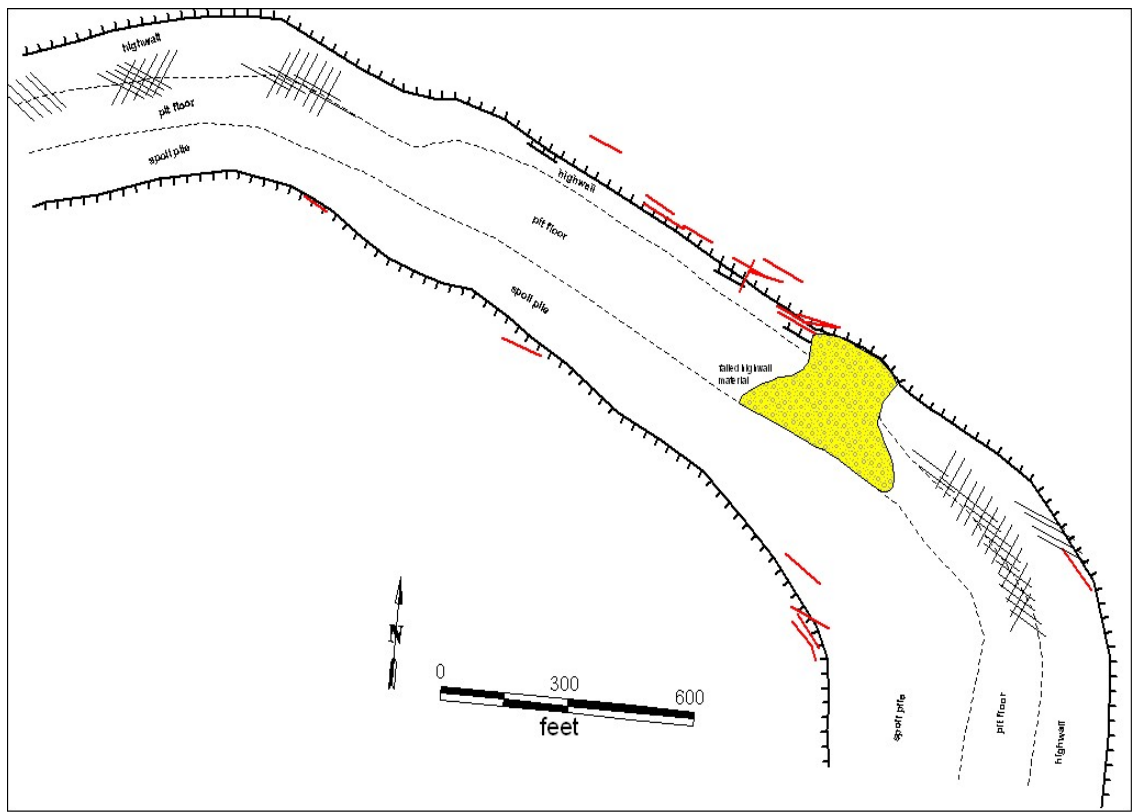
Two main joint sets are present throughout the 001 Pit, striking N 20-25° E and N 60-70° W, respectively (Figure 2). A joint is defined as a divisional plane or surface that divides a rock and along which there has been no visible movement parallel to the plane or surface or a fracture or parting that cuts through and abruptly interrupts the physical continuity of a rock mass. (1968 Bureau of Mines Dictionary of Mining, Mineral, and Related Terms) Joints in both sets were nearly vertical, and intersected at nearly right angles. Due to the S-shaped configuration of the pit, the relative orientation of the highwall changes with respect to the joints. In the middle and southeastern segments of the pit, both joint sets were at nearly 45° to the respective highwall trends. In contrast, the northwestern segment of the pit is oriented nearly parallel with the set of N 60-70° W-striking joints or the direction which these joints are running.

Figure 2. Outline of the 001 Pit in the vicinity of the slide (yellow), showing joint orientations (thin black lines) and trends of tension cracks (thick red lines) on the top of the highwall and spoil bank.

At the time of the investigation, numerous open cracks were observed at the top of the northwest-trending segment of the highwall in the thin layer of unconsolidated overburden, and nearly parallel to the N 60-70° W-striking joint set. Open aperture tension cracks are commonly developed in swarms within 20 feet of the berm at the top of the highwall, with individual cracks located 12-24 inches apart.

The N 77-90° W trend of tension cracks is very similar to the strike of the N 60-70° W joints. (See Appendix B, Figures 3, 4, and 5 for photographs)

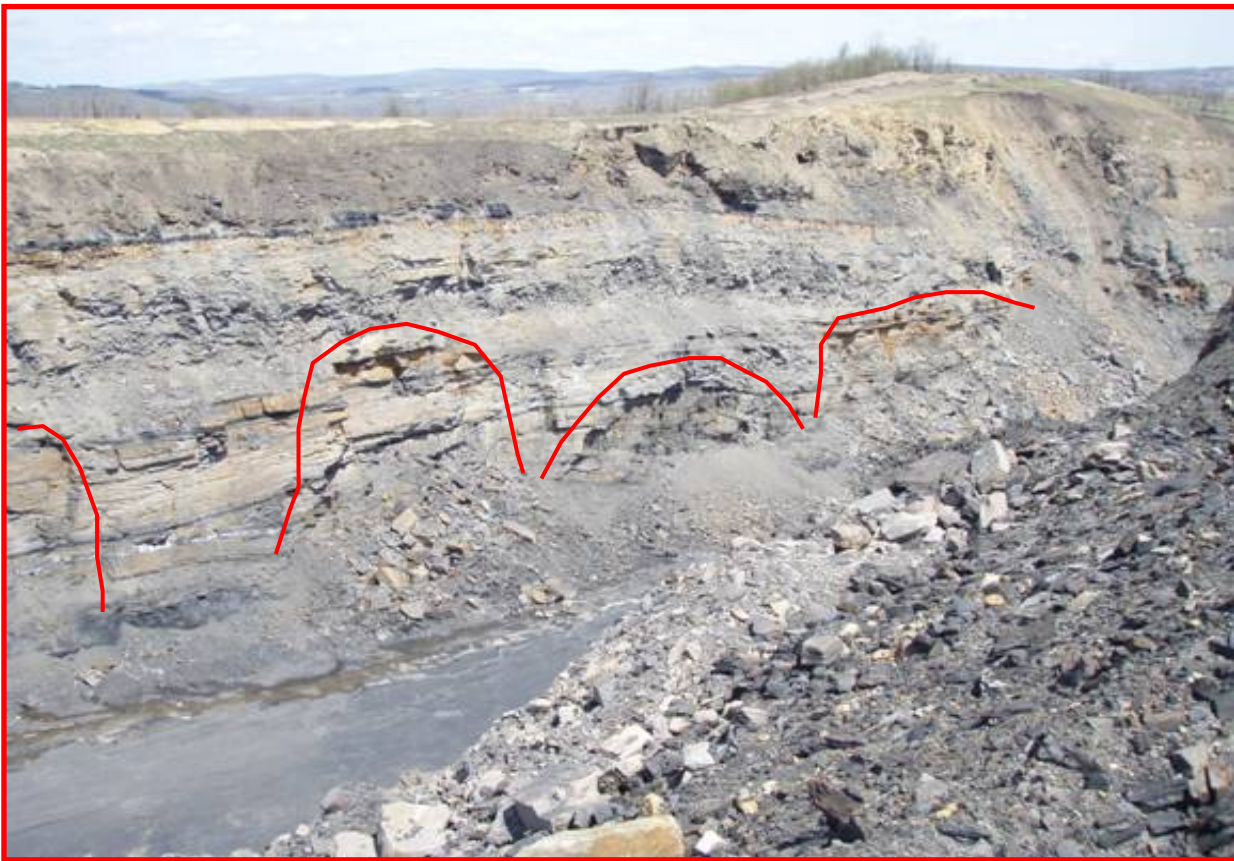
Underground workings in the Sewickley and Pittsburgh seams are exposed in the 001 Pit highwall, and are associated with subsidence features (Figure 6). Subsidence features observed in the highwall correspond with workings of the Caledonia Coal Co., and on property belonging to the Swanton Coal Co. The rock in the highwall above the old mining works was highly fractured due to subsidence. Several pillars that could be observed in the higher Sewickley coal seam had retained their rectangular profiles, preserving square pillar corners, but the entries had been completely filled with caved shale and sandstone from the immediate roof (See Appendix B Figure 8 for photograph). In the slide area, extensive subsidence indicated that mining had left little coal in the Sewickley coal seam. The strata exhibited total roof to floor convergence across extensive expanses of complete coal extraction. As viewed from the spoil bank, a very small remnant pillar on the Sewickley Limestone was the only indication that the Sewickley coal seam had been present. At the top of the highwall, large joint-bounded blocks had separated from the rock face, exhibiting apertures of up to 40 feet, and were localized above areas of high extraction in the underlying Sewickley seam.

Figure 6. Concave indentations (red arcs) defined by joint-bounded blocks in sandstone overlie subsided rooms in the Pittsburgh seam. Subsidence damage extends along the highwall through the slide area.

The most severe subsidence features were developed above the Pittsburgh seam, near the bottom of the pit. Possibly due to numerous episodes of second mining, and greater overburden depths, the Pittsburgh seam exhibited extreme convergence and deformation, with crushed and sheared coal pillars and rooms that were completely filled with broken subsided strata (rubble). The immediate roof above the Pittsburgh seam rooms was commonly characterized by downward-bowed strata. Convergence was so extreme that wood posts were encased in highly compacted rubble in former rooms, and remained hanging in the highwall face after being exposed by mining (See Appendix B Figure 9 for photograph). The coal pillars in the northwestern segment of the highwall had completely failed and turned to rubble, and were incapable of carrying significant load.

The extensive jointing present in the highwall provides existing planes of weakness that have increased the severity of the subsidence. The combination of joints and subsidence allowed joint-bounded blocks of the immediate and main roof to drop into the underlying rooms. Joints above Pittsburgh seam mine rooms are heavily iron stained and exhibit wider apertures than in the surrounding rock mass. Although shale layers commonly do not have joints that are as well developed as those found in adjacent sandstone, the shale immediate roof of the respective coal seams is commonly broken into rubble, and has sagged into the underlying mine entries. The rubble is stained with white, flour-like precipitant from circulating groundwater. Water was observed seeping from old works in the Sewickley and Pittsburgh seams exposed in the highwall. The iron staining and water seepage indicated

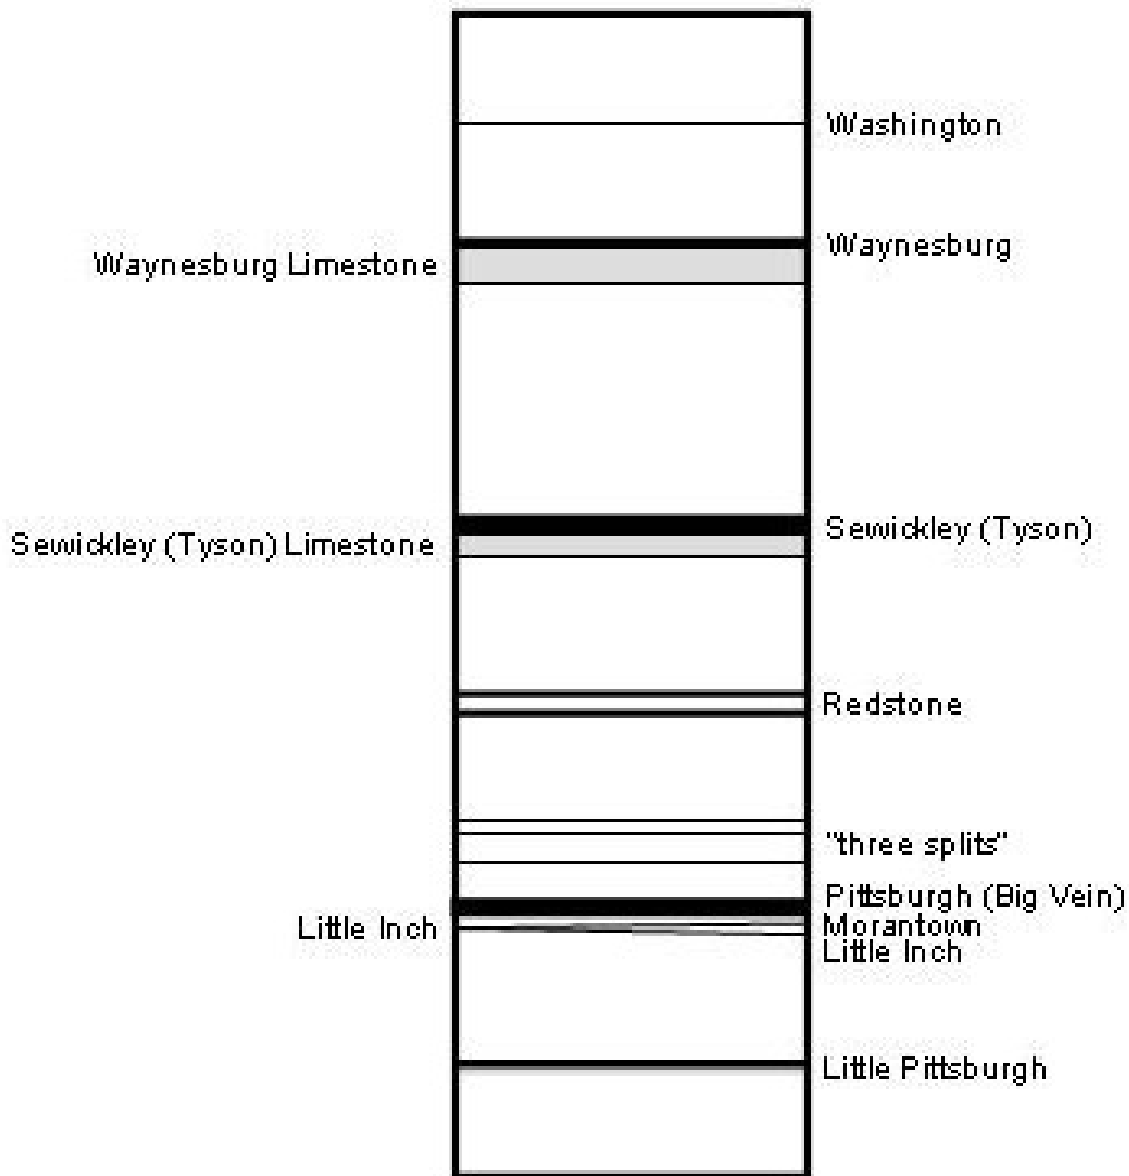
Figure 1. Stratigraphic column for mined coal seams at the 001 Pit. The Little Inch and Morantown merge into a single seam. Extensive underground mine works are present in the Sewickley and Pittsburgh seams.

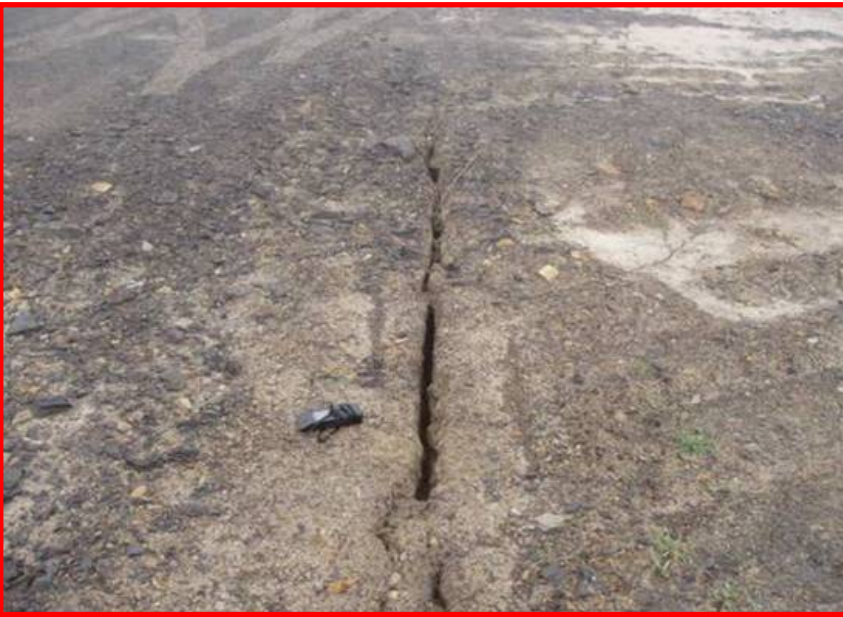
Figure 3. Open joint exposed at top of highwall, between the haul road and the highwall berm, exhibits aperture of three inches. Joint is parallel to trend of adjacent highwall.

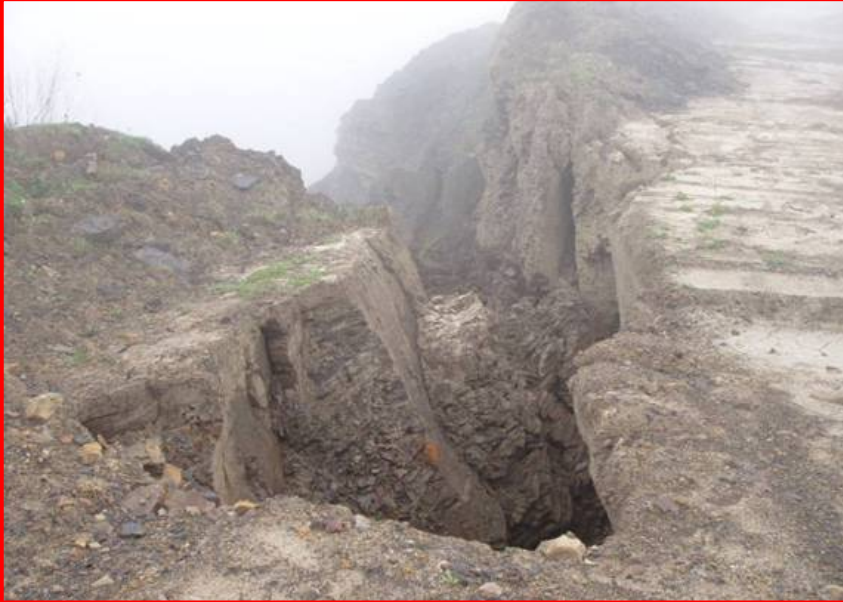
Figure 4. Block located 200 feet west of failure bounded by perpendicular joints has rotated from the highwall toward the pit, separating along a joint plane oriented parallel to the highwall. Block exhibits 12-foot separation with respect to the highwall.

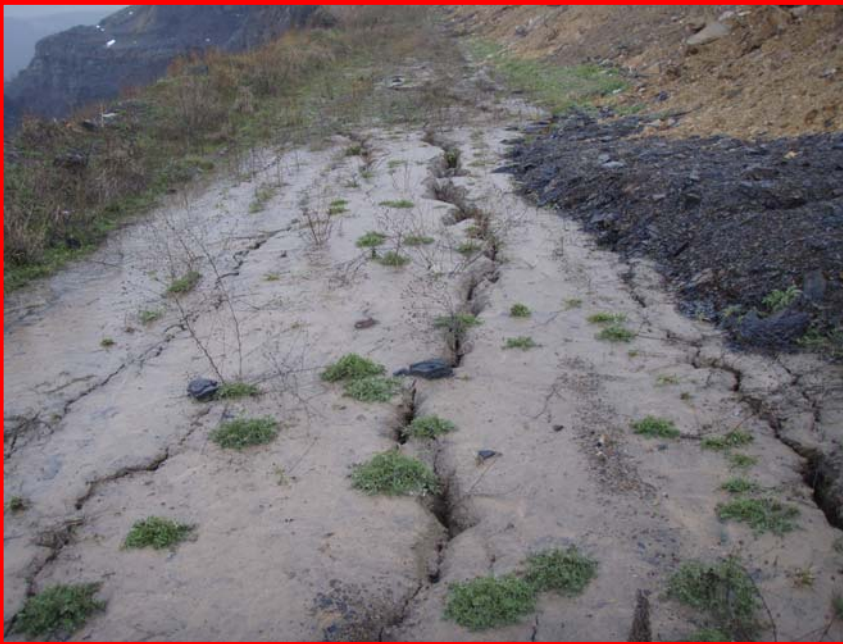
Figure 5. Rounded edges on middle tension crack indicate that it was present for a prolonged period, and most likely pre-dated the highwall failure. Swarm of cracks, present between the berm at the top of the highwall and the haul road, is oriented parallel to N 60-70° W-striking joint set. Area is located approximately 600 feet west of the failure.

The swarms of tension cracks were observed from directly adjacent to 700 feet west of the failure area, extending along the top of the highwall. The presence of mud, as well as the presence of cat-tail growth, along the top of the highwall between the berm and haul road indicated prolonged periods of standing water that was available to lubricate underlying joints. Rounded edges in some of the tension cracks indicated that they had been open for extended periods of time prior to the highwall failure (Appendix B Figure 5). The sides of some mud cracks were aligned into a continuous, ragged trend that was parallel to the N 60-70° W-striking joint set in the underlying rock.

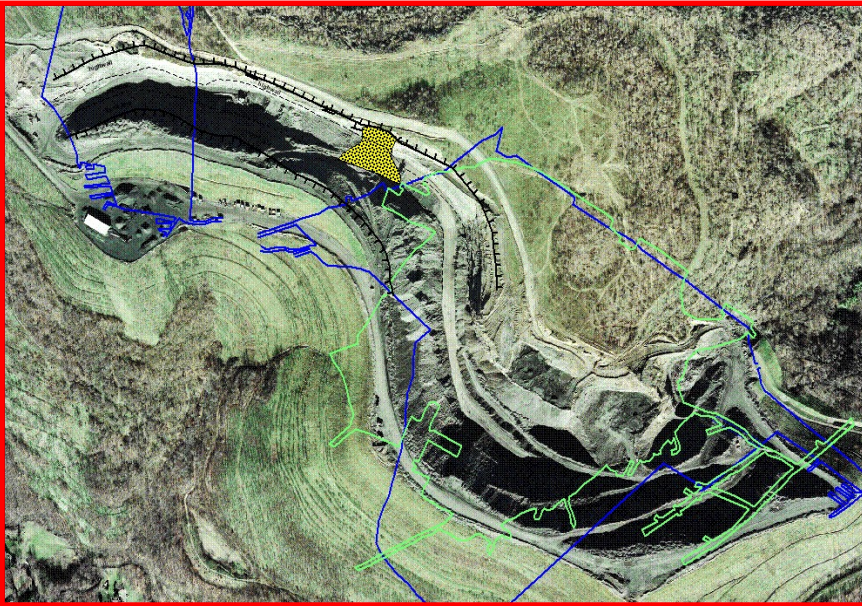
The spoil from the mining operation was truck dumped across a long, narrow area that is roughly parallel with, and south and west of the highwall (See Appendix B Figure 7). The pit bottom is constrained on the north and east side by the active highwall and on the south and west side by the spoil bank. The spoil bank height varies, but was estimated to be 270 feet at its highest point in the area across from the highwall failure. The base of the spoil bank is in places underlain by up to 50 feet of unmined rock that is referred to as the low wall. Roads and ramps were located on the spoil bank in various areas, primarily near the top of the bank. The slope angle of the spoil bank varied greatly from location to location, but in the area of active mining, the slope tended to be much steeper through the bottom 150 feet and flatter through the upper 120 feet. The largest angle measured on the lower slope of the spoil bank was approximately 60 degrees. The spoil contained a large percentage of fine material and it was estimated that the spoil angle of repose was 36 degrees. The average angle of the spoil bank, combining the flatter upper and steeper lower sections, was estimated to be 42 degrees.

Figure 7. November 2006 aerial photo of the 001 Pit overlain by April 2007 failure area and outlines of underground mine workings. Blue outline represents underground mining in the Pittsburgh seam; green outline represents underground mining in the Sewickley seam. Additional mine workings were observed in the highwall, for which no mine maps were found. Highwall and spoil bank locations documented during investigation are slightly offset from the older pit outline shown in the photo.

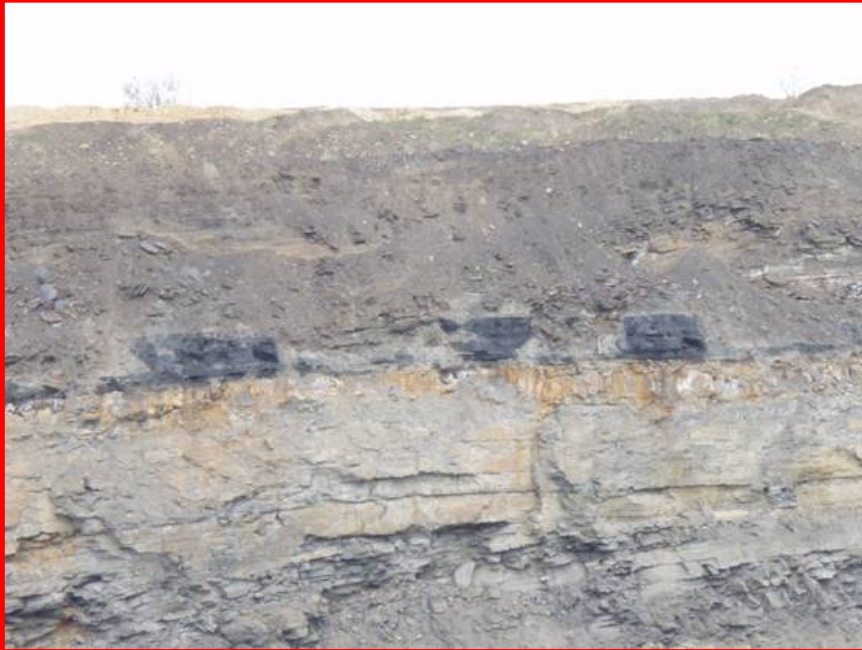
Figure 8. Pillars visible in the Sewickley seam retain square pillar corners despite total failure of the immediate roof and complete in-filling of old rooms. Layers of the immediate roof typify sag into the underlying rooms.

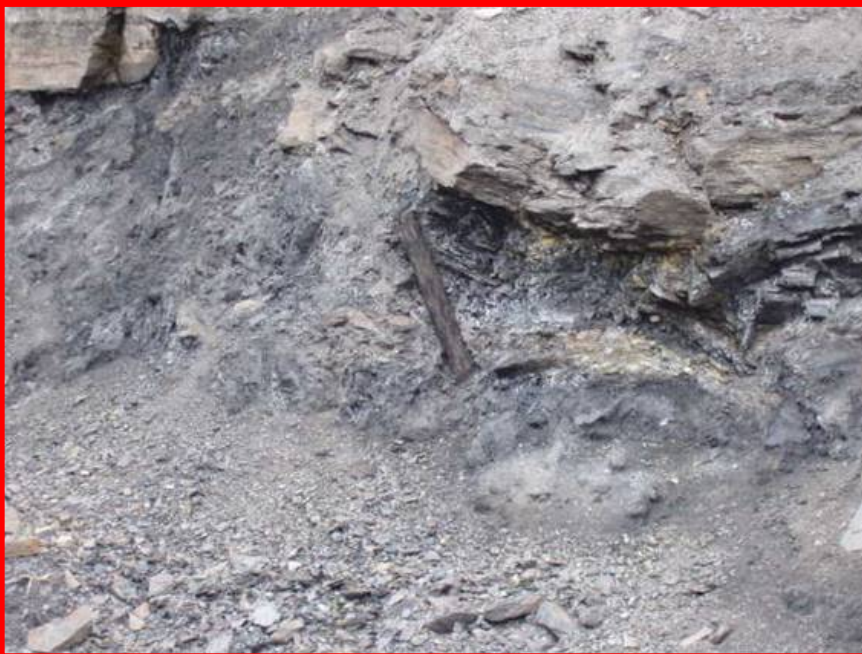
Figure 9. Wood post is preserved in crushed, in-filling rubble in a Pittsburgh seam room. Coal pillar is completely failed, characterized by extensive crushing and shearing, and illustrates the extent of damage in the Pittsburgh seam.
