Reactor Vessel Head Inspection Current Status and Future Plans

Calvert Cliffs
Nuclear
Power Plant
Unit 2

March 18,
2003

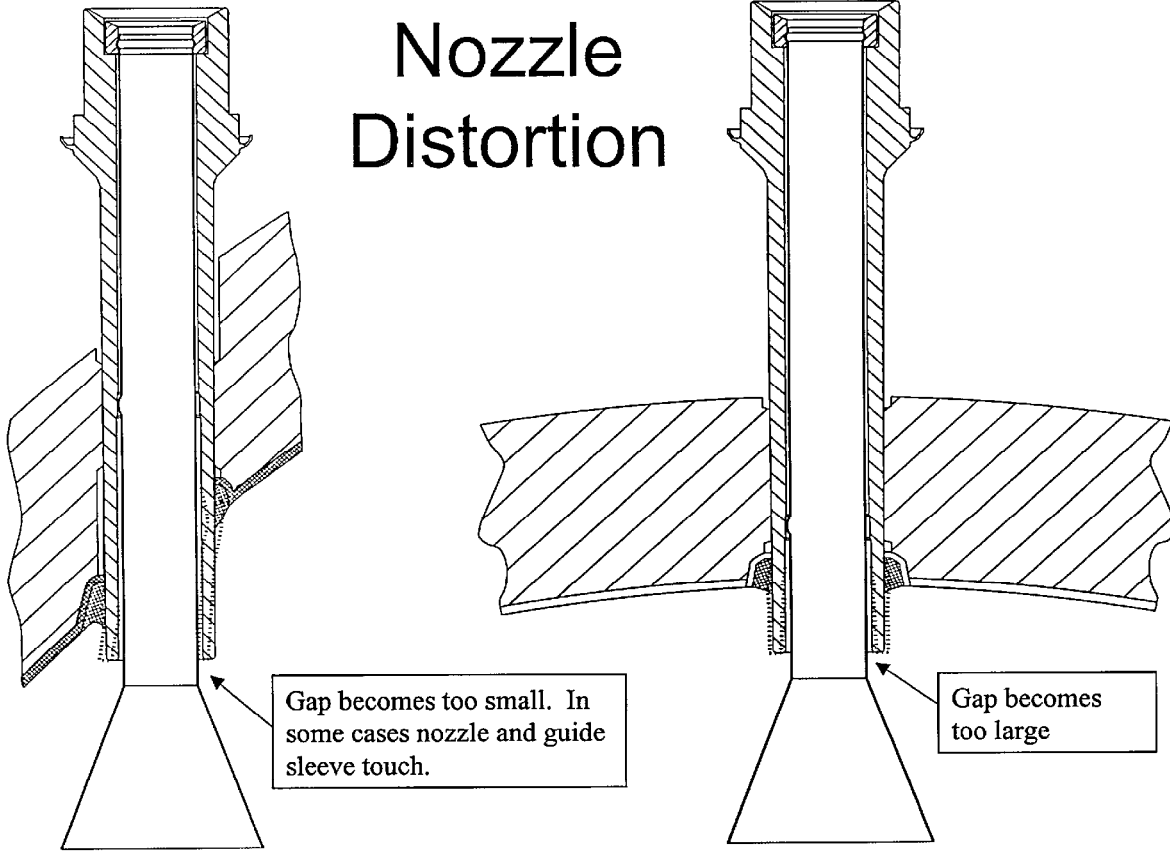
Nozzle Distortion

- Order issued three days before outage
- Discovered nozzle distortion
- Coverage to date was less than anticipated
- Clarity of the ground rules is necessary to complete our inspections

- Nozzle distortion
 - Probe coupling
 - Probe access

- Working with vendor to improve probe design, mockup/testing
- Assessed removal of guide sleeves
 - Acceptable level of quality and safety without removal
 - Dose and new residual stress considerations

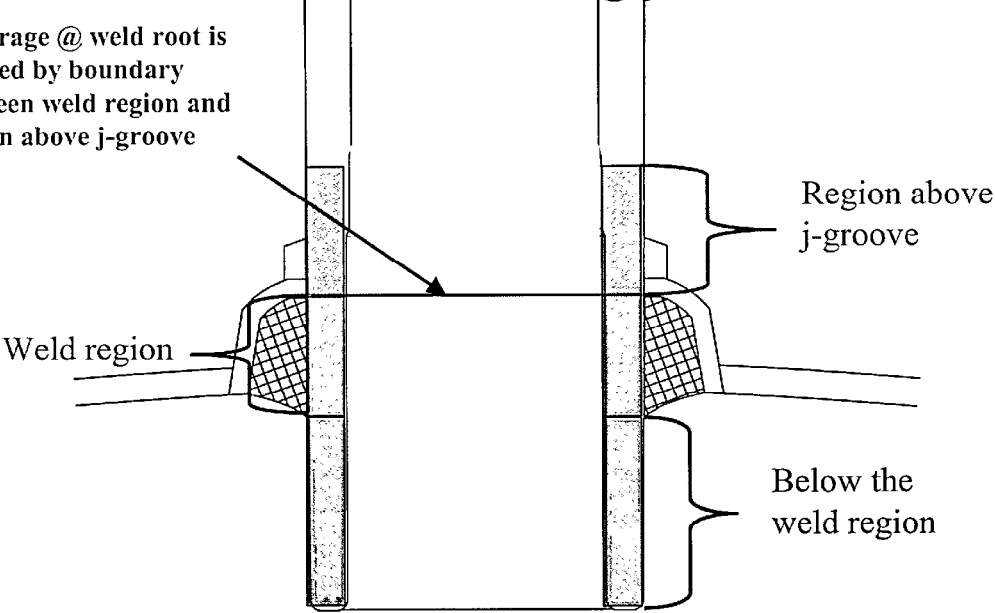
Nozzle Exam Coverage Terminology

Coverage @ weld root is defined by boundary between weld region and region above j-groove weld

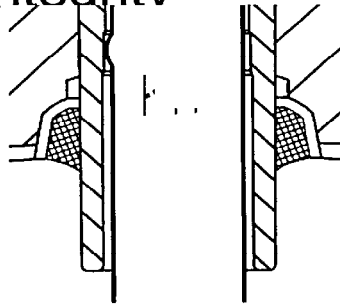
Coverage Above Weld Region

- Have achieved examination of approximately 214 of 227 in²
- Unavailable azimuths assessed deterministically for structural integrity
 - 11 nozzles have 360° coverage
 - One has 355° coverage
 - One has 117° coverage
