Re: St. Lucie Unit 2
Docket No. 50-389
Order (EA-03-009) Relaxation Requests 1 and 2
Examination Coverage of Reactor Pressure
Vessel Head Penetration Nozzles – Supplemental Data

**ST. LUCIE UNIT 2 RELAXATION REQUEST NO. 1
FROM US NRC Order EA-03-009**

**ST. LUCIE UNIT 2 RELAXATION REQUEST NO. 2
FROM US NRC Order EA-03-009**

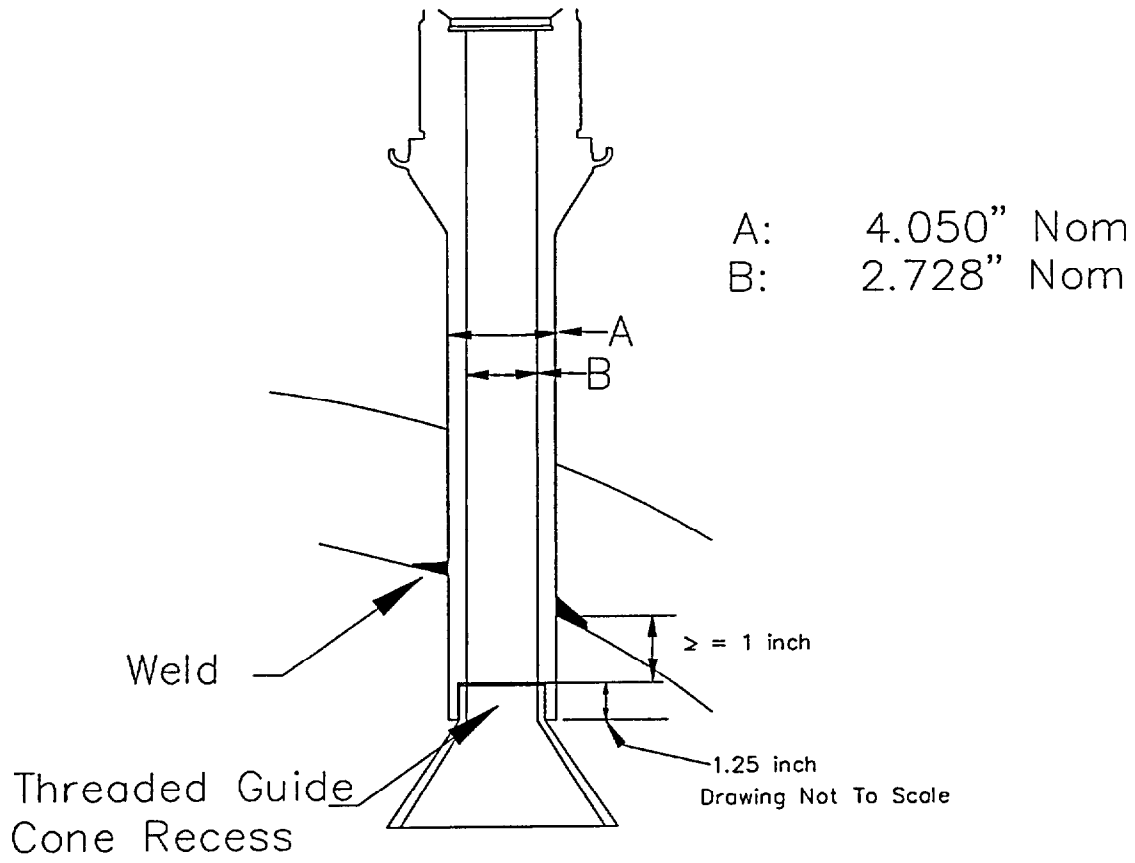
Figure 1: Typical RPV Nozzle with Threaded Guide Funnel

Pursuant to Order Section IV.F.(2) "Compliance with the Order for specific nozzles would result in hardship or unusual difficulty, without a compensating increase in the level of quality and safety", FPL is requesting this relaxation for St. Lucie Unit 2. The 91 CEDM nozzles contain areas that will have less coverage than required by the NRC Order. The Order requires examination from two inches above the J-groove weld to the bottom of the RPV head penetration nozzle. The reduced coverage is caused by the nozzle configuration, and the limitations of probe design used for the Ultrasonic (UT) examination. Specifically, actual coverage below the weld, in the non-pressure boundary portion of the nozzle, is precluded by the threaded area used for attachment of the guide cone as shown in Figure 1.

The proposed alternative is to perform the UT examination to the extent practical. This is defined as "the examination shall be performed to include two inches above the weld down as far as UT data can be acquired below the weld." FPL anticipates acquiring UT data to the maximum extent possible. This minimum dimension of area examined (approximately 1 inch below the weld) exists on the downhill side of the nozzle and increases towards the uphill side.

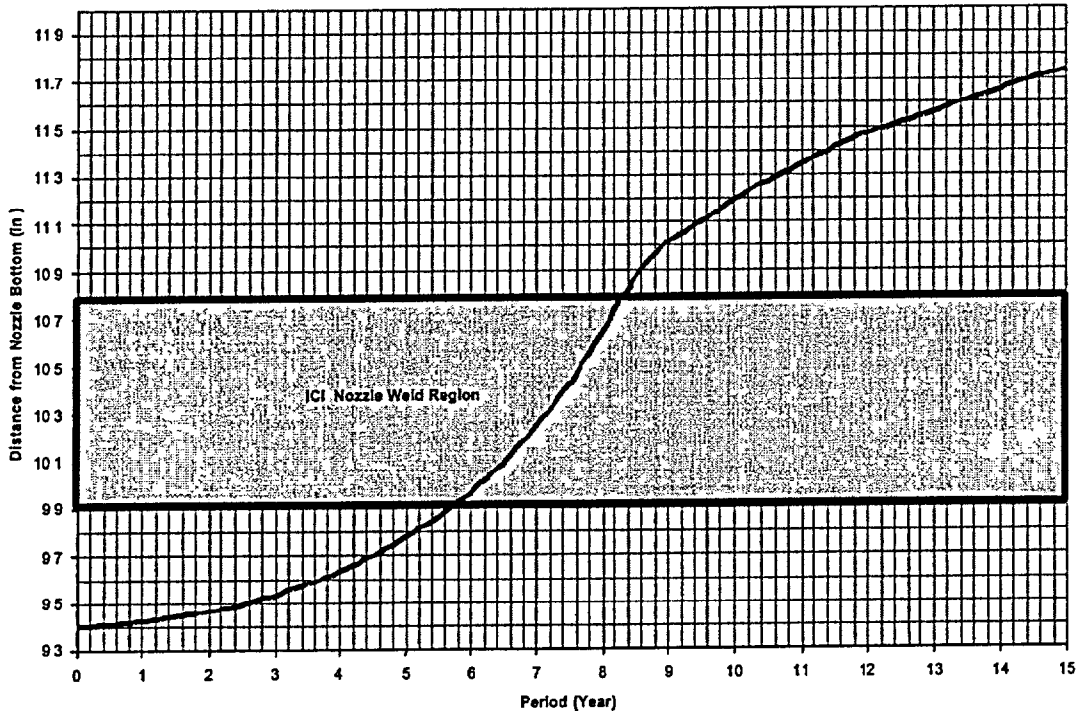
Figure 2: Through-Wall Axial Flaws Located in the 55.3 Degrees Row of Penetrations, Uphill Side - Crack Growth Predictions (From Figure 6-19, WCAP-16038-P)

To determine the significance of an axial flaw that is contained in the nonpressure boundary nozzle material in the uninspected region equal to or greater than one inch below the weld, a flaw tolerance approach is used. A flaw evaluation was performed postulating an axial flaw in the area of missed coverage below the weld using WCAP-16038-P³. A through wall flaw is postulated in the nozzle material from the bottom of the penetration to one half-inch from the bottom of the weld. The flaw evaluation in WCAP-16038-P is based on St. Lucie Unit 2 specific stresses in the nozzle penetrations. Since the stresses equal to or greater than one inch below the weld are too low to propagate an axial flaw, the WCAP-16038-P flaw evaluations start at one-half inch below the weld, and evaluate the time to propagate the flaw in the nozzle to the bottom of the weld (start of the pressure boundary portion of the nozzle material or toe of the J-groove weld). Assuming a through wall flaw below the weld, with the flaw end located at one-half inch below the weld (which is in the area of complete UT examination coverage), an axial flaw would take greater than 5 years of operation (Figures 6-12 through 6-20 in WCAP-16038-P) in any nozzle location to grow to the point of contact with the weld. This time period is significantly greater than the current inspection frequency of every refueling cycle (18 months for St. Lucie Unit 2) identified in NRC Order EA-03-009. As an added conservatism, this evaluation does not attempt to evaluate the time for the axial flaw to grow from the bottom of the weld through the pressure boundary. Figure

flaw to grow from the bottom of the weld through the pressure boundary. Figure 2 provides a graphical presentation of the above flaw evaluation discussion for the outer most penetration location.

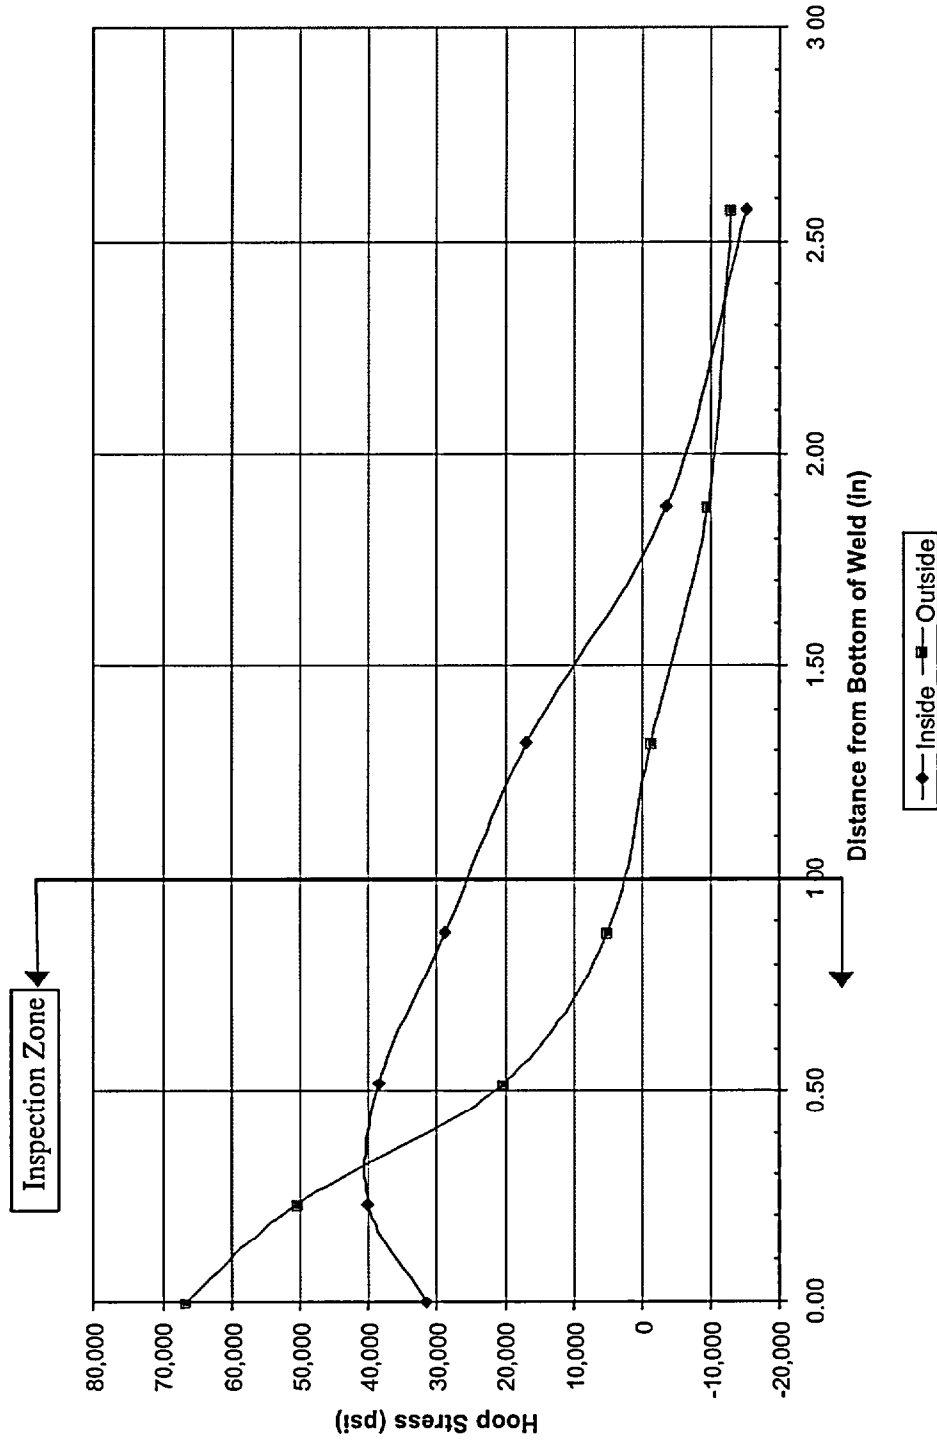
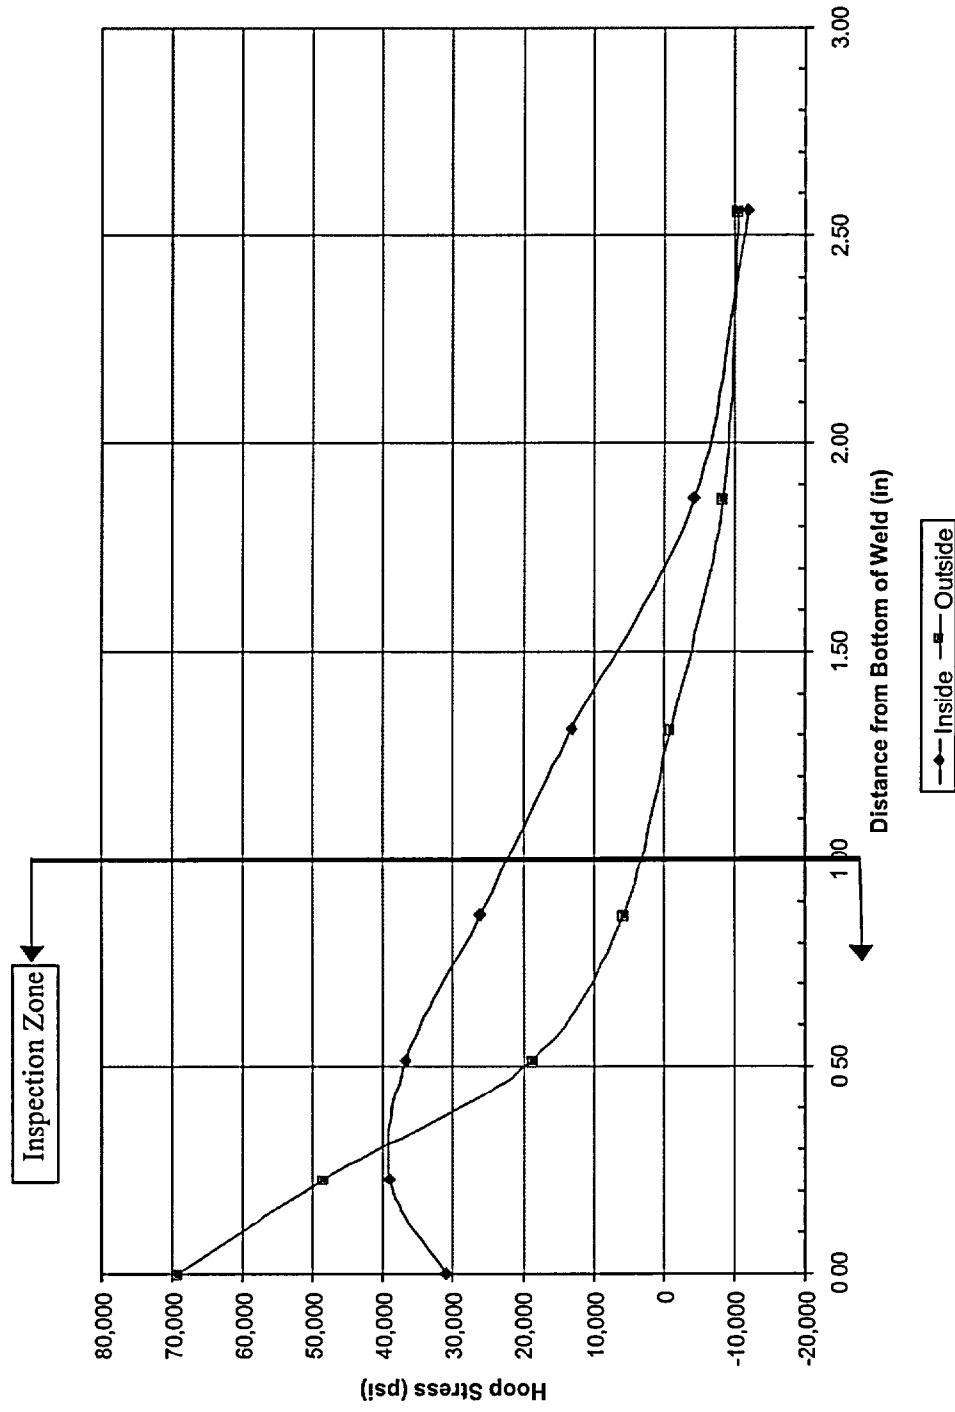
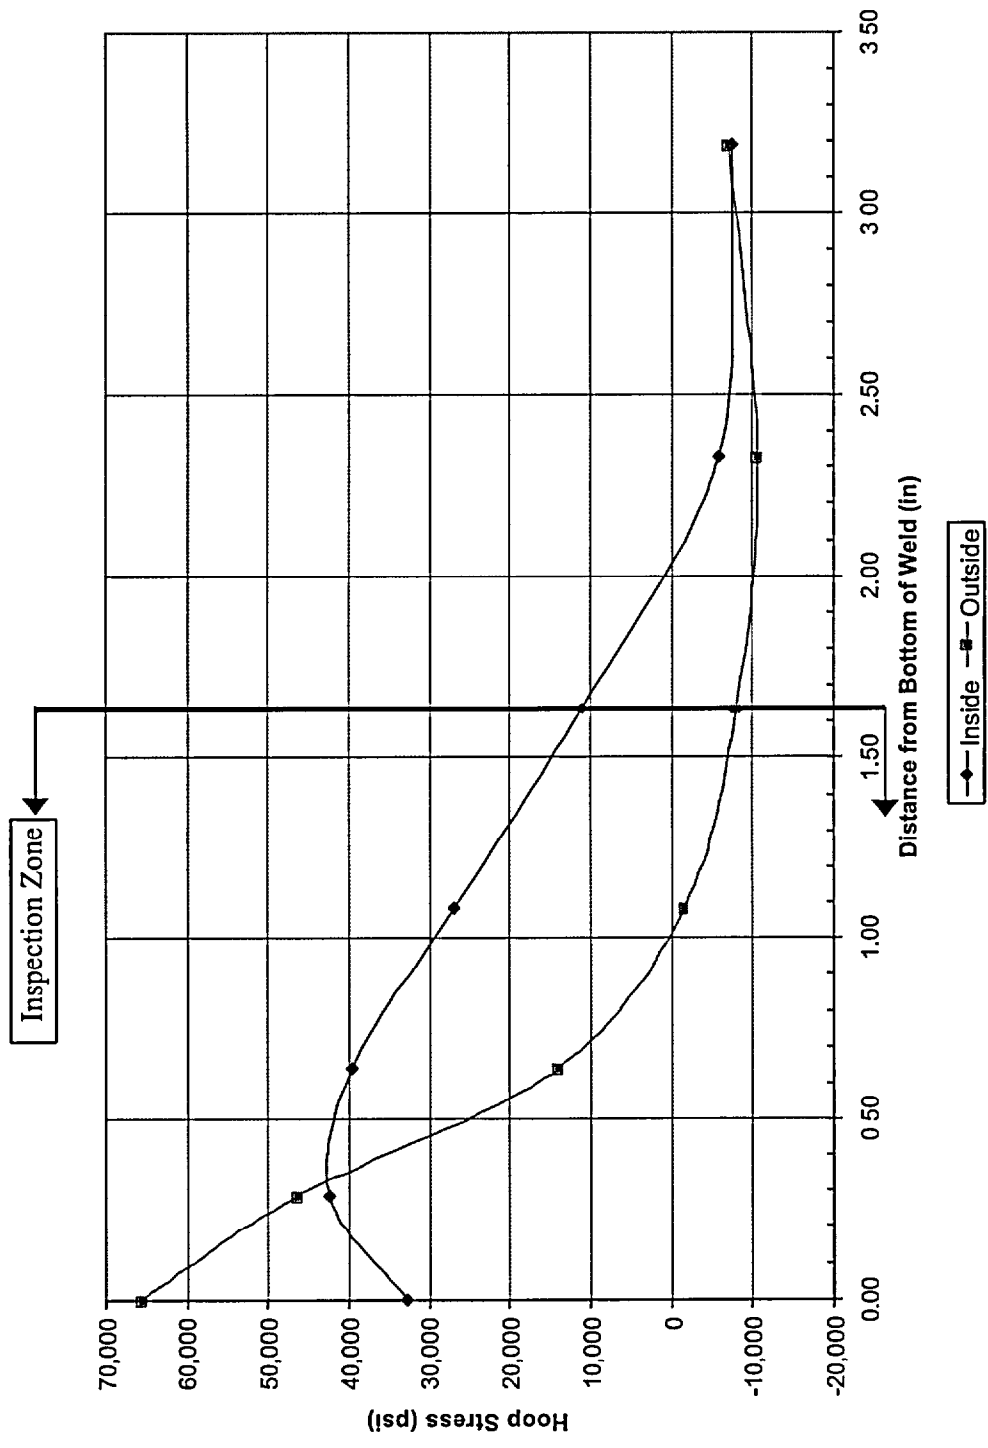
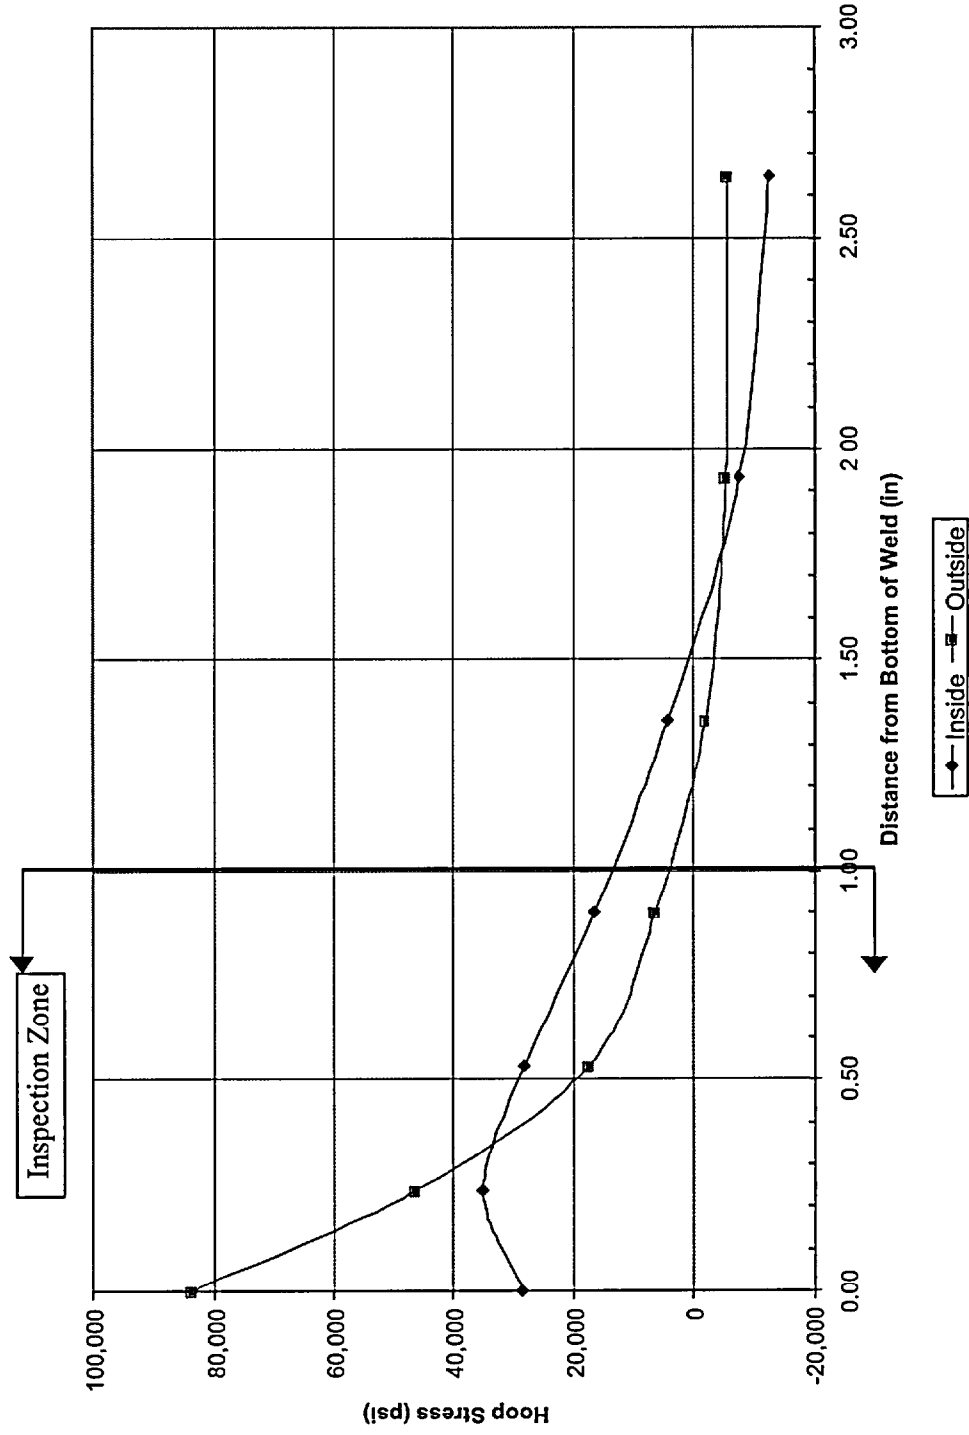
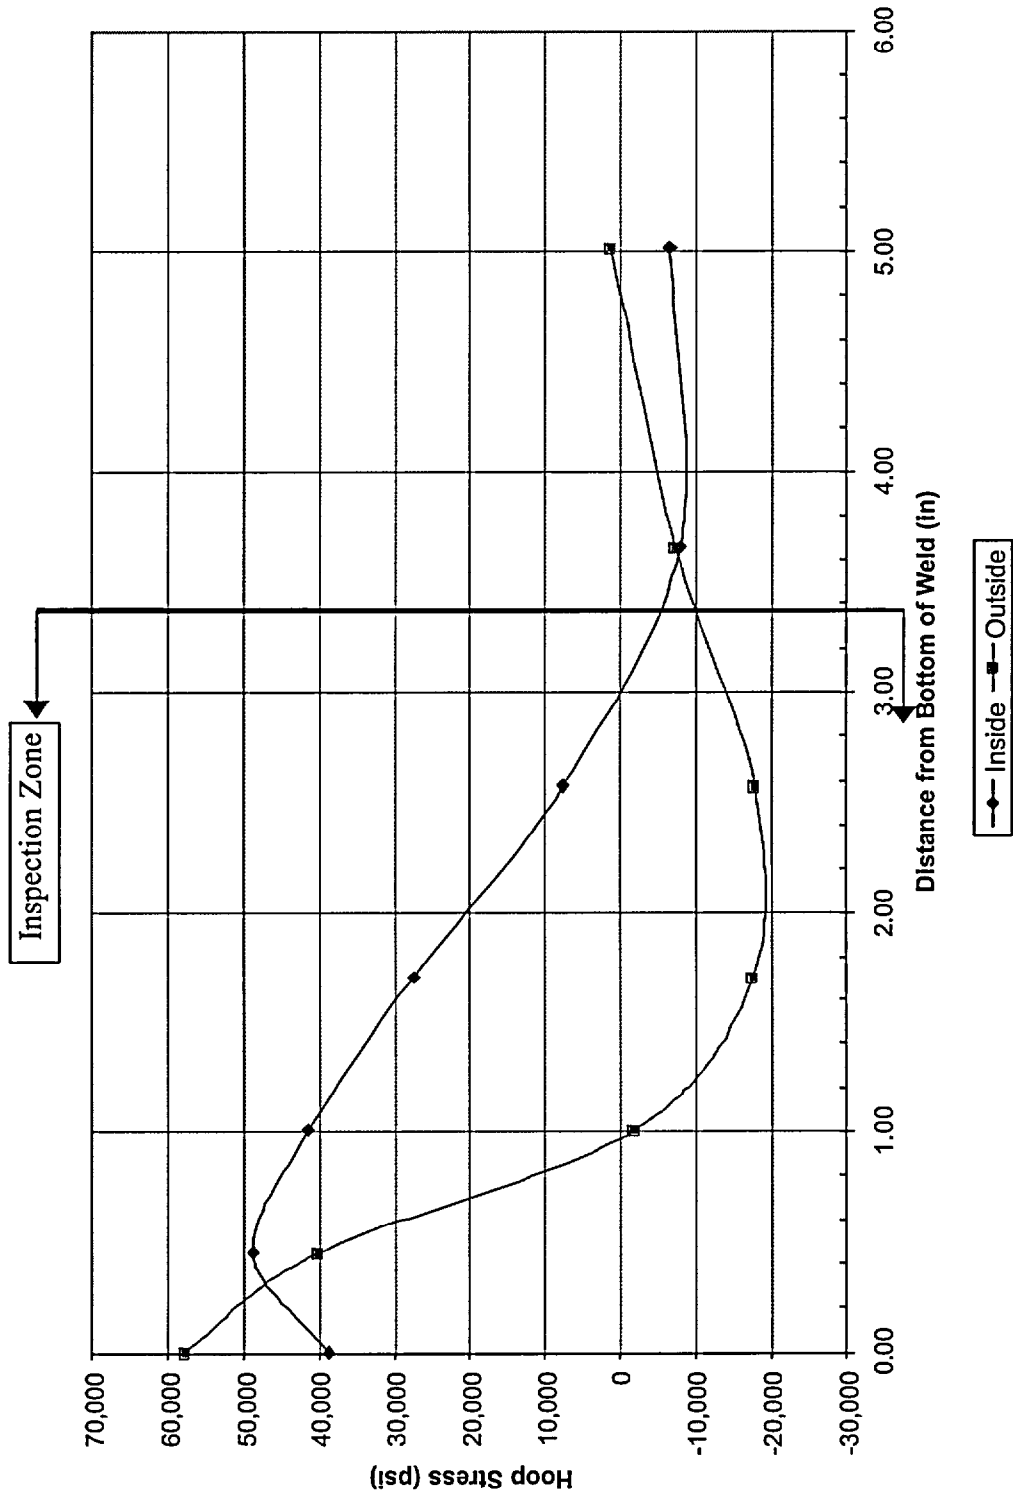
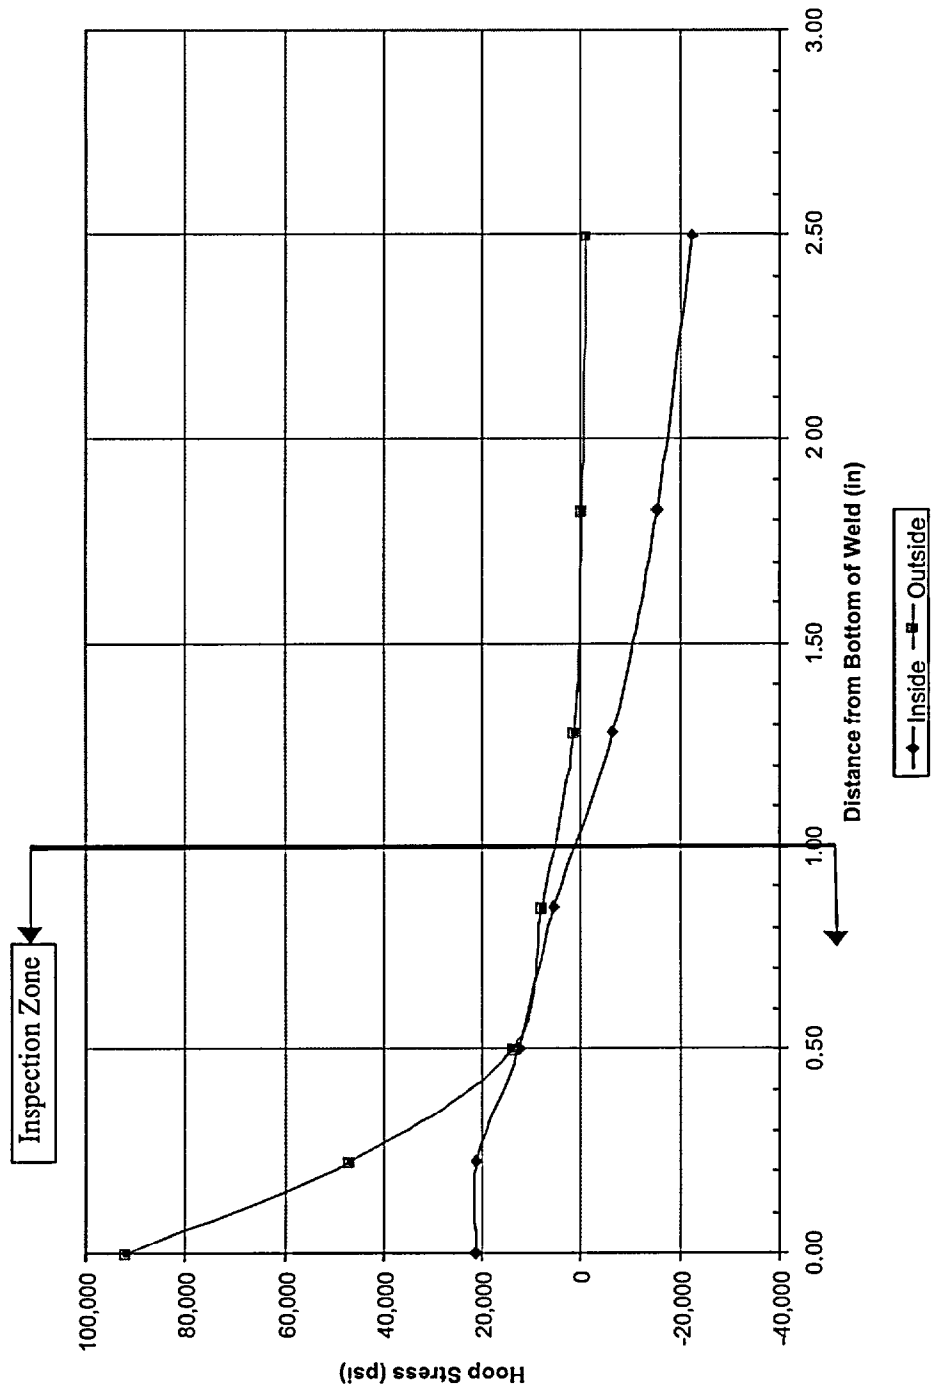
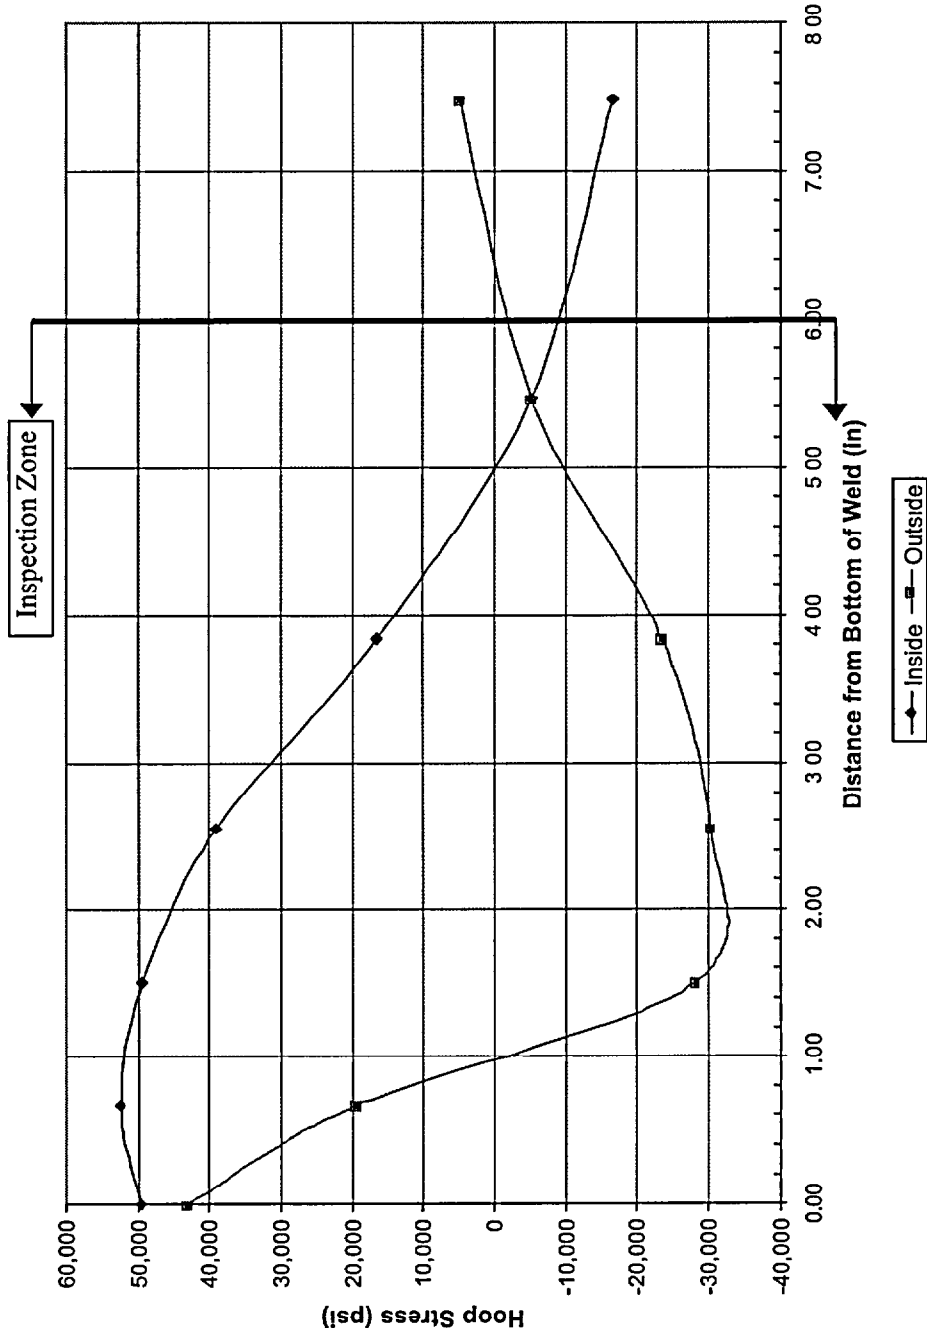
Figures 3 to 9 provided below (Appendix E, Figures E-1 through E-7 of WCAP-16038-P), show the hoop stress distribution as a function of distance from the bottom of the weld. These are the same nozzles whose stress distribution is shown in Figures 5-4 through 5-7 of WCAP-16038-P. These figures provide assurance that the stress levels below one inch are quite low, thereby reducing the potential for cracking.

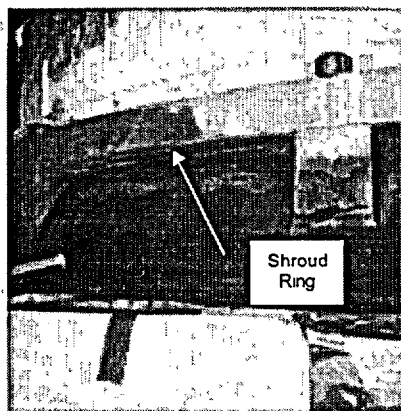
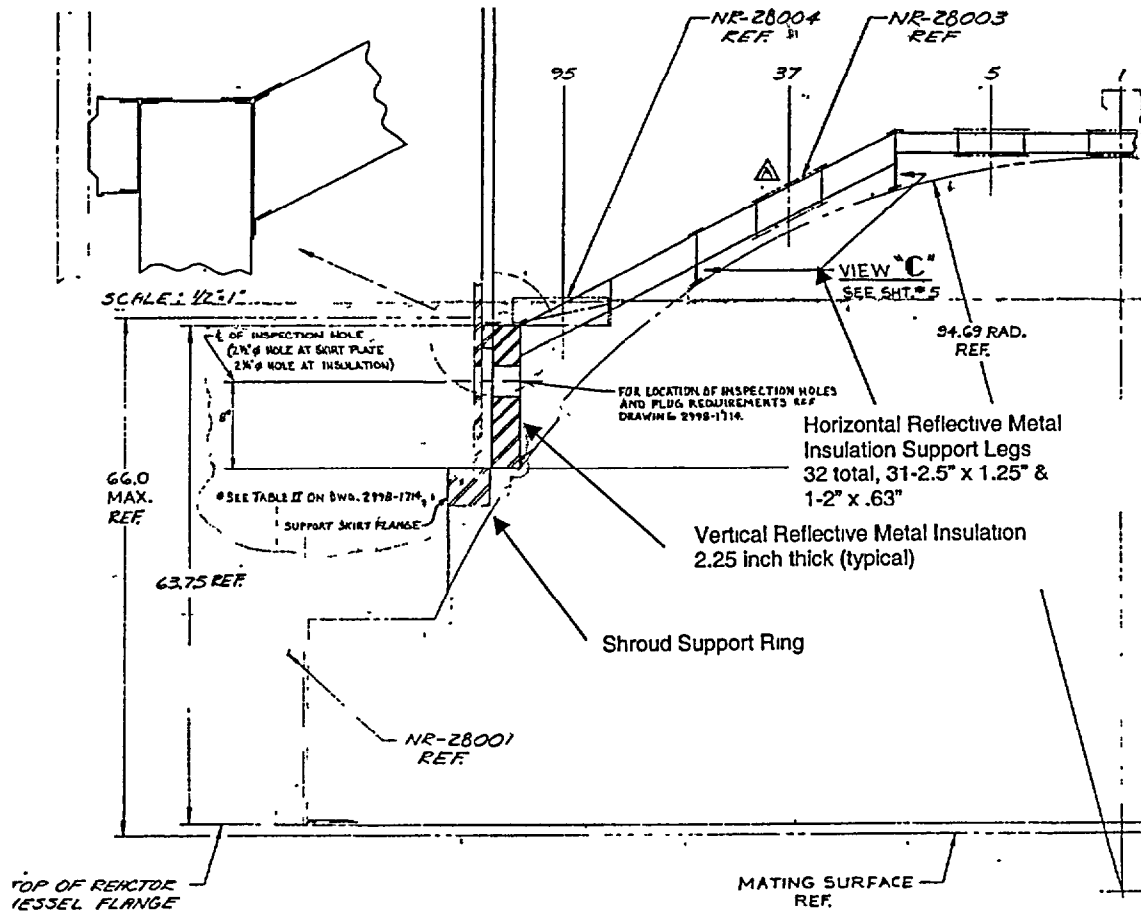
Pursuant to Order Section IV.F "all Licensees shall notify the Commission if: (1) they are unable to comply with any of the requirements of Section IV, or (2) compliance with any of the requirements of Section IV is unnecessary." FPL is requesting this relaxation for St. Lucie Unit 2. FPL is unable to comply with the requirement for 100% visual examination coverage due to lack of access and proposes that the requirement is unnecessary in that the inaccessibility of a small percentage of the head surface due to the vertical RMI panels, horizontal panel support legs, and shroud ring do not preclude performance of an effective bare metal visual examination of the RPV head to identify evidence of wastage. A side view of the RPV head showing the shroud ring location and RMI is shown in Figure 1 and Figure 2.

FPL proposes to achieve substantial compliance with the 100% requirement by conducting a bare metal visual examination of the RPV head surface to the extent practical, excluding the inside of the 54 RPV stud holes. Specifically, the examination will include a visual examination of 360° around each RPV head penetration nozzle for evidence of leakage and examination of the bare head surface within the vertical RMI panels and outside of the shroud ring for evidence of wastage.
