**Subject: Beaver Valley Power Station, Unit No. 1  
BV-1 Docket No. 50-334, License No. DPR-66  
Supplemental Response to Bulletin 2002-01, Reactor Pressure Vessel  
Head Degradation and Reactor Coolant Pressure Boundary Integrity**

**Attachment A**  
**BVPS Supplemental Response to NRC Bulletin 2002-01**

**The following is supplemental information regarding the condition of the  
Beaver Valley Power Station (BVPS) Unit 1 reactor pressure vessel head**

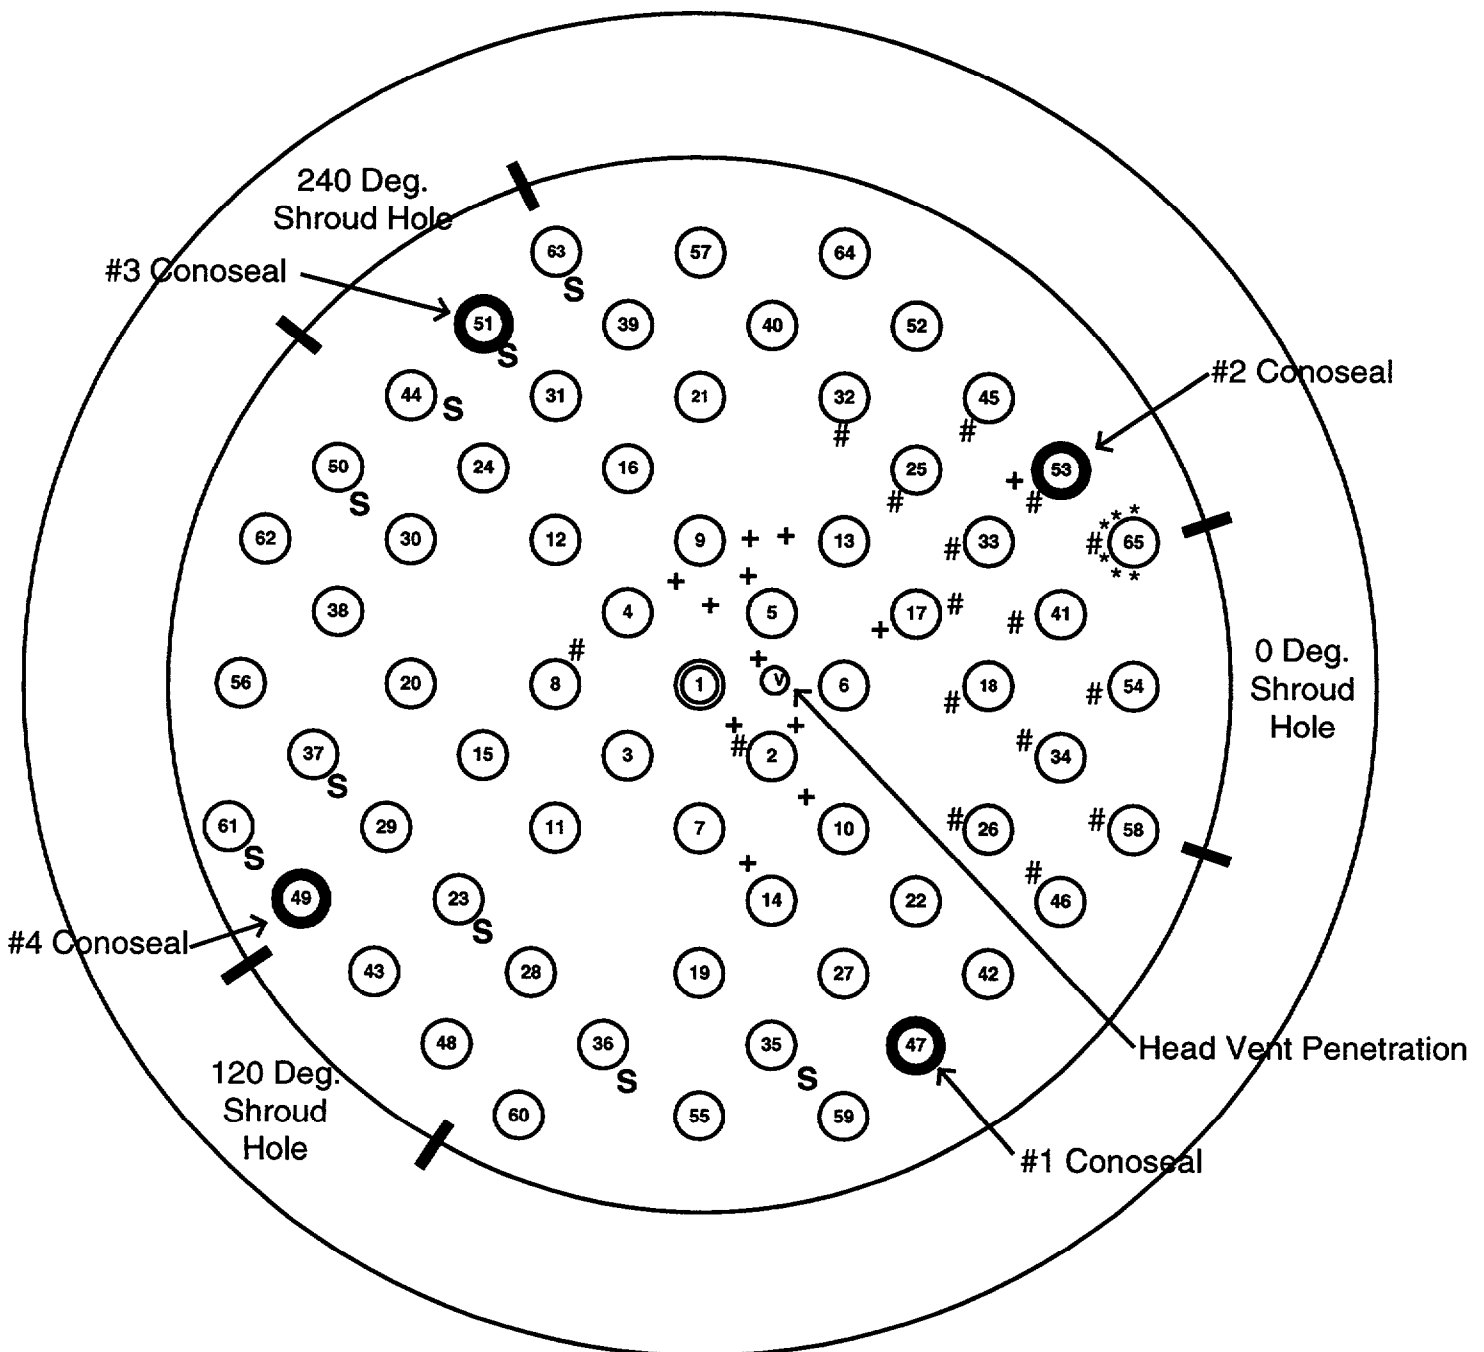
Figure 1  
BV- 1 Reactor Vessel Head Map

Based on the visual examinations performed in September 2001 on the Unit 1 reactor vessel head area captured on video, a mapping of the entire head has been performed. The map (Figure 1) includes a legend to denote the various degrees of boric acid residue on the head surface, ranging from a light dusting to larger flakes and debris, as well as photos (Figures 2 through 6) to depict examples of the various conditions present. Figure 7 is provided to illustrate the mirror insulation configuration (plan view). The four conoseal joints identified in Figure 1 as penetrations #47, #53, #51, and #49 are located above the insulation and shroud.

Greater than 90% of the reactor vessel head surface within the shroud periphery has a light dusting of boric acid residue. This dusting is primarily white in color and is generally less than 1/32" in thickness, and is illustrated in Figure (2)

- + = Head surface areas with larger, loose flakes and other debris present. (Figure 3)
- # = Penetrations with loose debris in vicinity of penetration (usually "uphill"). (Figure 4)
- S = Head surface areas with pronounced white stains (Figure 5)
- \* = Corrosion adjacent to Penetration # 65 (Figure 6)

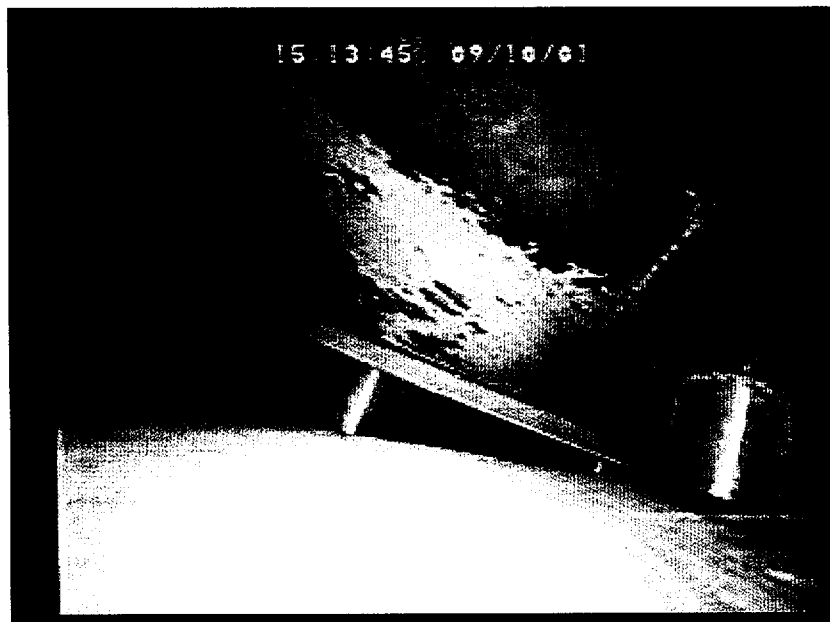
Image from the crawler camera looking uphill toward penetration #9. This illustrates some of the boric acid coating on the overhead mirror insulation as well as the general overall condition of the head surface. In many cases the crawler camera was used to navigate and confirm penetration locations and to assess the overall head condition. The crawler was also used to deliver the video probe to selected locations for specific examinations. The image foreground is saturated by the crawler light reflection.

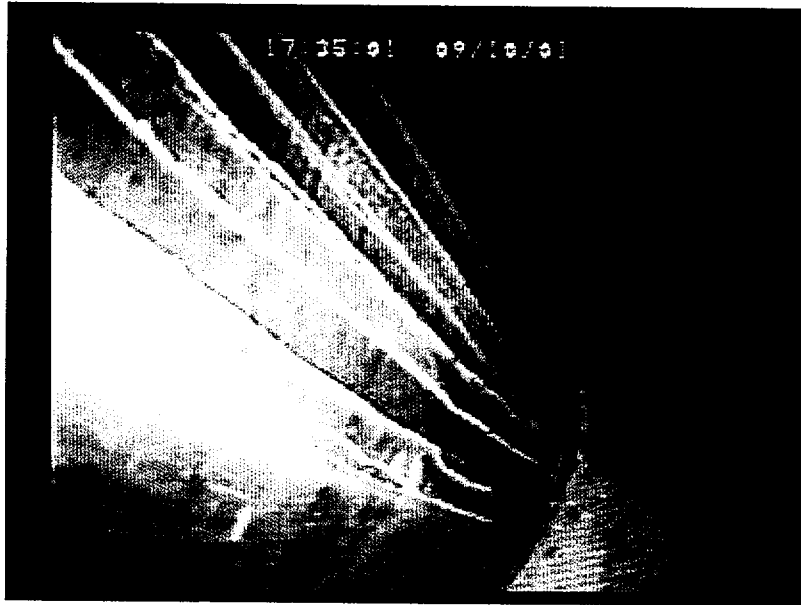
Figure 5  
Typical Areas with distinct stains (S symbol on map)

View looking down from penetration 44 clearly shows boric acid residue from previous leakage above the insulation running down the penetration, resulting in a white stain on the penetration and at the head surface. This indicates the leakage was minor, which is borne out by the lack of rust, discoloration or other evidence of damage in this head quadrant.
