Crystal River Nuclear Plant
Docket No. 50-302
Operating License No. DPR-72

Subject: Crystal River Unit 3 – Supplemental Information Regarding the 15-Day Response to NRC Bulletin 2002-01, “Reactor Pressure Vessel Head Degradation and Reactor Coolant Pressure Boundary Integrity”

CRYSTAL RIVER UNIT 3

NRC Question and FPC Response

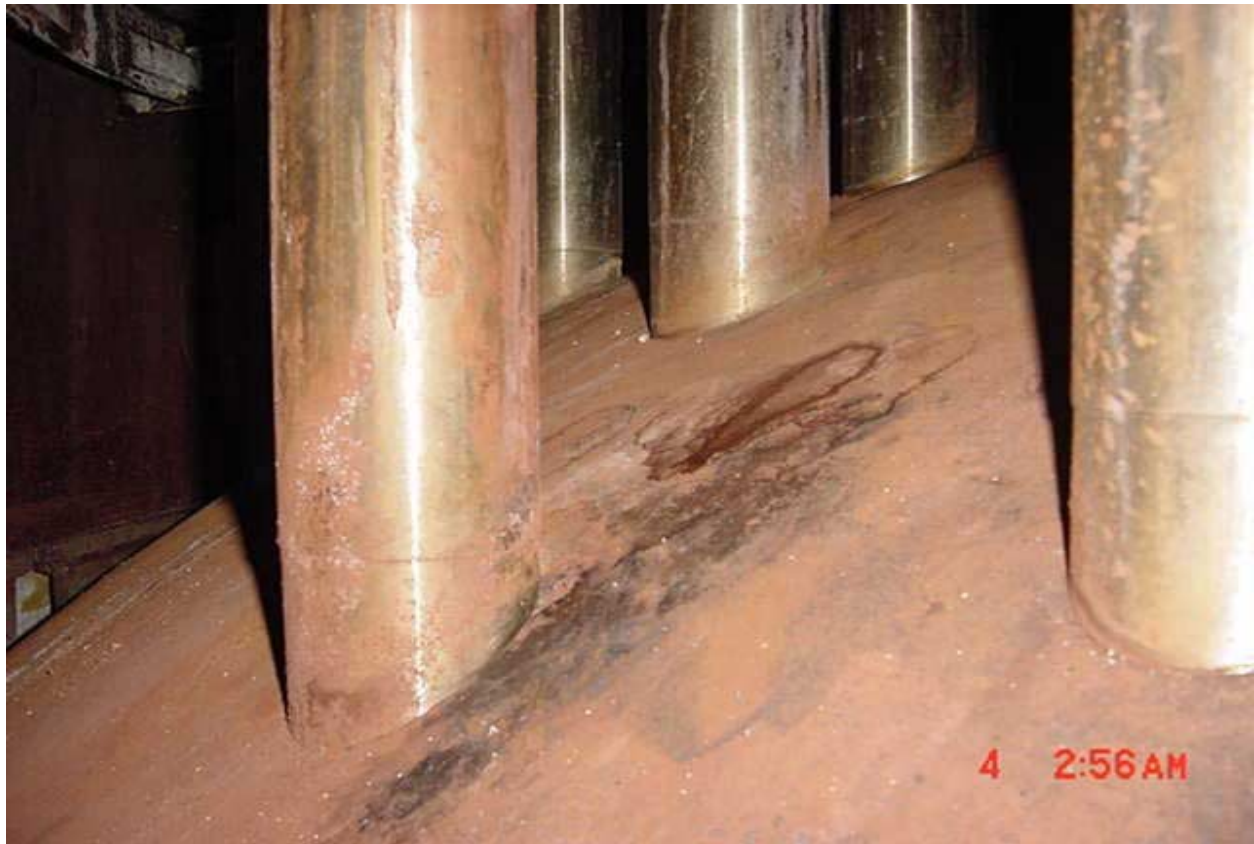
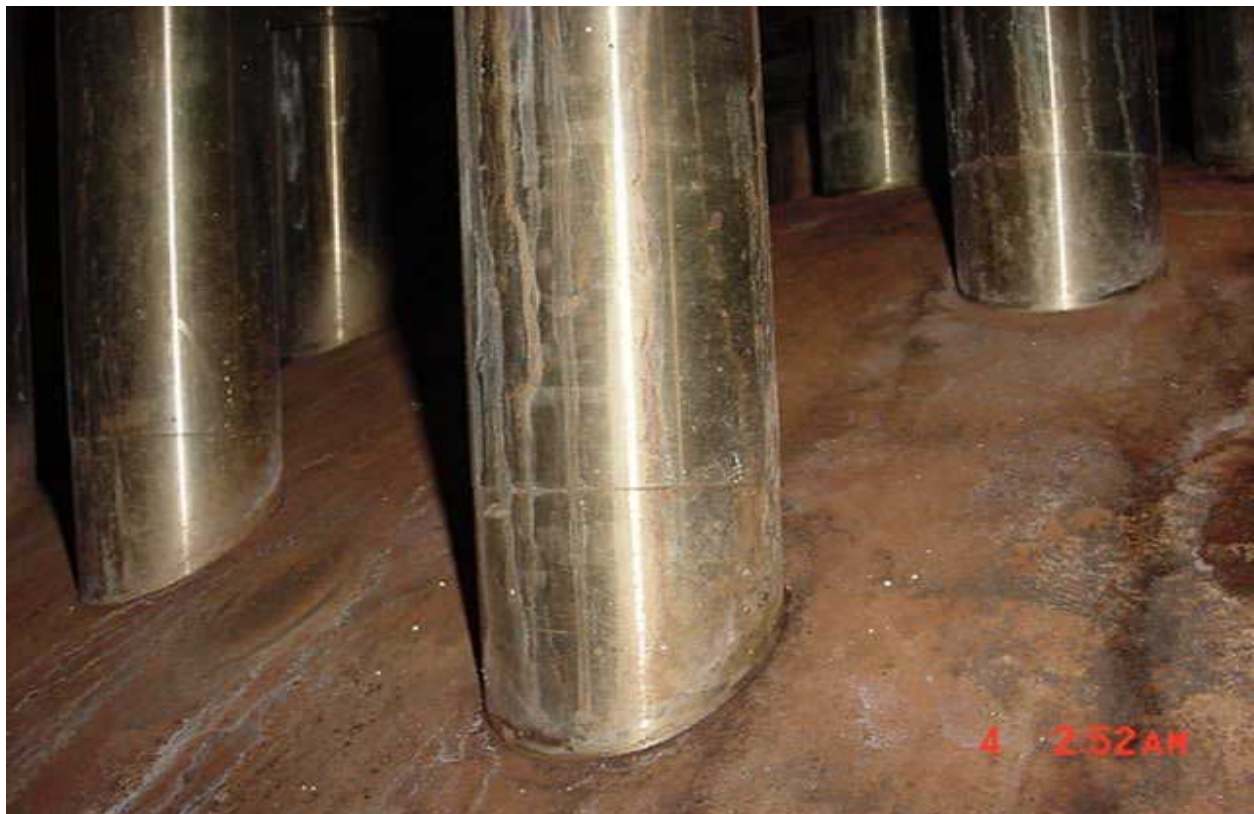
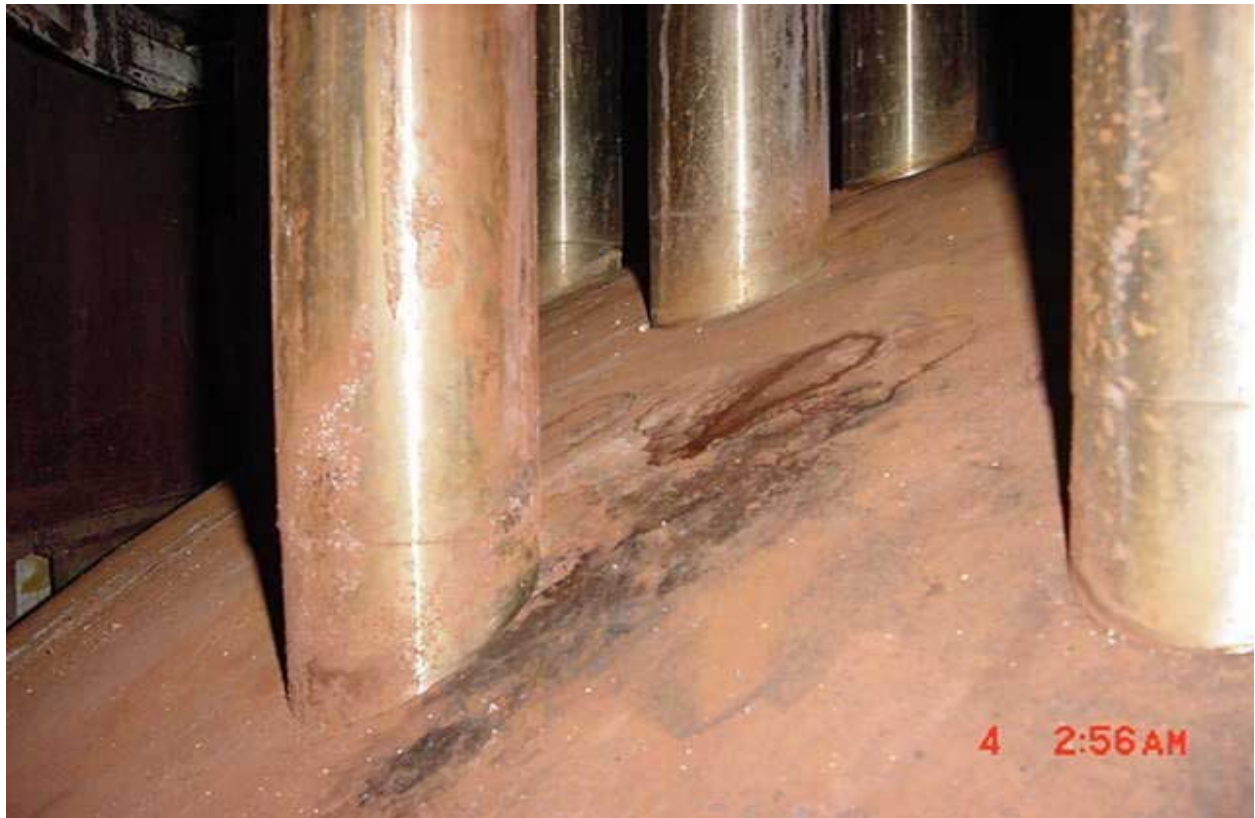
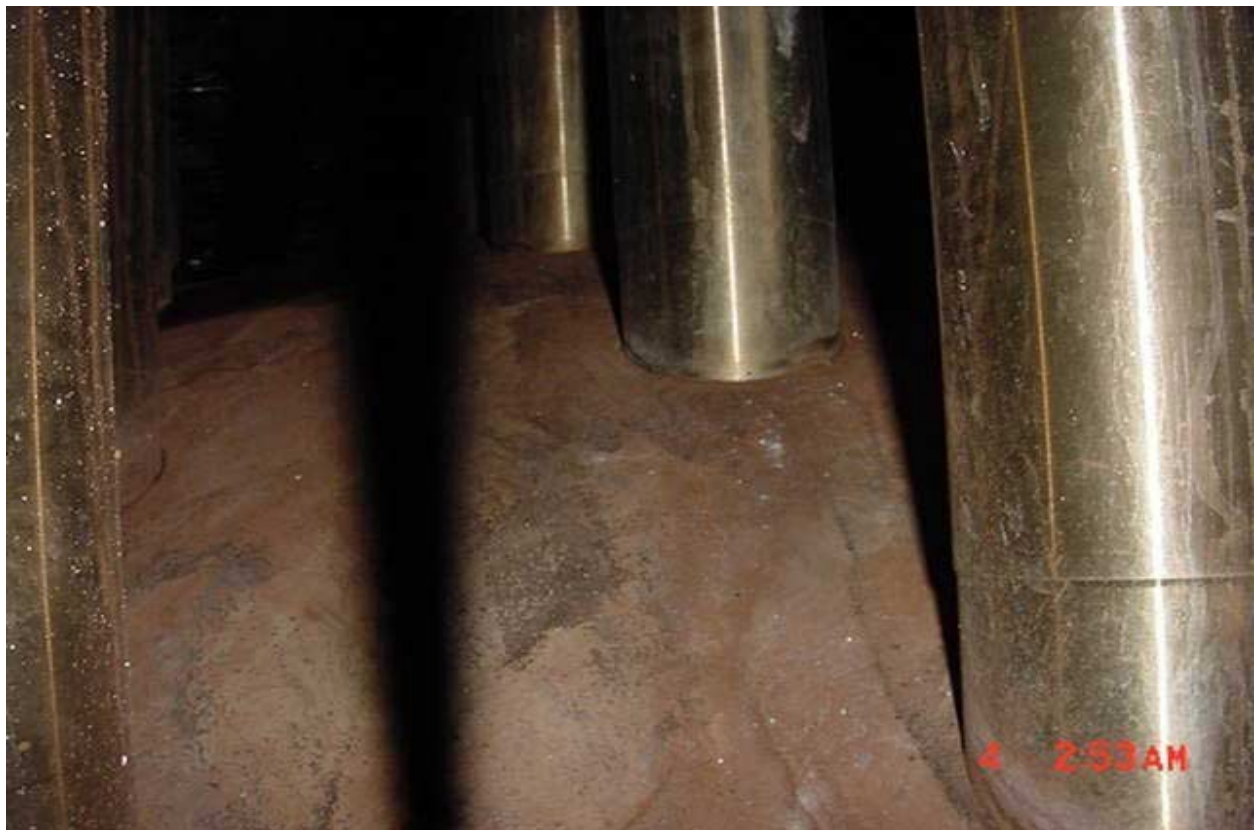
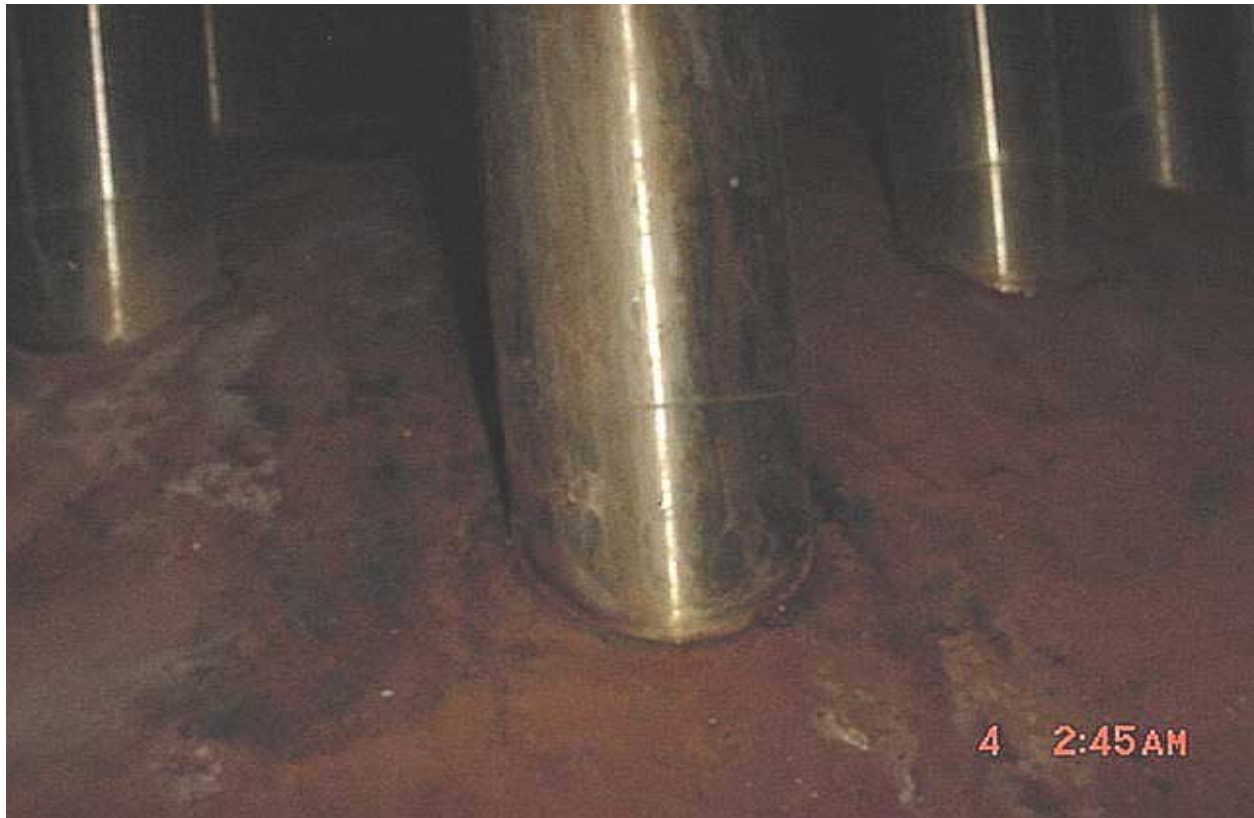
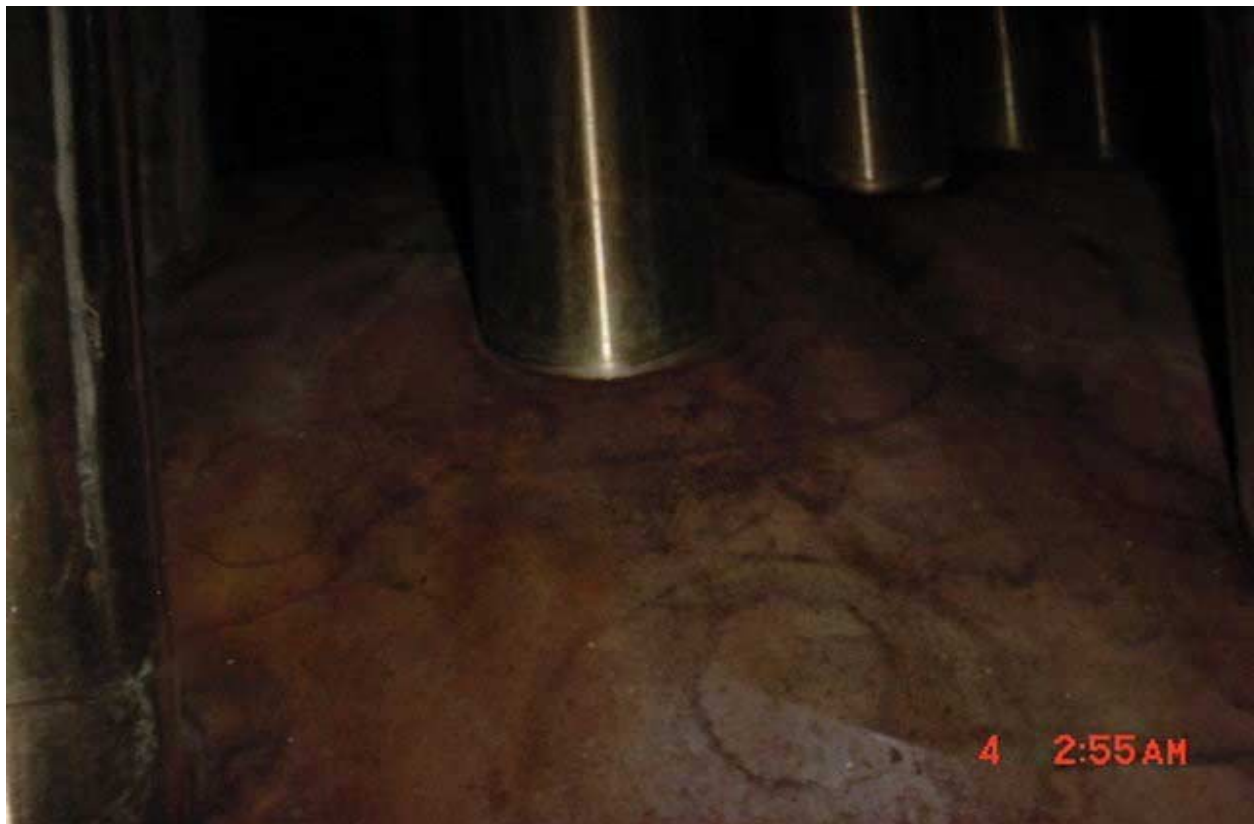
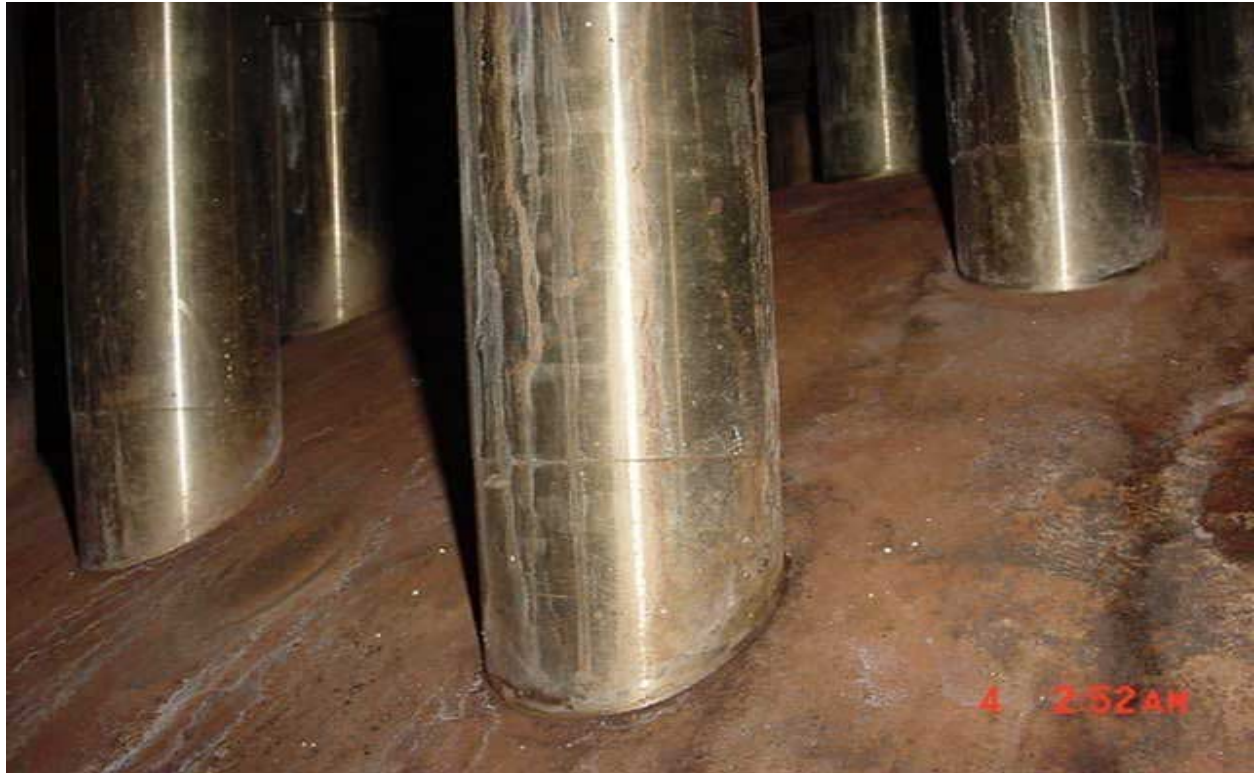
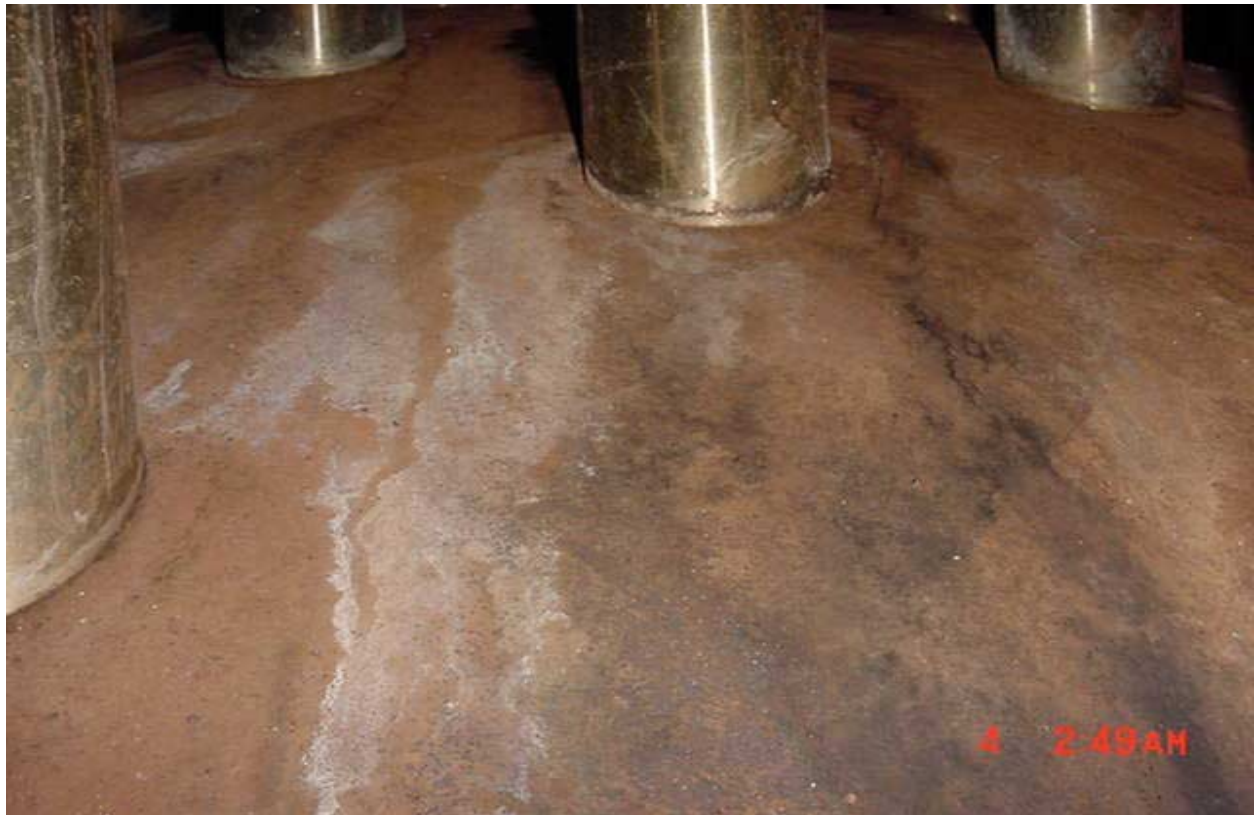
The visual inspection performed after cleaning the RPV head revealed that there were no significant deposits left on the head.

**Pictures Taken During Refuel Outage 12,
After the RPVH Cleaning,
While the Water Had Not Yet Dried on the RPVH**

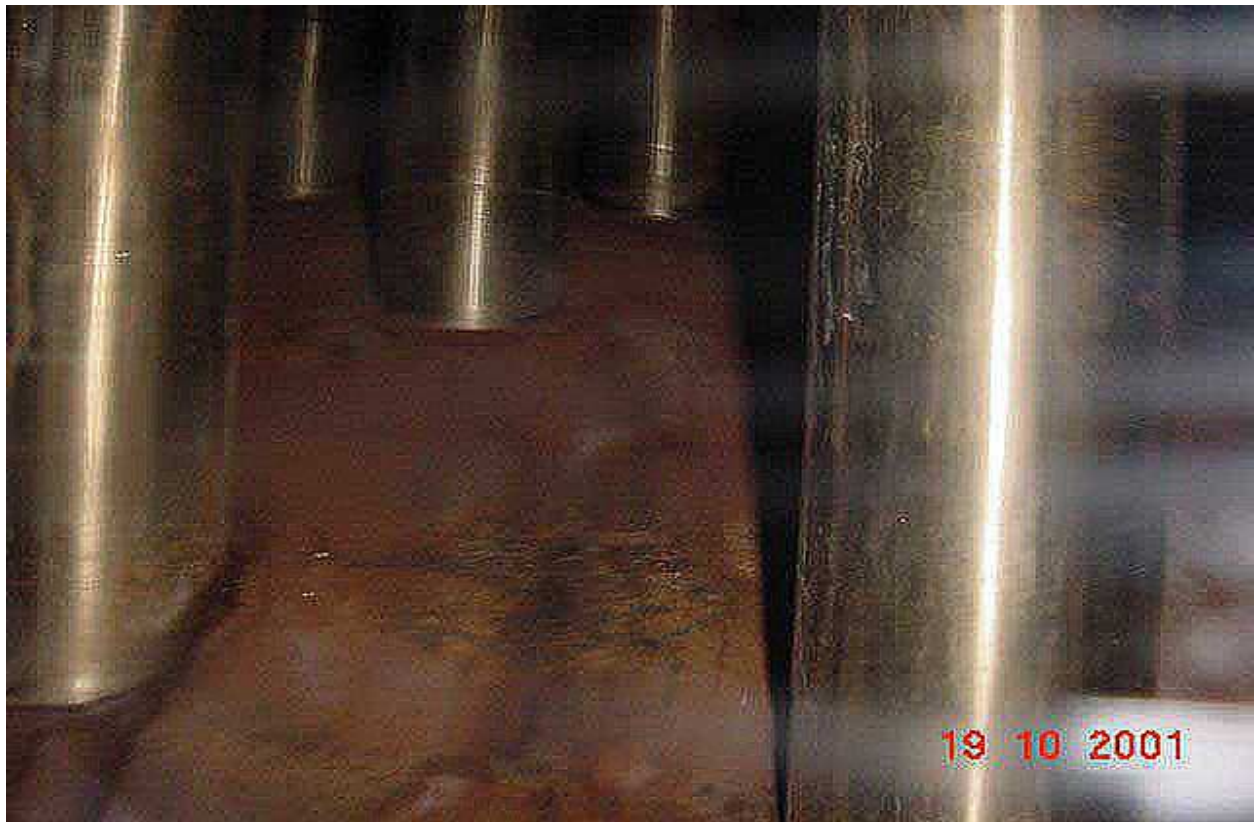
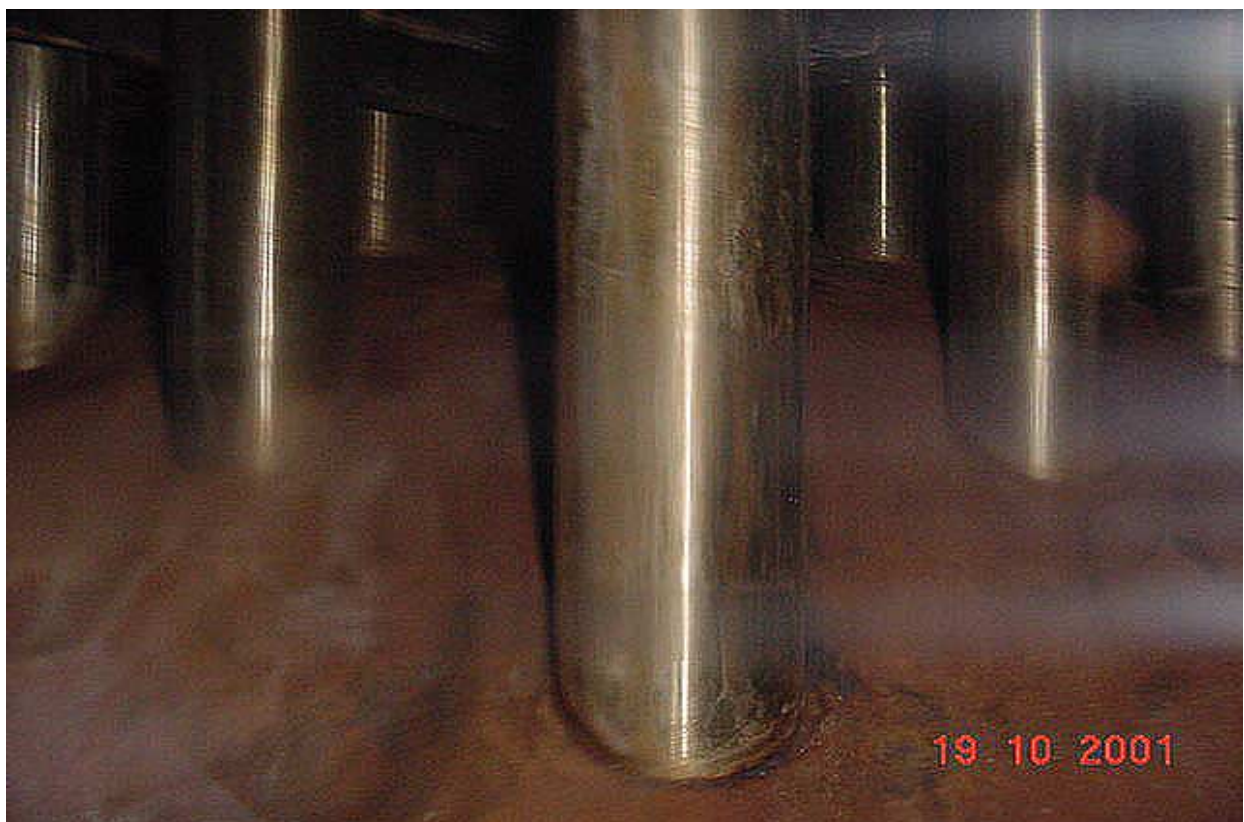
Pictures Taken After the RPVH Was Totally Dry
