SUBJECT: Indian Point 2 and 3 Nuclear Power Plants
Docket Nos. 50-247 and 50-286
License Nos. DPR-26 and DPR-64
"Supplement to 15-Day Response for NRC Bulletin 2002-01"

**SUPPLEMENT TO 15-DAY RESPONSE TO
NRC BULLETIN 2002-01
FOR INDIAN POINT UNIT 2**

FIGURE I
 UNIT 2 REACTOR VESSEL HEAD
 LEAK LOCATIONS AND INSULATION REMOVAL

FOR INDIAN POINT UNIT 3

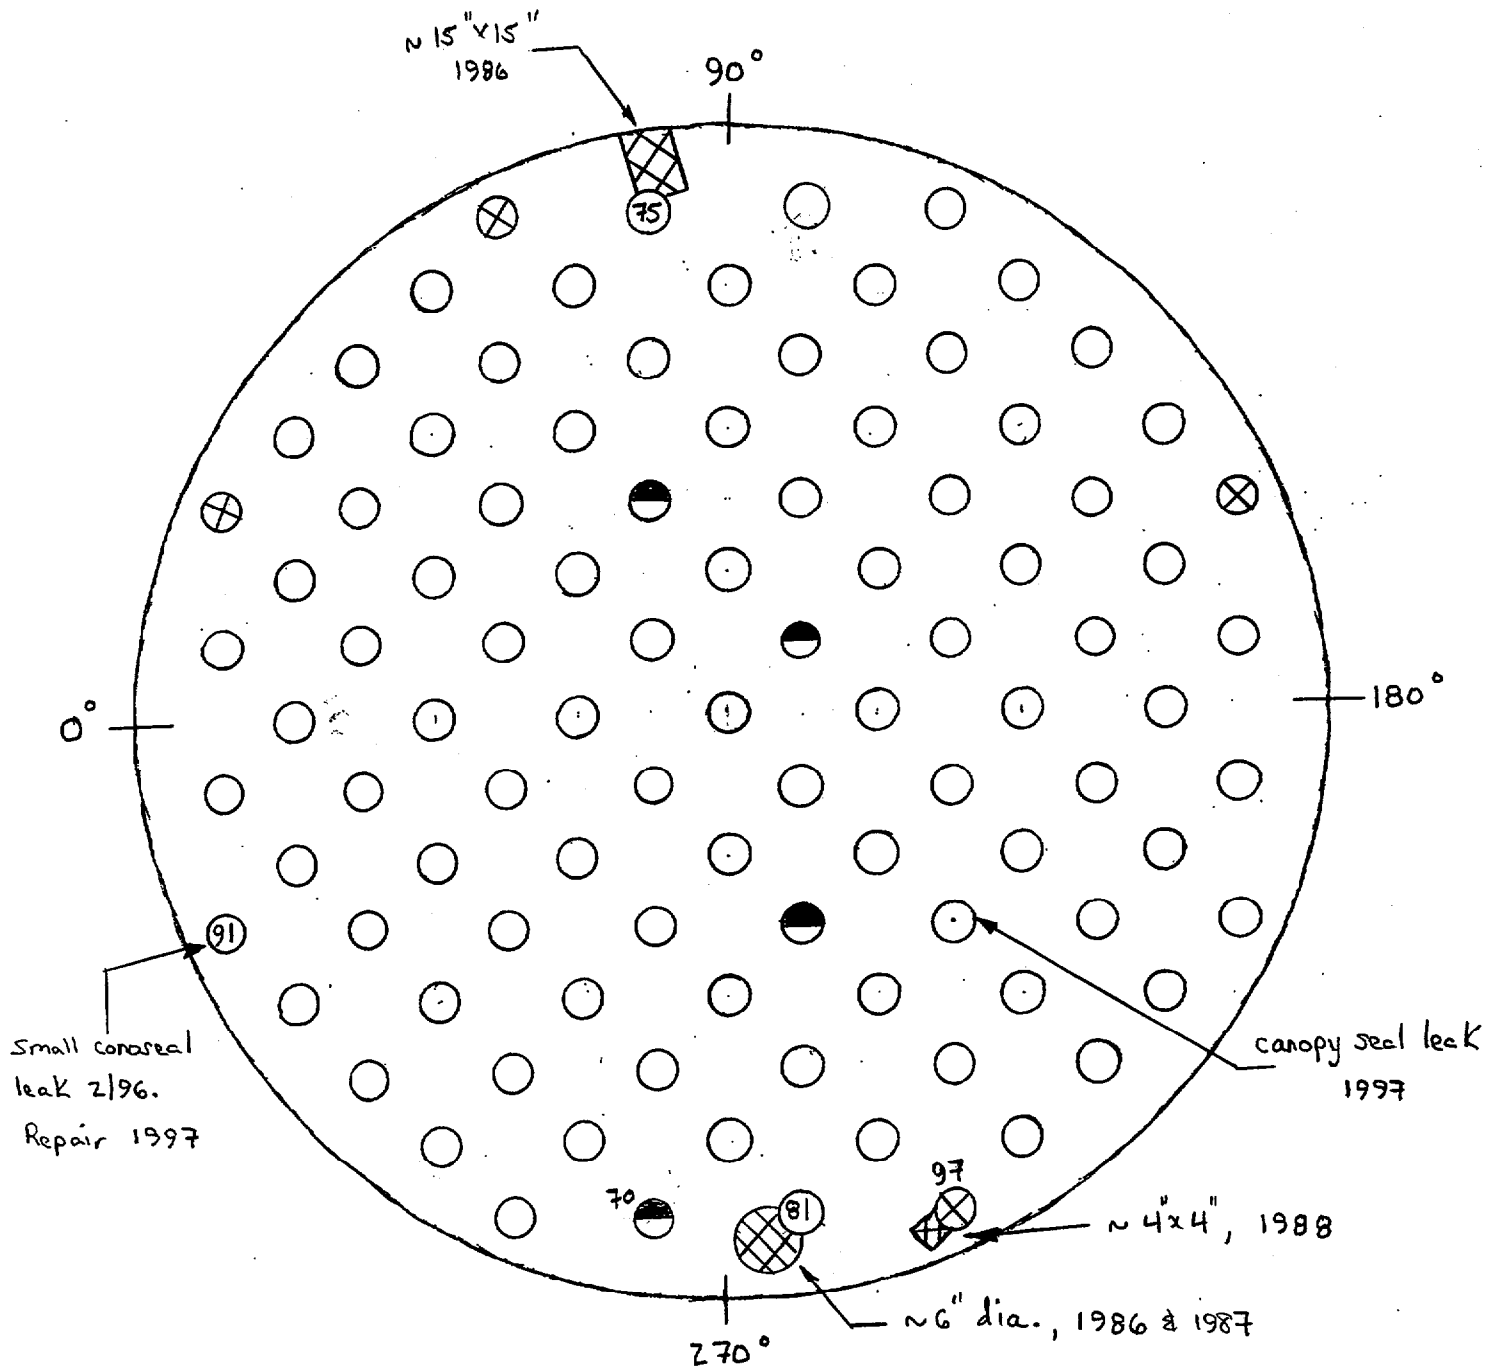
Removal of insulation and inspection of the bare metal was performed as described below. Locations are shown on Figure I.

- 1986: Approximately 6 inch diameter section removed between nozzles 70 and 81.
Approximately 15 inch x 15 inch section removed adjacent to nozzle 75.
- 1987: Same location as 1986, between nozzles 70 and 81.
- 1988: Approximately 4 inch x 4 inch section removed adjacent to nozzle 97.

In all above cases, no boron accumulation on the vessel head or degradation of base metal was observed, and the head coating (high-temperature aluminum silicate) appeared to be intact. During the 1986 / 1987 inspection and repair efforts, samples of insulation were tested to determine the degree to which the leaking, borated water had penetrated the head insulation. The results of these tests showed that, although the insulation provided some protection against the leaking water contacting the head base metal, some boron was found through the thickness of the insulation, indicating that the insulation is not water tight. However, no visible signs of boron were found on the vessel head.

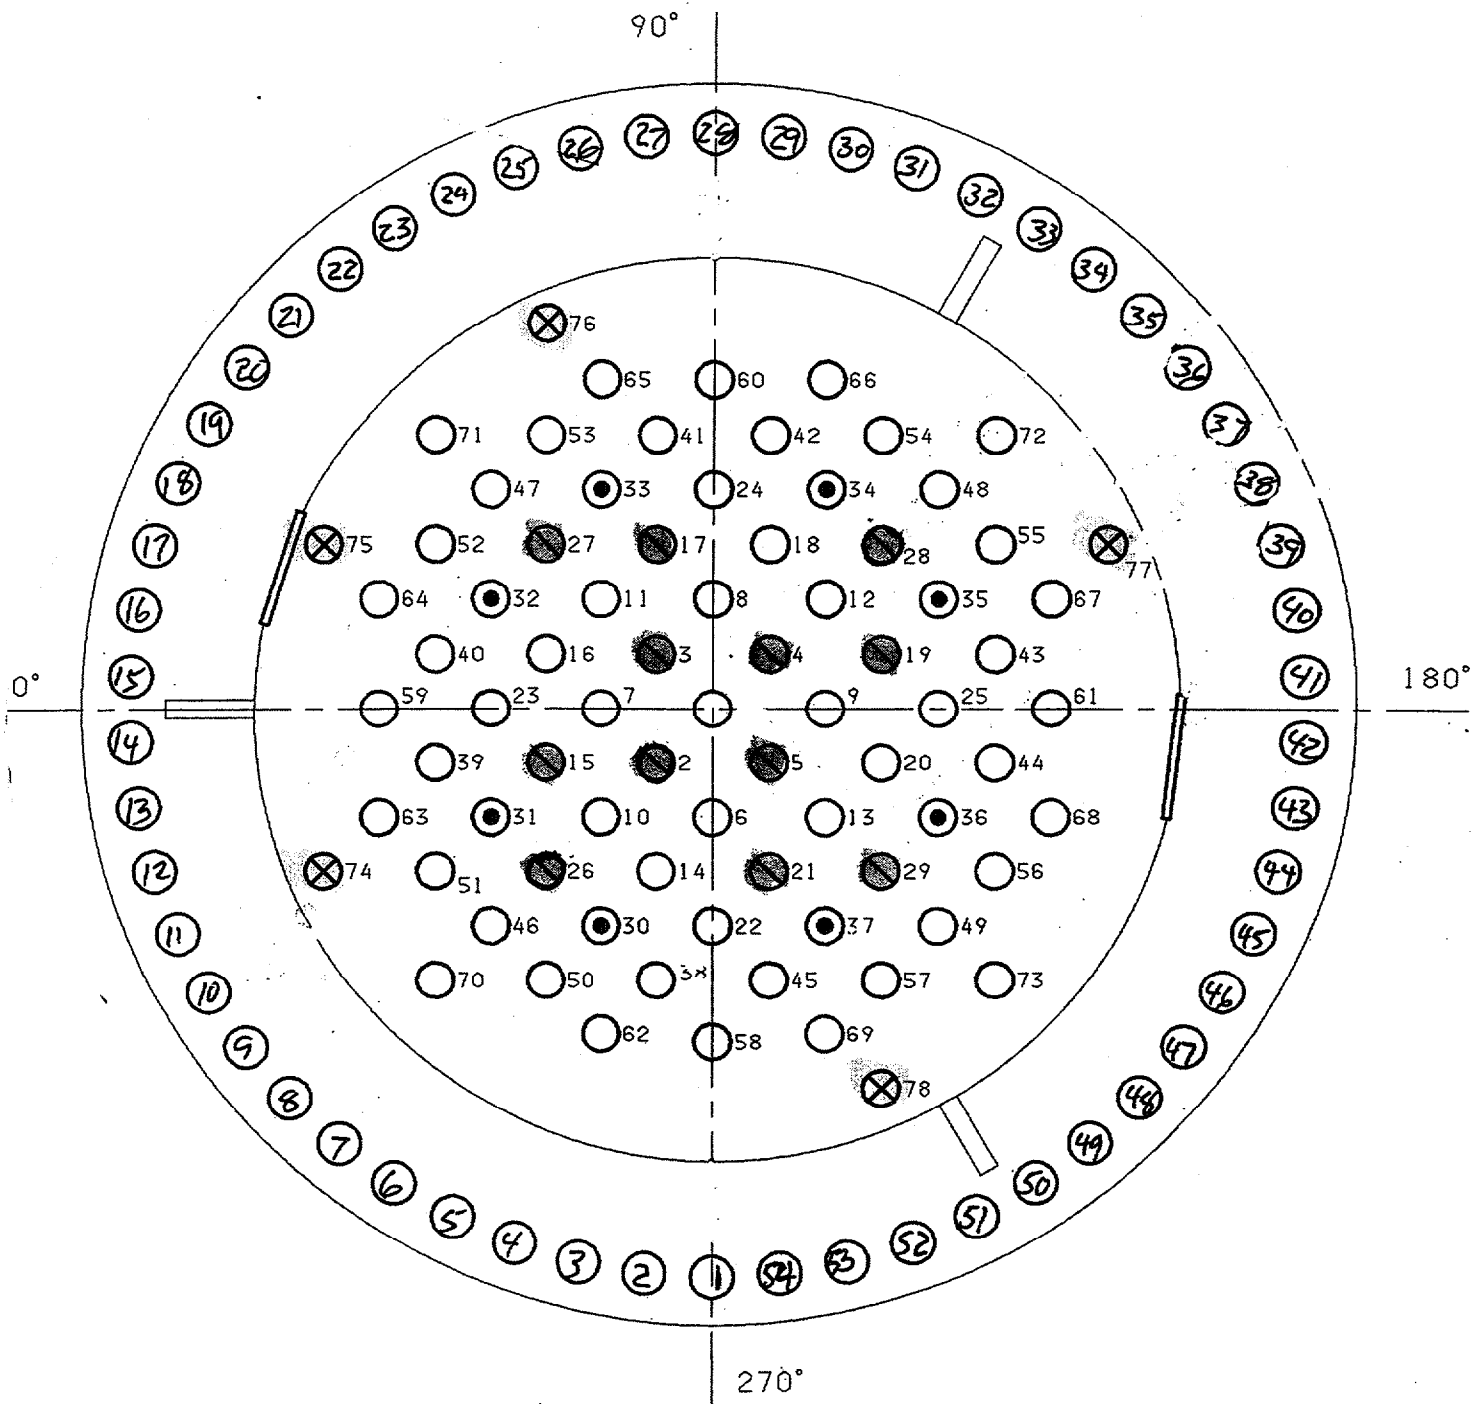
FIGURE II
 UNIT 3 REACTOR VESSEL HEAD
 PENETRATIONS AND CLOSURE STUD LOCATIONS

A plan view of the Unit 3 reactor vessel head is provided in Figure II to show the relative locations of areas described in answers to several of the NRC questions.

Leakage from the canopy seal on CRDM 28 was detected during startup from a scheduled outage in March 1990. A clamp assembly was installed (Work Request 21446) to repair the leak and the wetted insulation over an area approximately 3 feet by 5 feet was removed (Work Request 21284). In addition, a clamp assembly was installed on CRDM 26 (Work Request 21447) because boric acid residue was found on the canopy seal area, although no active leakage was detected. Prior to installing new insulation, the reactor vessel head was cleaned and inspected in the area of removed insulation. No corrosion was noted in the work package documentation.

Another inspection of this area (top of insulation) was performed during a subsequent refueling outage (RO 11) in April 2001. The visual assessment report (see response to question 4) concluded that there is no evidence of leakage or corrosion products at the areas reviewed, that could be attributed to a penetration / vessel joint failure or leakage from above the insulation.
