Subject: Duke Power Company, Oconee Nuclear Station, Unit 2
Docket No. 50-270
Reactor Vessel Head and Penetration Nozzle Condition Report

**Oconee Unit 2
End-of-Cycle 19 Refueling Outage
Reactor Vessel Head Penetration Nozzle Indication Report**

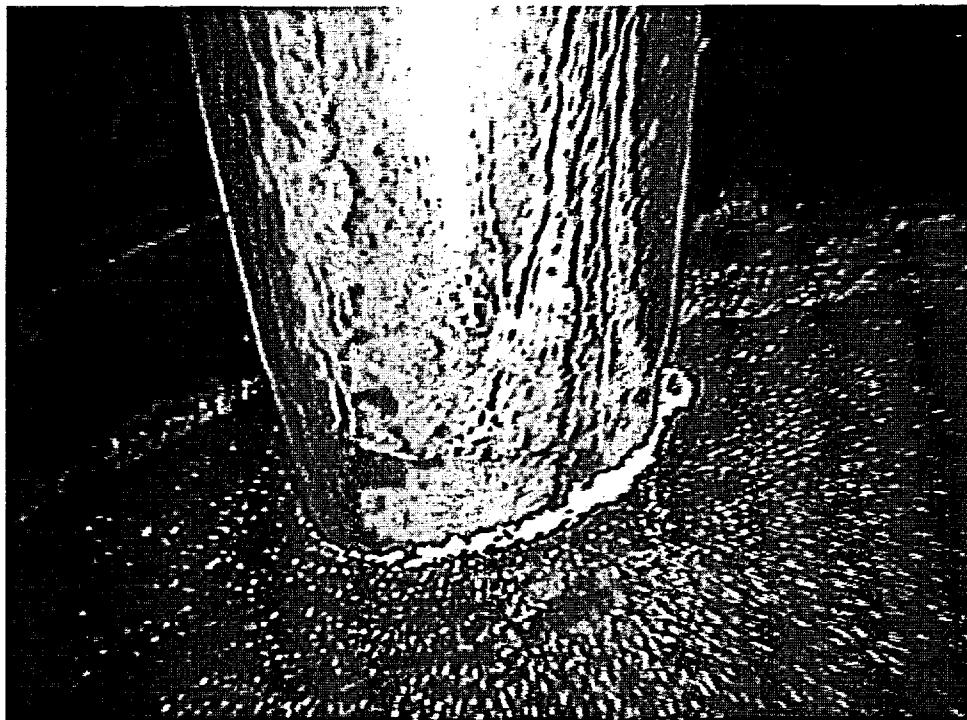
Figure 6 Oconee Unit 2 CRDM Nozzle 63 Identified as Masked, Top of RV head
Inspection for Boric Acid Crystals, 10/15/02

Fifteen CRDM Nozzles (numbers 1, 8, 9, 11, 15, 19, 21, 24, 31, 36, 38, 42, 60, 63 and 67) were repaired during this outage using the automated Framatome-ANP "ID Ambient Temper Bead" weld repair technique as described in the Relief Request 02-07². Corrective actions taken and future outage plans remain consistent with Duke's NRC Bulletin 2001-01, 2002-01 and 2002-02 submittals. Specifically, RV head replacement is scheduled at the next refueling outages for all three Oconee units (i.e., for ONS-3 in the spring of 2003, ONS-1 in the fall of 2003, and ONS-2 in the spring of 2004).

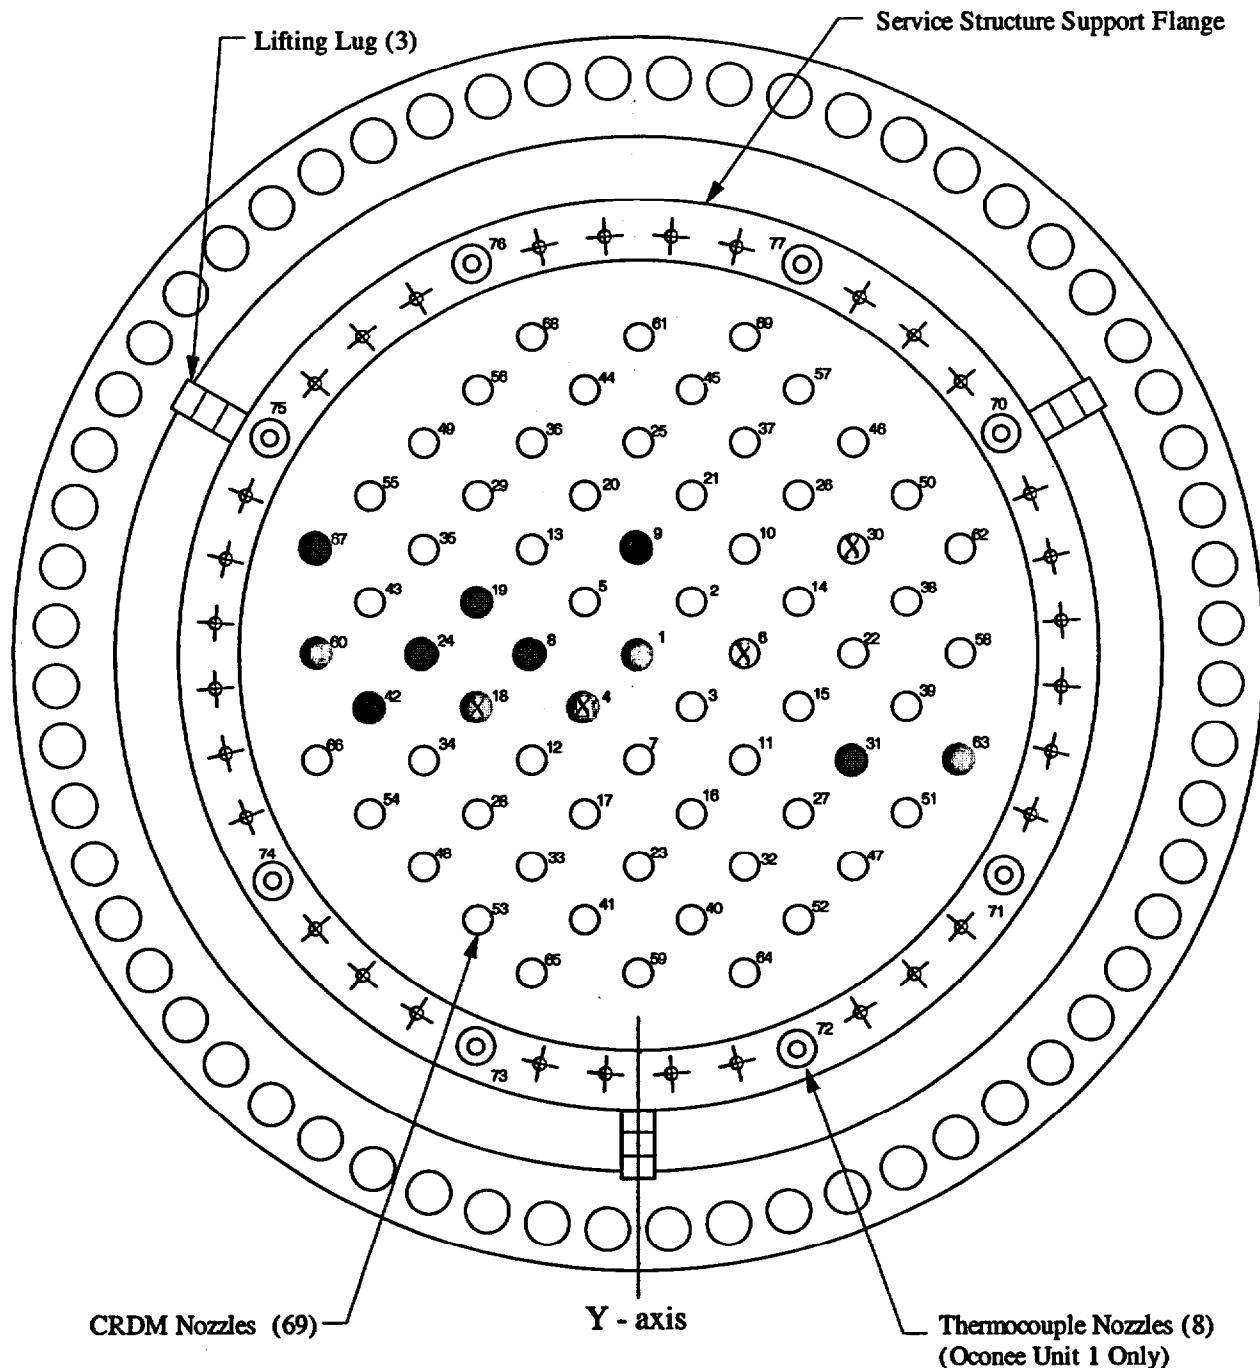
- Nozzles 8, 9, 19, 24, 31, 42 and 67 identified as leaking during EOC-19
- Nozzles 1, 4, 18, 60 and 63 identified as being masked during EOC-19
- ✗ Nozzles 4, 6, 18 and 30 were repaired (ID Temper Bead) during EOC-18

Figure 7 Bare metal visual inspections of RV head, Oconee Unit 2 CRDM nozzles identified as suspect, during EOC-19 refueling outage, October 15, 2002
