Accelerator Safety Workshop

Lessons Learned at C-AD Accelerators

August 7-9, 2007

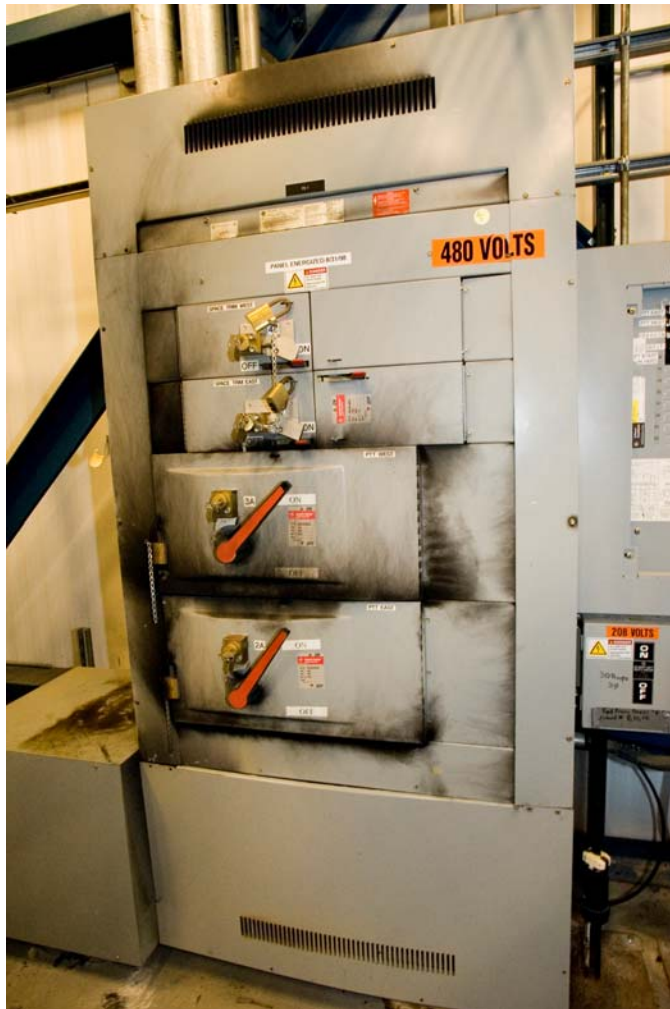
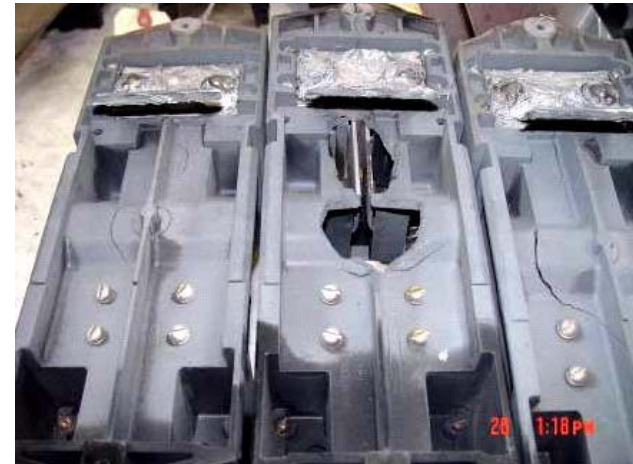
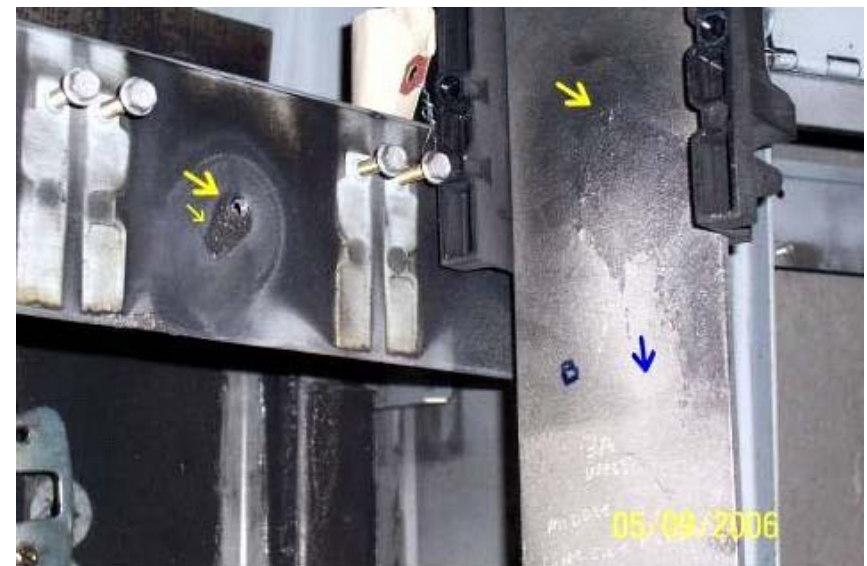
GE Spectra Switches and Arc Flash Event

- On April 14, 2006, at Brookhaven National Laboratory (BNL), an electrical engineer was injured (first aid) by an arc flash while closing a General Electric (GE) Spectra Series 400 ampere (A) fused-disconnect switch in a 480 volt (V) electrical panel at the Relativistic Heavy Ion Collider (RHIC)
- The subsequent accident investigation listed the failure of the switch as a possible contributing cause of the arc flash. The switch being operated was destroyed together with an adjacent 400 A switch located in the same panel

- Cracks, broken insulating support structure, dislocated metallic clips observed
- A spare was operated approximately 4000 times during subsequent testing

- Cracks in plastic support backing observed; almost identical to failed switches
 - During testing, screws became loose and fell out in the location of high voltage bus work

- Examined other Spectra series switches in operation
 - Switches were found to have significant structural defects
 - 32 percent of the GE switches rated at 400 amperes greater were found to have problems

- Units rated below 400 amperes were found to have a 0.30 percent problem rate
 - In the higher rated switches, repeated switch operations cracks the backing material

- Lesson Learned: discovery of degradation of the switches over time with repeated operation prompted a general concern over the inspection and preventive maintenance program of fused disconnect switches; these switches were all replaced with a different brand switch and a routine inspection program was put into place

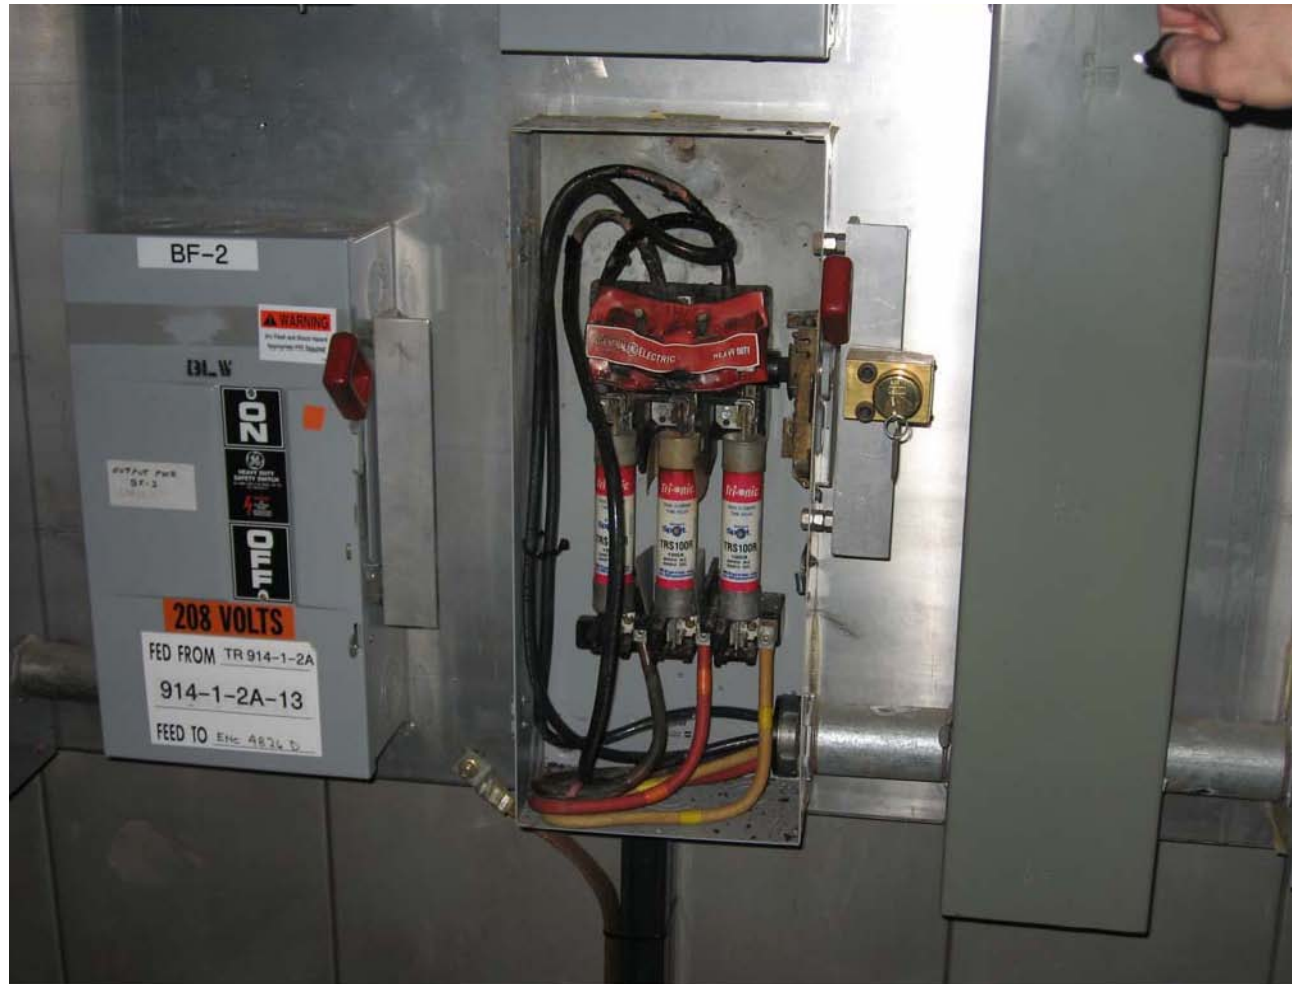
Melted Disconnect Switch

- On 5/10/07 at 0130, a power supply used for Booster to AGS extraction tripped. The power supply disconnect switch was found with the front panel off about 10 feet from the switch, and the plastic shield on the line side of the switch melted
- The subsequent accident investigation indicated the connection on at least one of the phases on the line side of disconnect switch caused heating from increased resistance, and the heating degraded the wire insulation and caused a phase-to-phase short

- The C-AD complex has on the order of 1000 metal-enclosed disconnect switches
- C-AD operates the facility with these switches closed for ~20 to 30 weeks per year. Literature shows an average failure rate of 5.4×10^{-8} per hour for flashover on busses. Thus, 1:1000 C-AD disconnect switches is expected to fail this way on average every 4.4 years
- Lessons Learned:
 - Begin a proactive program to periodically check electrical device panel temperatures with an infrared detector to determine potential overheating conditions
 - Develop procedure on how to react to as found temperatures on electrical device surface temperatures
 - As part of acceptance on new systems, infrared test all new connections and new systems put into service

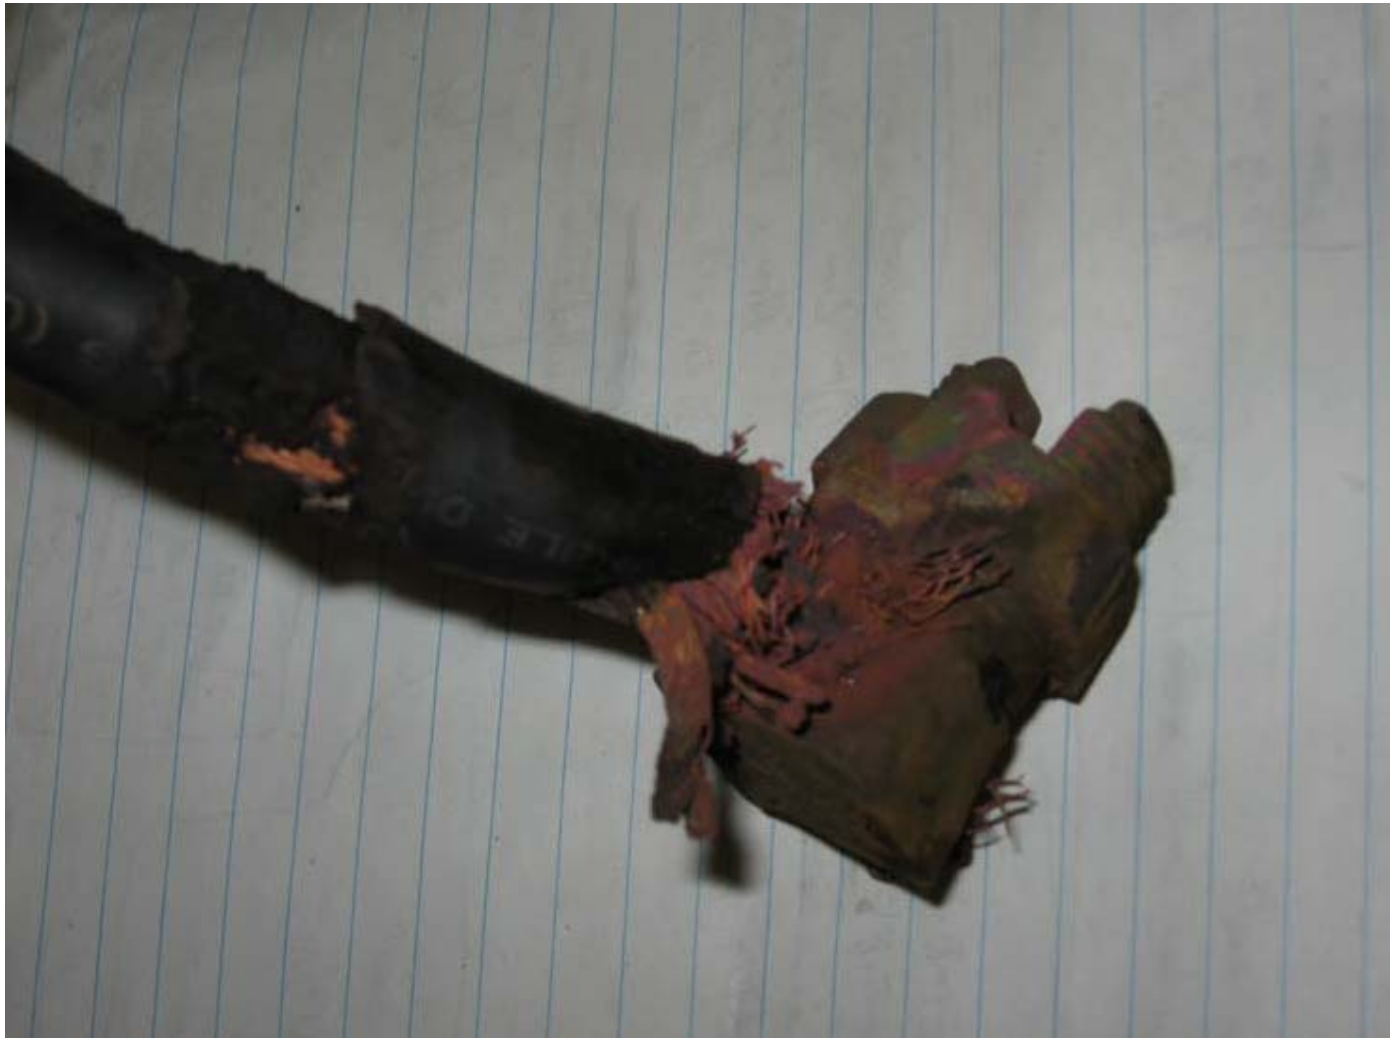
Overheated Wire

- On Friday February 2, 2007 a technician was testing a power supply. The power supply has an output of 15 V and 300 A. Part of the testing included attaching a resistive load to the power supply and cycling the power supply at +/- 300 A rms. The resistive load consisted of a length of 2/0 AWG cable.
- Normally this test is performed over a period of ½ hour and the resistive load warms during this test
- The cable overheated and smoke alarms went off. The Fire Department used a small fire extinguisher and there were no injuries or significant equipment damage
- The subsequent accident investigation determined the 2/0 AWG cable was spliced together with a split-bolt connector and that significant overheating initiated at the connector

- Lessons Learned:
 - The use of split-bolt connectors are common throughout the complex
 - These connectors require routine inspection and maintenance since they can become loose and cause local overheating
 - When applicable use un-spliced cable or when splicing stranded cables, use permanent compression-type connectors
 - When using split-bolt connectors for splicing stranded cables, perform periodic inspection for corrosion and tightness of the connector
