**URGENT
DEVICE
CORRECTION**

December 13, 2005

Re: COLLEAGUE VOLUMETRIC INFUSION PUMP, PRODUCT CODES 2M8151 & 2M8151R;
COLLEAGUE 3 VOLUMETRIC INFUSION PUMP, PRODUCT CODES 2M8153 & 2M8153R;
COLLEAGUE CX VOLUMETRIC INFUSION PUMP, PRODUCT CODES 2M8161 & 2M8161R;
COLLEAGUE 3 CX VOLUMETRIC INFUSION PUMP, PRODUCT CODES 2M8163 & 2M8163R

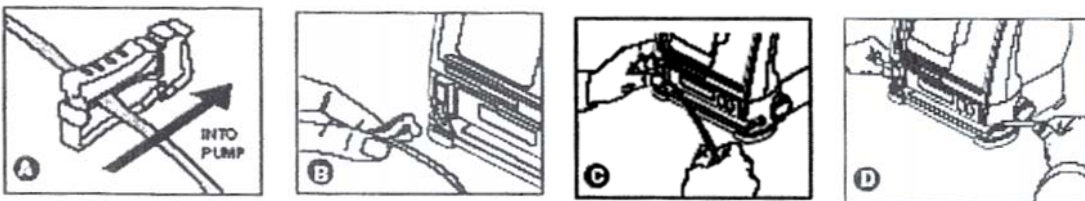
When loading the IV set, pull the administration set taut and slide it all the way into and along the tubing channel (Figure C and D). The pump pulls in the keyed slide clamp, then loads the administration set into the pumping mechanism. The pump module displays **LOADING** and then **STOPPED**.

If the above instructions are not followed, there is a potential for misaligning the pump chamber components, which may result in an under-delivery condition.

- Never insert tools or other objects into the tubing channel when attempting to load or unload the administration set.
- Never use the Manual Tube Release to load or unload the administration set during normal operation.
