REPORT OF THE COMMITTEE INVESTIGATION OF  
THE CATEGORY "R" RECURRING OCCURRENCE  
(CH-BH-BNL-2004-005)

MAY 20, 2004  
(Revision 1)

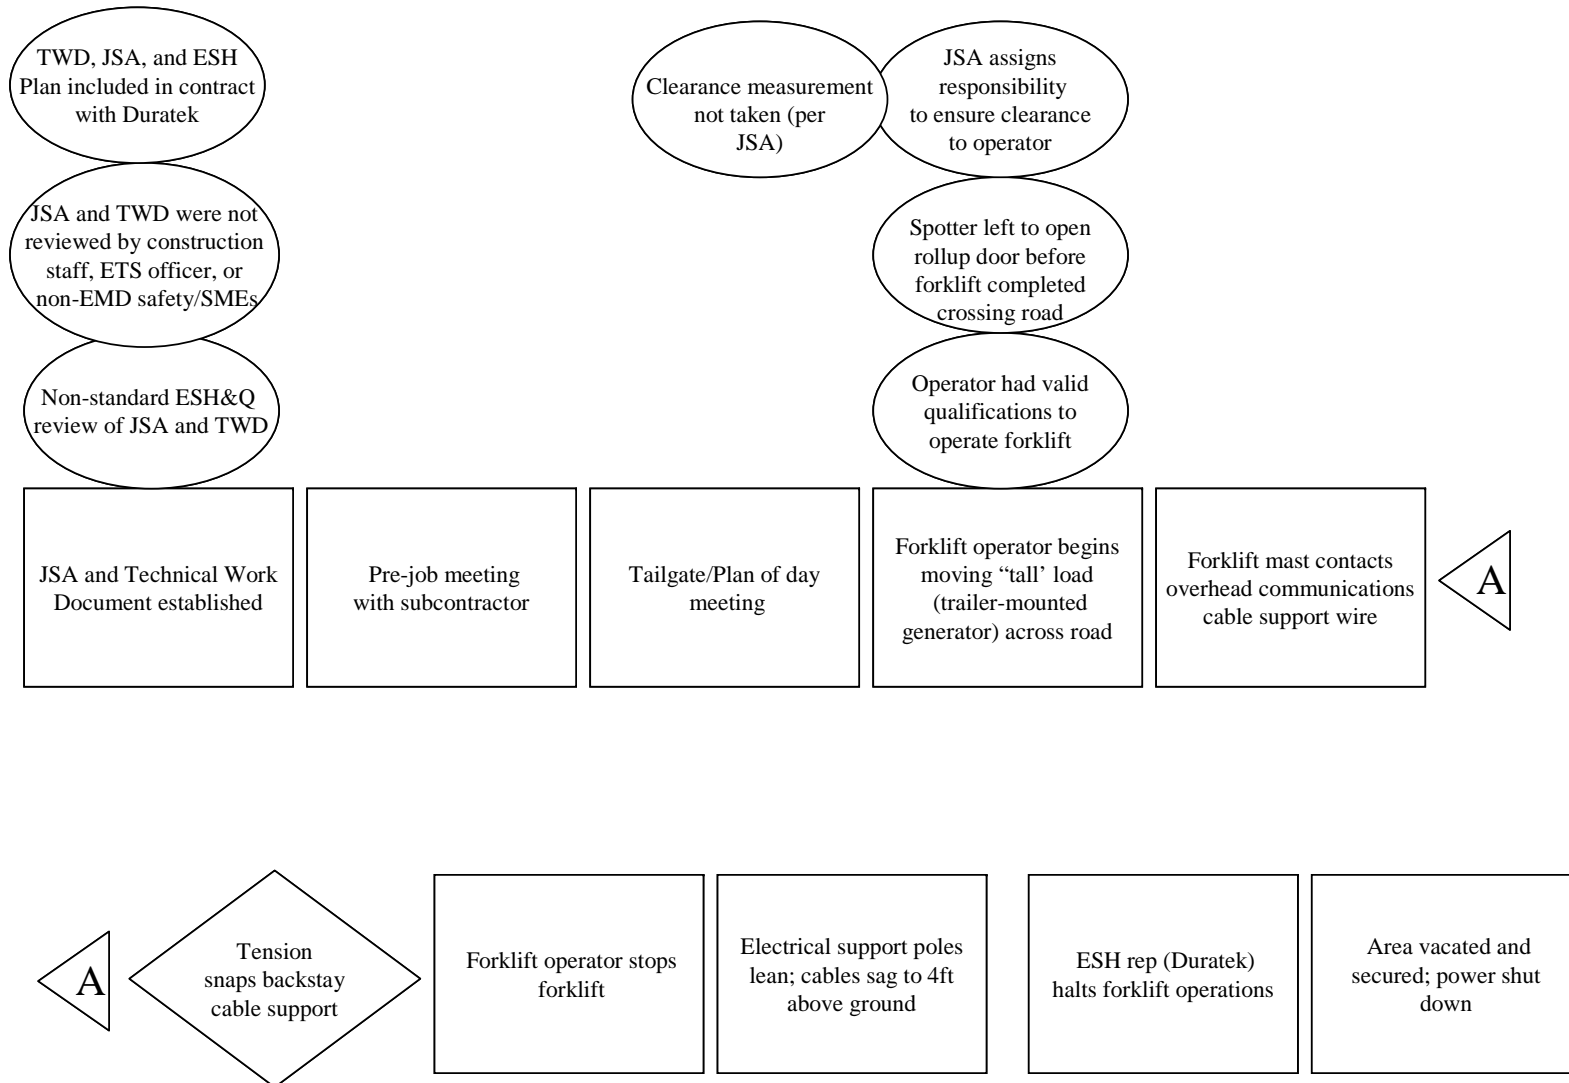
**Figure 1. Forklift Strikes Overhead Lines**

Under a contract with the Environmental Management Directorate, a subcontractor was operating a powered industrial truck (forklift) within the fenced yard of the former Hazardous Waste Management Facility (HWMF). The forklift was transporting a trailer-mounted generator along a roadway passing close to Building 445 below the power and communication lines. This task was covered in the work plans included in the Job Safety Analysis (JSA).

The tension caused by contact with the cable put stress the backstay cable at the pole. It parted, causing the cables to sag close to the roadway. There were no injuries, and at no time was there contact with the electric-power cables.

<b>ORPS Occurrence</b>	Forklift load strikes overhead lines	
<b>Date</b>	August 12, 2003	
<b>Consequence</b>	Backstay cable parted, pole leans over, cables sag to within 4 feet of road surface	
<b>Direct Cause</b>	Forklift mast contacts lower most cable	
	<b>Issue A</b>	<b>Issue B</b>
<b>Contributing Cause(s)</b>	No spotter	Forklift mast extends ~ 1 foot higher than lower most cable
<b>Why?</b>	Spotter stopped spotting to open rollup door	Inappropriate forklift used
<b>Why?</b>	Work was not properly planned	Clearance measurement not taken
<b>Why?</b>		JSA which requires "measure height of backrest extension to height of lowest overhead obstruction" was not followed.
<b>Causal Code(s)</b>	1. Planning and organizing f. Inadequate work organization ▪ Roles and responsibilities not defined or clear	3. Work process controls d. Work performance not within controls ▪ Original work plan (JSA) not followed

<b>7 Deadly Sins</b>	4. Overconfidence/Hubris	4. Overconfidence/Hubris
<b>Root Cause</b>	Roles and responsibilities of the spotter were not defined in the work plan, and the clearance measurement was not taken as required by the JSA

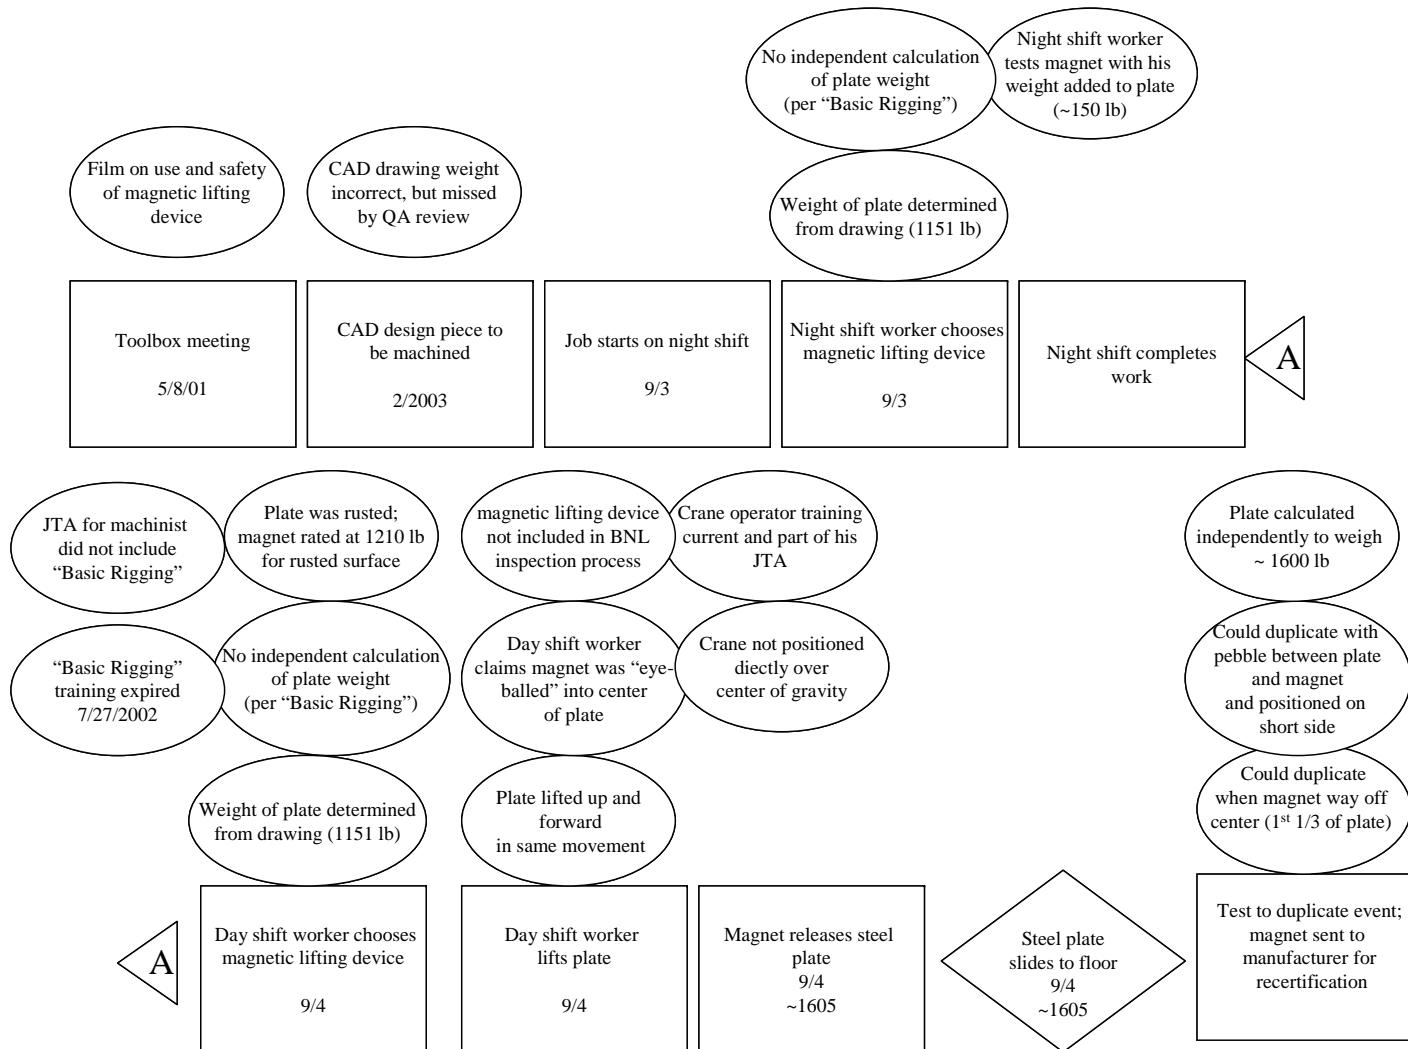
**Figure 2. Lifting Magnet Device Releases Steel Plate During Lift**

This person already had completed the process on the first of two plates on the previous night, but now was unable to complete the second. Therefore, he left that plate ready to be turned and completed on his next shift, but failed to leave a note informing the day shift operator of his intentions. He erroneously assumed that the day-shift operator would not continue the job.

Two issues were identified: (1) The plate weight exceeded the rated capacity of the magnet, and (2) the crane was not positioned directly over the hook attached to the magnet. The facts were that there was no independent calculation of the weight, and none of the five signatories on the CAD drawing verified the noted weight, which was incorrect. The crane operator failed to follow training and procedures.

<b>ORPS Occurrence</b>	Lifting magnet device releases steel plate during lift	
<b>Date</b>	September 4, 2003	
<b>Consequence</b>	Near Miss	
<b>Direct Cause</b>	Magnet releases plate	
<b>Contributing Cause(s)</b>	1) Failure to determine weight 2) Weight on drawing incorrect	
<b>Why?</b>	Magnetic force was insufficient to overcome the other forces acting on the plate (weight, off-center crane hook)	
	<b>Issue A</b>	<b>Issue B</b>
<b>Why?</b>	Plate weight exceeded rated capacity of magnet	Crane was not positioned directly over the hook attached to the magnet.
<b>Why?</b>	1) No independent calculation of weight 2) Weight marked incorrectly on drawing	Crane operator failed to follow training and procedures
<b>Why?</b>	1) Failure to follow basic crane operator procedure 2) Weight marked incorrectly on drawing	
<b>Why?</b>	2) Neither one of the five signatories on the CAD drawing independently verified the weight

<b>Causal Code(s)</b>	3. Work process controls g. Procedures not used or followed correctly ▪ Unexpected result 3. Work process controls b. Design Implementation Process Inadequate ▪ Design Verification inadequate	3. Work process controls g. Procedures not used or followed correctly ▪ Unexpected result
<b>7 Deadly Sins</b>	4. Overconfidence/Hubris 5. Ignorance, lack of fundamental knowledge/ tunnel vision/thinking inside the box	4. Overconfidence/Hubris
<b>Root Cause</b>	An under-rated lifting magnet was used because the weight of the plate was not independently calculated by the operator (per crane operator training) nor verified by the drawing signatories, and an additional lateral force was applied to the magnet because the operator failed to follow the procedure for positioning the crane directly over the magnet.

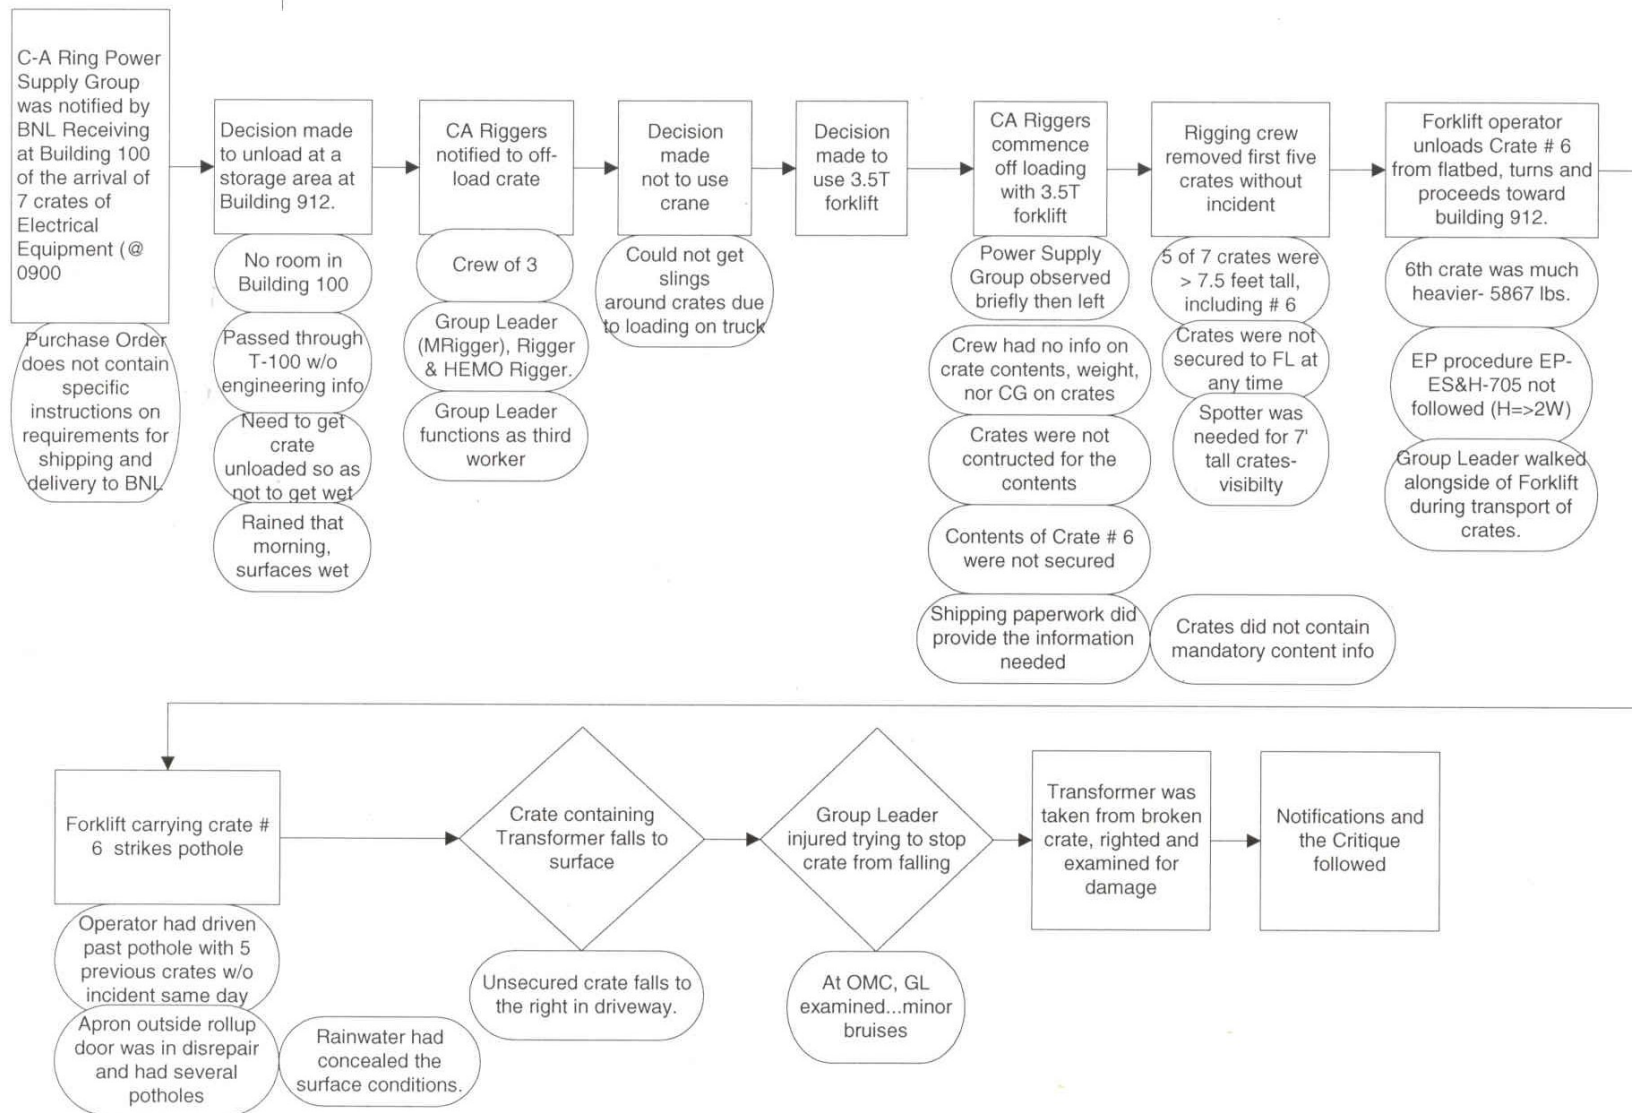
**Figure 3. Transformer Dropped During Rigging**

Two issues were identified: (1) The load was not secured as required, and (2) the forklift struck a pothole. The facts were that the riggers did not have enough information to safely move the load because there was little to no communication. The pothole had existed for some time and was not repaired because it was not deemed a significant hazard.

<b>ORPS Occurrence</b>	Transformer dropped during rigging	
<b>Date</b>	December 30, 2003	
<b>Consequence</b>	Property damage and occupational injury, Significance Category 3 occurrence	
<b>Direct Cause</b>	Employee received minor abrasions when unstrapped load fell while traveling over an uneven surface.	
<b>Contributing Causes</b>	<ol style="list-style-type: none"> <li>1. No one from the CAD Power Supply Group, nor Receiving communicated with the riggers about the load.</li> <li>2. There was no preliminary inspection of documentation (bill of lading, shipping manifest) before unloading at BNL's receiving control point.</li> <li>3. The transformer was not properly secured in crate by shipper, nor was the crate properly labeled.</li> <li>4. The method of transport chosen was less than adequate.</li> <li>5. Job planning was less than adequate as it failed to identify that it was important to properly secure the load.</li> <li>6. Assumption that it was a routine job despite the unknown risk posed by the load.</li> <li>7. The level of the staff's experience had declined significantly.</li> <li>8. Forklift struck a pothole.</li> <li>9. Riggers' perception that they needed to please the customer and complete the job without all the information normally required.</li> </ol>

<b>Issue A</b>	<b>Issue B</b>
<b>Why?</b>	Load was not secured	Forklift struck pothole
<b>Why?</b>	Riggers did not know what was in the crates and did not think they needed to secure them	Potholes were in the path of travel from the flatbed to the storage area
<b>Why?</b>	Previous five crates were successfully moved without securing them	Potholes were not repaired
<b>Why?</b>	Riggers recognized that the conditions changed and that the configuration of the sixth crate was very different, but did not stop to evaluate	Potholes had not been reported for repair.
<b>Why?</b>	Riggers did not have enough information on the load (weight, center of gravity, how it was mounted in the crate, and what it was)	They were not deemed a significant hazard
<b>ORPS Causal Codes</b>	A1B5C02: Physical environment LTA A2B4C03: Material packaging LTA A2B4C07: Marking/Labeling LTA A2B5C04: Procurement LTA A3B1C06: Wrong action based A3B3C06: Individual underestimated A4B3C11: Inadequate work package prep A5B4C01: Communication between WG

<b>7 Deadly Sins</b>	Overconfidence/Hubris based on limited experience	
<b>Root Cause</b>	Riggers developed a false sense of security while handling the first five crates. Since they were so light, they decided not to strap the loads, thus violating procedures. The Group Leader violated procedure by escorting loads in the danger zone

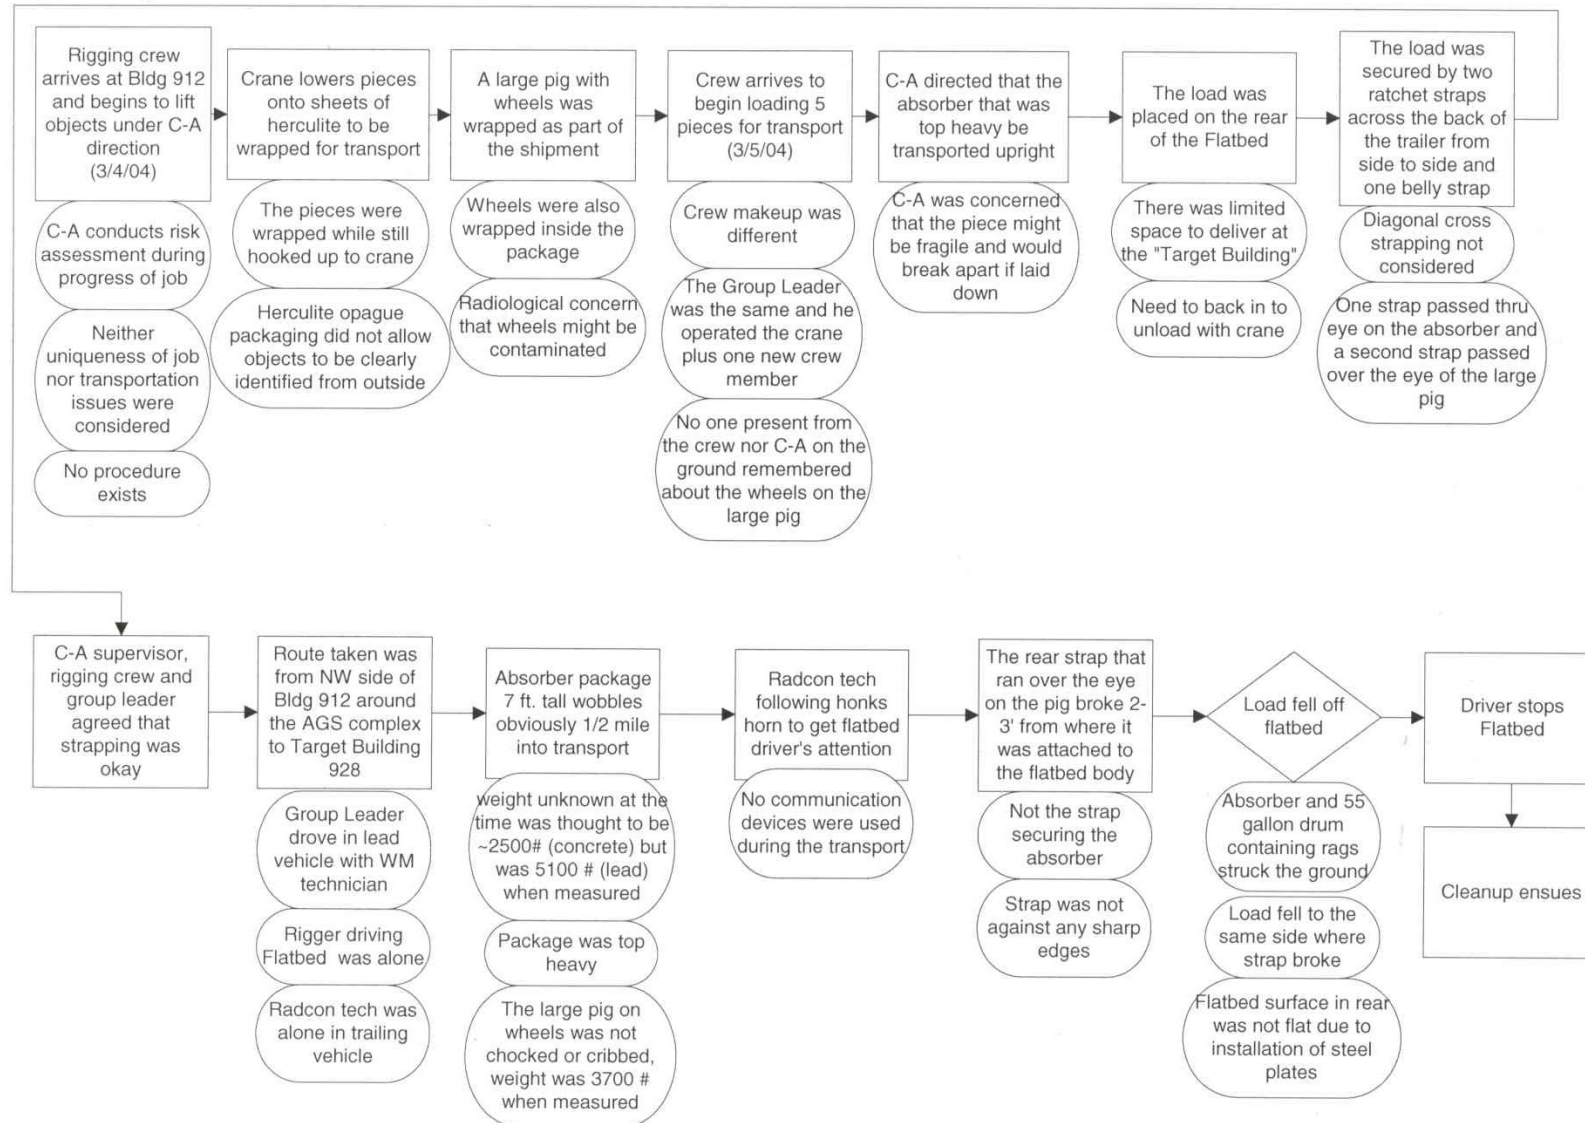
**Figure 4. Load Falls Off Flatbed Truck During Transport**

A few seconds later, the same technician observed a restraining strap break. The package with the absorber struck a 55-gallon drum and both fell to the ground. The driver of the vehicle carrying the load responded to the honking of a horn behind him, and slowed to a stop just forward of where the load fell off his truck.

The issue identified was that the load was not properly secured. The rigging crew made an error in judgment when they decided on placing, distributing, and strapping the load. The weight of one of the pieces was underestimated, and the crew's knowledge and experience about the forces that act on the load was inadequate. Overall, the Laboratory did not appreciate the significance of the cargo and load, and the methods used to secure and transport it.

<b>ORPS Occurrence</b>	Load falls off flatbed truck during transport
<b>Date</b>	March 5, 2004
<b>Consequence</b>	Near Miss, Significance Category 3 Occurrence
<b>Direct Cause</b>	During transport, an inadequately secured load fell from a flatbed trailer onto the roadway
<b>Contributing Cause (s)</b>	<ol style="list-style-type: none"> <li>1. Load inadequately secured because of means and methods chosen.</li> <li>2. Load's configuration with the heavy pieces off to one side on the rear of the trailer.</li> <li>3. BNL has no guidance or procedure on properly securing loads.</li> <li>4. Underestimated weight of the absorber at ~ 2500 lbs.</li> <li>5. Assumption of acceptable risk was based on incorrectly estimating the weights of objects transported, leading to the poor conclusion that the top-heavy load was not an issue.</li> <li>6. Work plan and permit consisted of Health Physics (RWP) concerns only, and reliance on skill-of-the-craft.</li> <li>7. The absence of clear roles and responsibilities made it difficult for workers to understand who was in charge of the transportation.</li> <li>8. The use of Herculite opaque plastic sheeting concealed the wheels, which may have caused the workers to forget their presence and possibly prevented them from chocking or cribbing the target cave.</li> </ol>

<b>Root Cause</b>	Work planning was less than adequate and planning staff did not recognize its importance. No other aspects were considered. Several elements of the ISM Program failed as a result. BNL management's emphasis on maintaining skilled and knowledgeable rigging personnel was not adequate. The number of BNL's experienced rigging personnel has dwindled greatly in the last few years due to retirements and lay-offs. This is exemplified by the dearth of fundamental knowledge needed in dealing with this type of load and more difficult ones.
