Bottom Mounted Instrument Penetration Condition Resolution

South Texas Project's Failure Modes and Effects Analysis for Bottom Mounted Instrument Nozzle Leakage

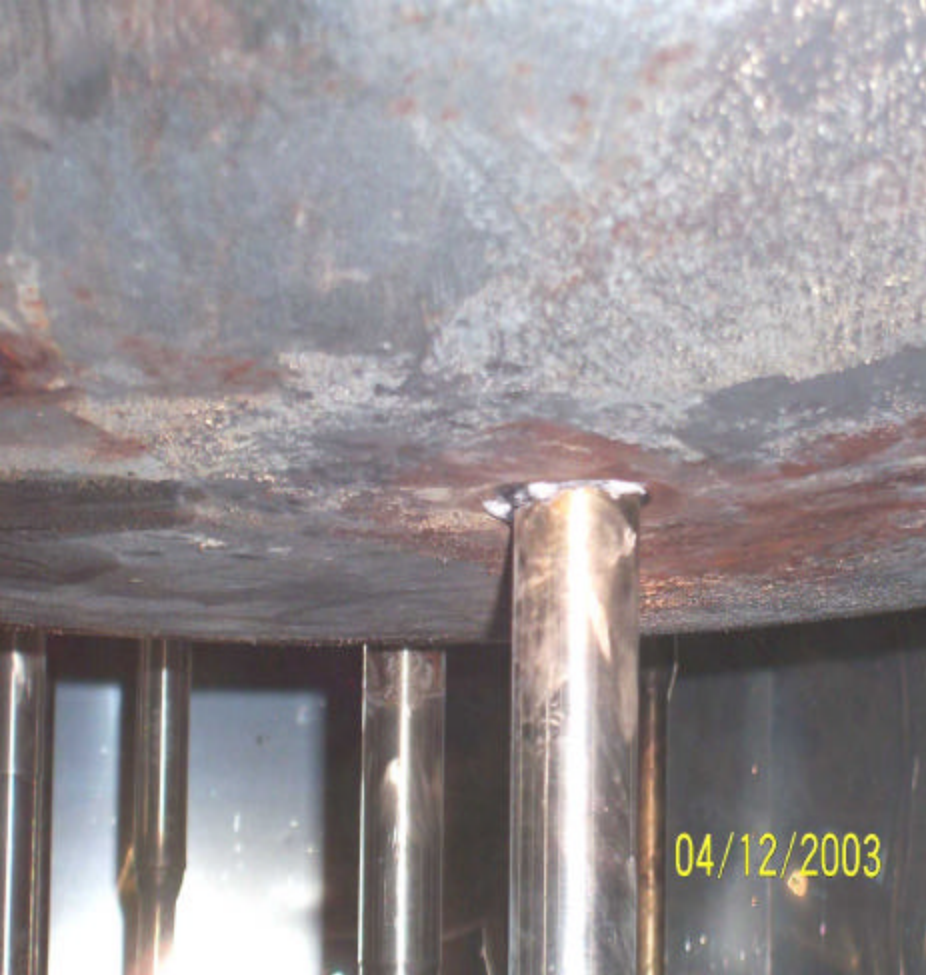
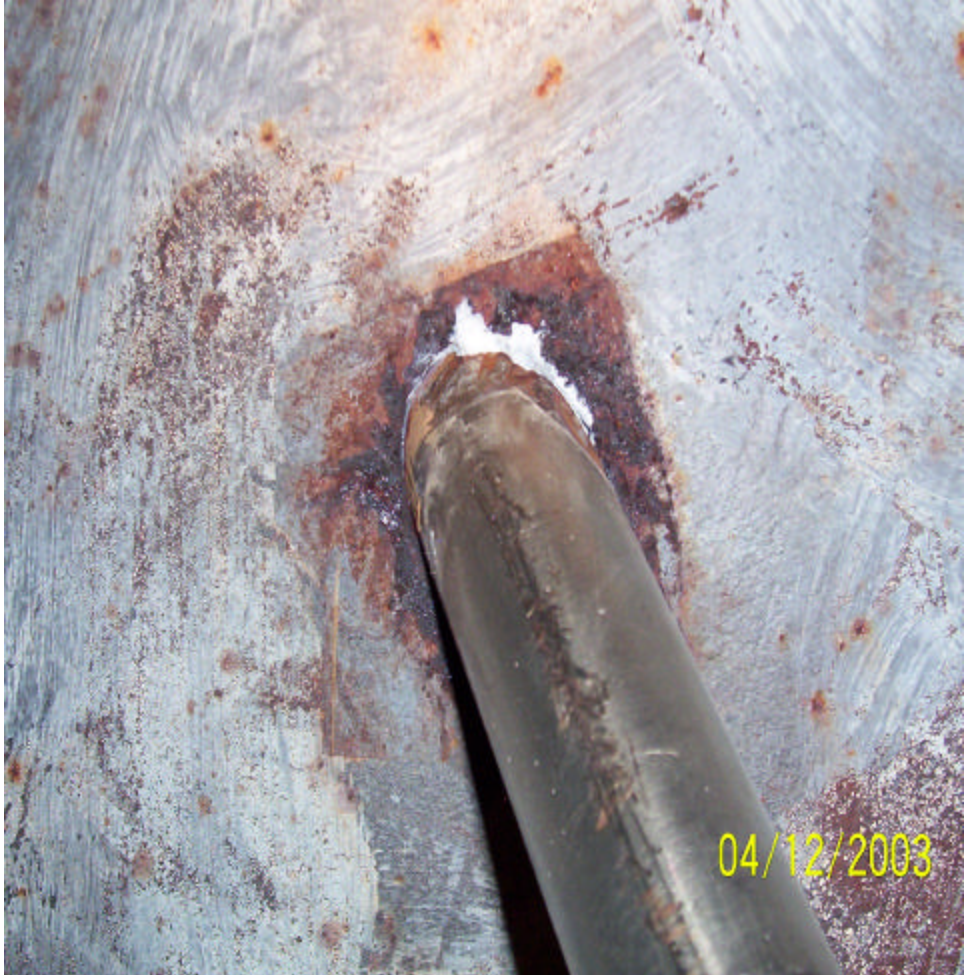
Evidence of Very Small Leakage Found in Routine Inspection

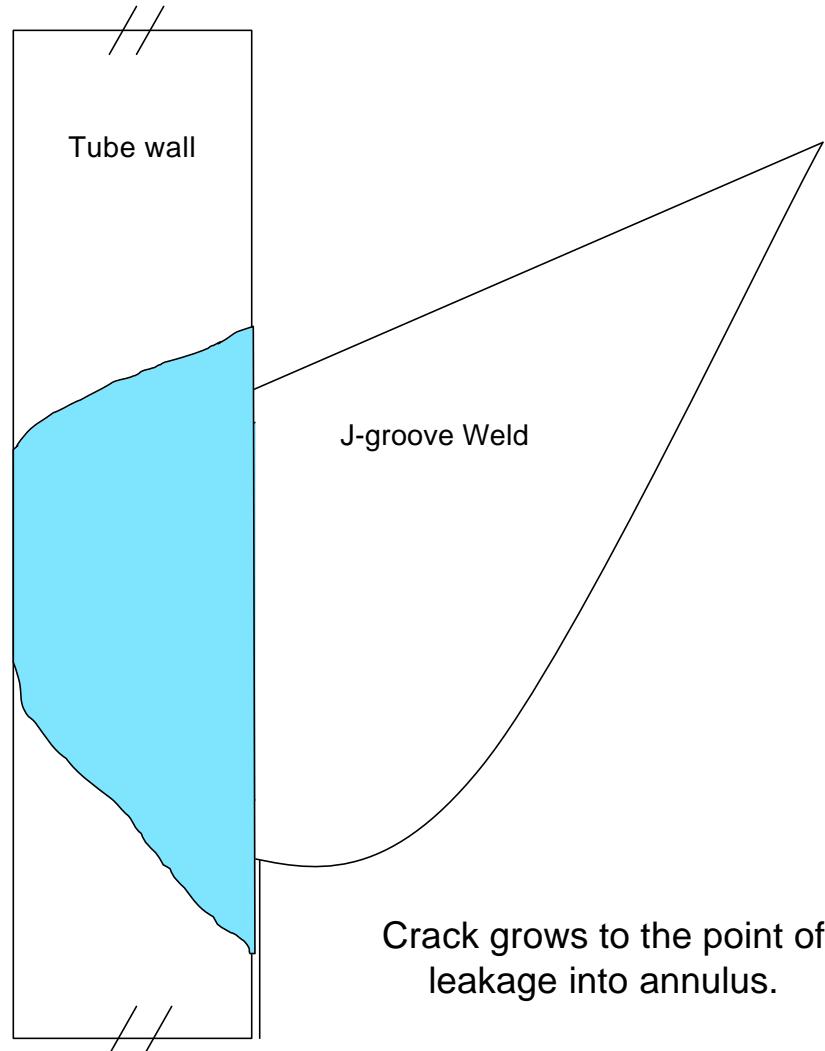
Crack Propagation Scenario

- No cracks identified except in #1 and #46
- Cracks relatively old (3-5 yrs), about same age
- Cracks not ID initiated

- Cracks not at highest residual stress locations
- Penetrations #1 and #46 are different in terms of residual stress
- Some cracks do not appear to be in contact with primary water

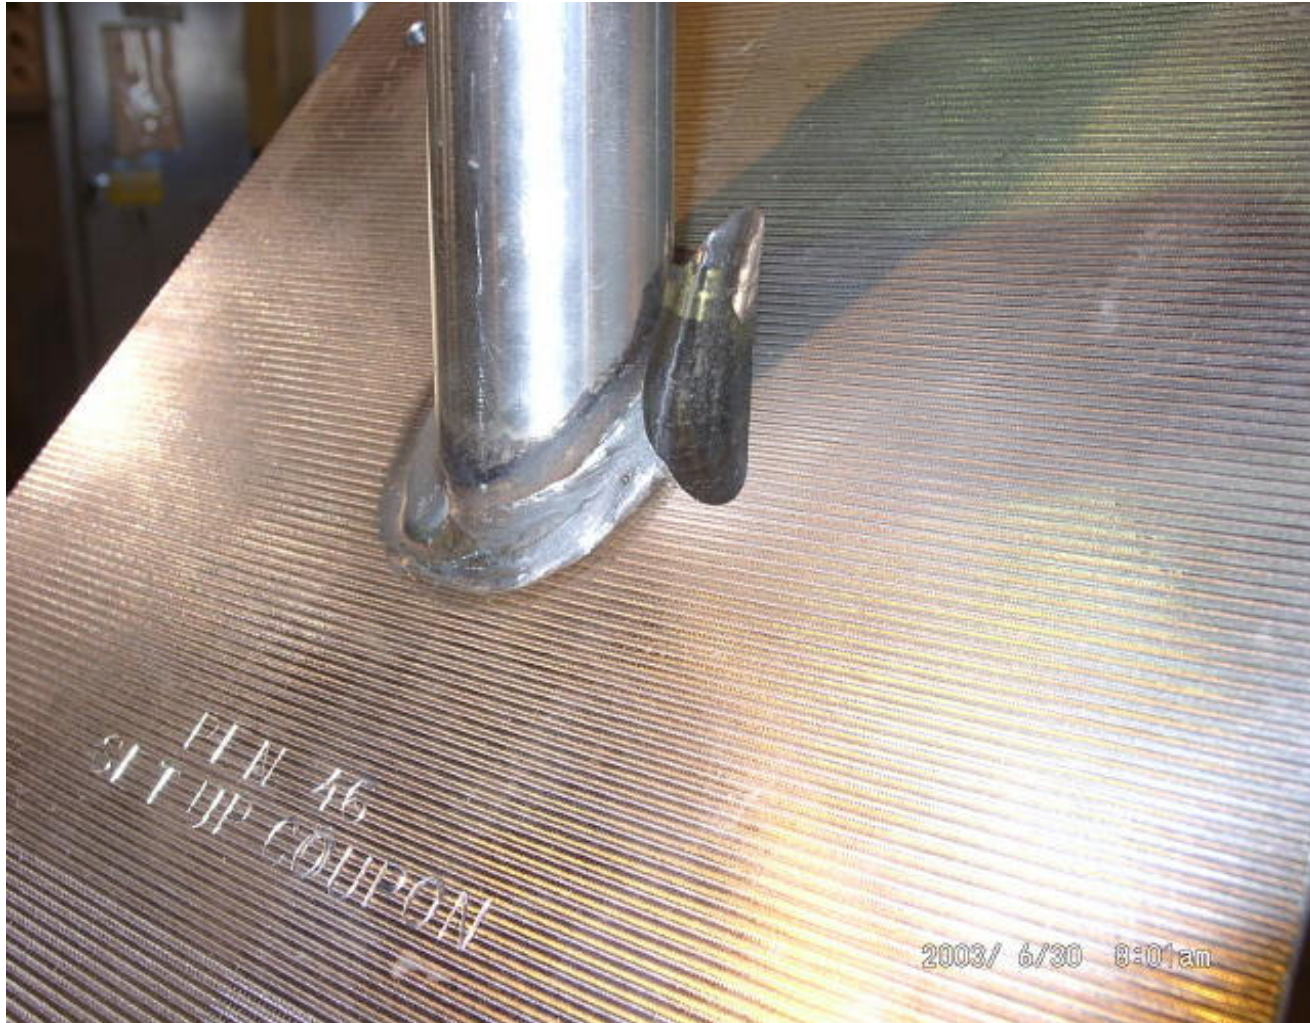
Mock-up Penetration #46 Boat Sample

- Capture portion of crack shown by UT not to connect with the surface
