#### **South Texas Project Unit 1**

Bottom Mounted Instrument Penetration Condition Resolution

## EXTENT of CONDITION, CAUSE, CORRECTIVE ACTION

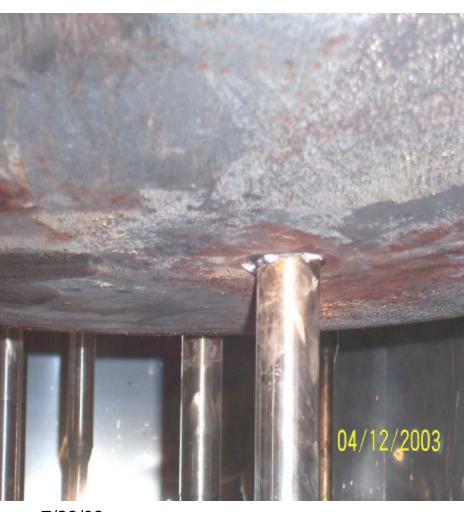
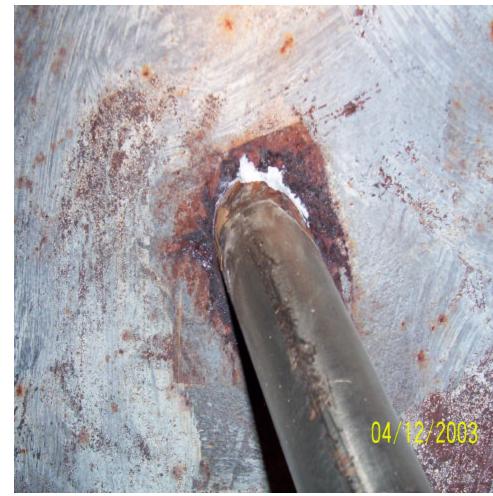
## **Evidence of Very Small Leakage Found in Routine Inspection**

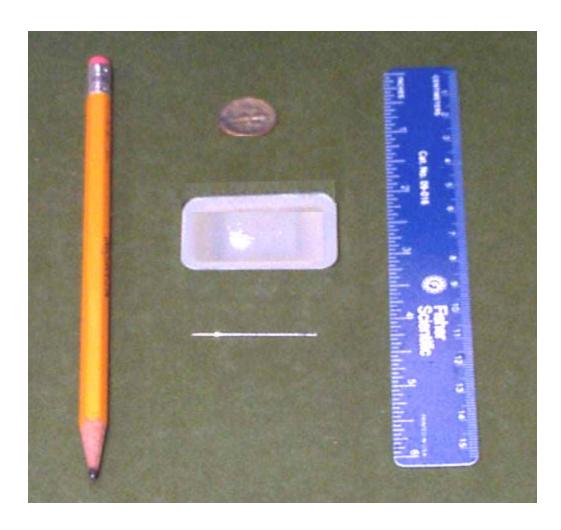
#### **Actual Amount of Residue**

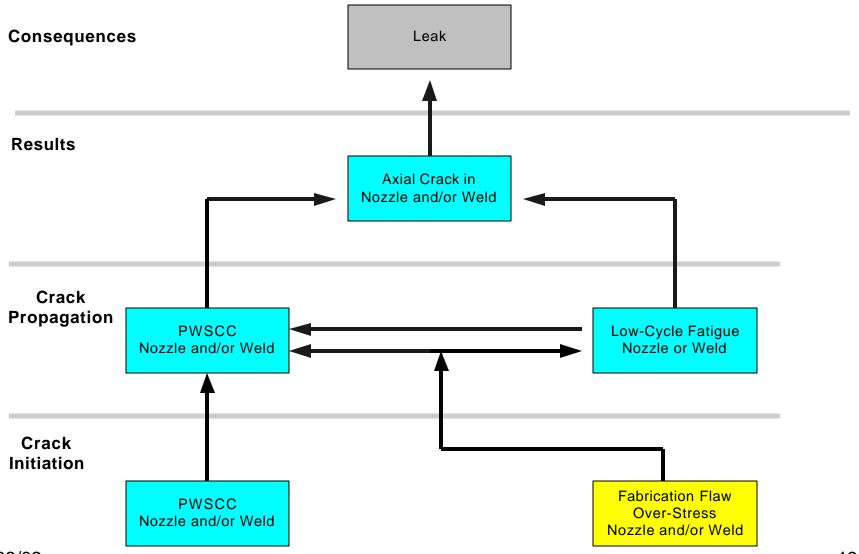
- Penetration #1
  - Three axial indications, one leak path
- Penetration #46
  - Two axial indications, one leak path

#### **Investigation Results**
