The Rio dos Padres case study – Working in a dangerous area and minimizing the impact of clean-up activities on the environment.

In April 2001, a truck accident in the Brazilian Atlantic rainforest in Morretes, Parana State, caused a 30,000 liter fuel oil spill in a pristine water river. A quick response was necessary to collect oil from the river before the next rain. The river, running along the mountains valley is dangerous, stony, hard to walk on and rain causes its' level to raise rapidly and its' flow to increase, endangering the workers during the cleaning operations. To minimize risks and response time, oil was swept downstream and collection was then made in an advanced point where a dam was built in an easy access location. The decision proved to be satisfactory, reducing operation time. Oiled stones were cleaned one by one after the free oil collection. Workers selection was an important item; they had to be able to exit the area on their own if it rained, and go to safe points. It was an atypical fast water situation where the scenario changes significantly along the river and even alpinism techniques had to be employed.

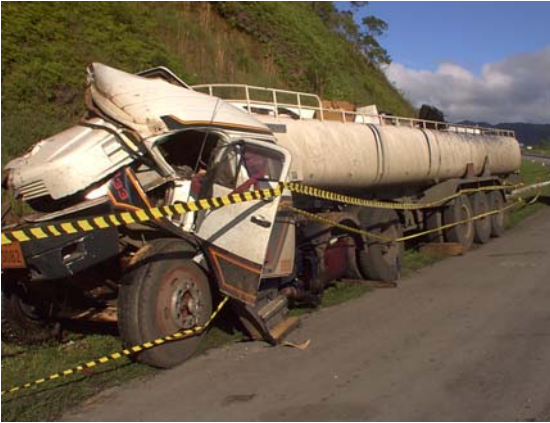
In April 2001, a tank truck carrying fuel oil collided with a soy bran truck, the oil tank ruptured and all its 30,000 liter of fuel was discharged. The oil contaminated the road and run to the rainwater sewer. The sewer discharged the oil to the roadside, into the rainforest and then to a pristine river in this forest.

Fig 1 – The tanker truck in this casualty.

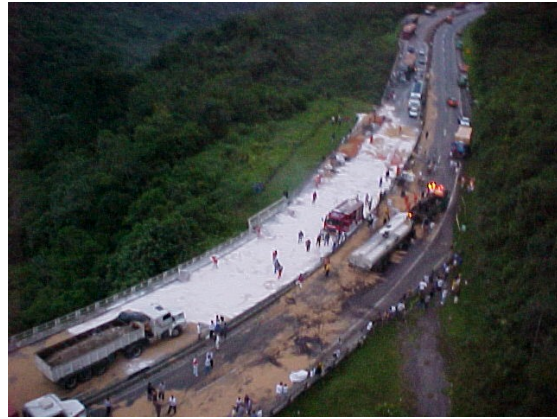
Fig. 4 – Road and truck accident.

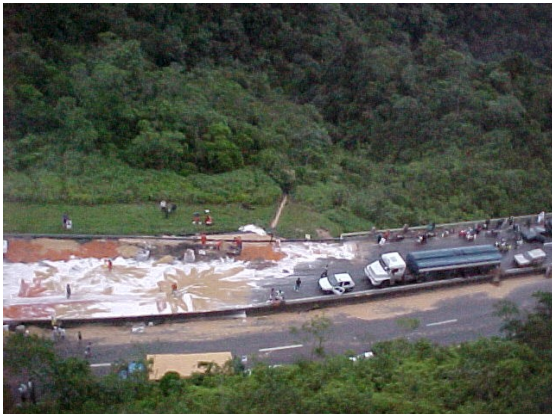
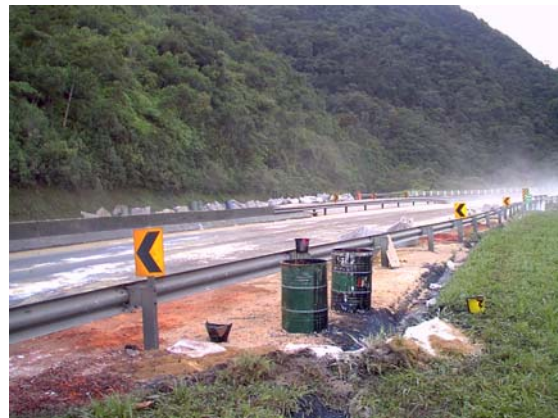
Fig. 5 – Road cleaning and decontamination.

Fig. 6 – Road cleaning and decontamination.

The first job was to finish the road cleaning. The oil on the road was absorbed with the second trucks' soy bran, sawdust, lime and peat powder, all material was removed from the road surface with shovels and hoes. Contaminated material was conditioned in plastic bags and sent to a petroleum refinery for treatment.

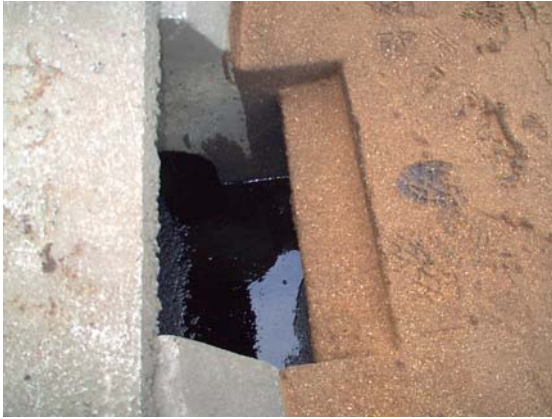
Fig. 7 – Rainwater sewer inlet.

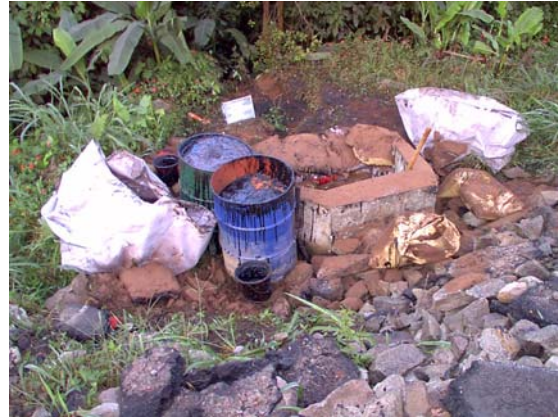
Fig. 8 – Sewer discharge to the forest.

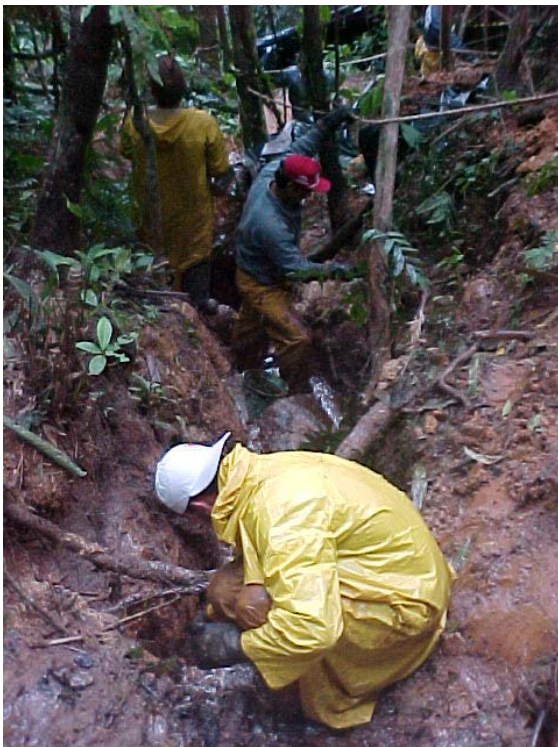
Fig. 17 – Workers cleaning one of the “tracks”.

In the “tracks”, the oil was absorbed with sawdust and/or peat powder, packed in plastic bags, and then carried manually up hill; most of the way with rows of men and passing the bags hand to hand up hill, once walking up the hill was very exhaustive. Some residue bags

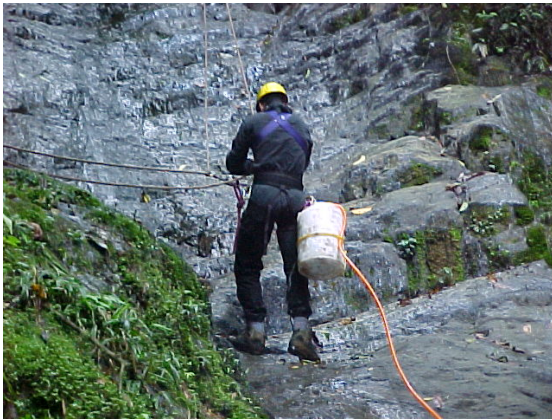
Fig. 19 – Ready to climb the rock wall.

The tracks finished at a vertical rock wall, around a hundred feet high. The wall was soaked with oil and workers were rock climbing to clean it using high-pressure water jets. At the bottom of this wall, the team built a pool to contain the wash water and recover the oil. The pool was made of sand bags, coated with plastic sheet and drained at the bottom. The oil could then be recovered from the surface of this pool with cans and absorbent material as booms and pads. The oil was conditioned in sealed light drums and carried up hill to the roadside base.

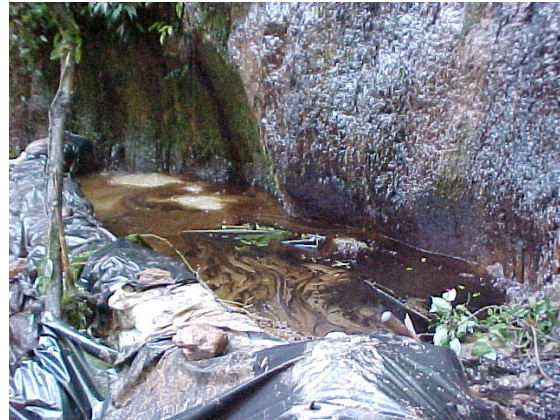
Fig. 20 – Pool for containment of the wall wash water.

No chemical product was used to wash the rock wall, since it could contaminate the river. The pool water was drained at the bottom into portable oil-water separators and from them to the river.

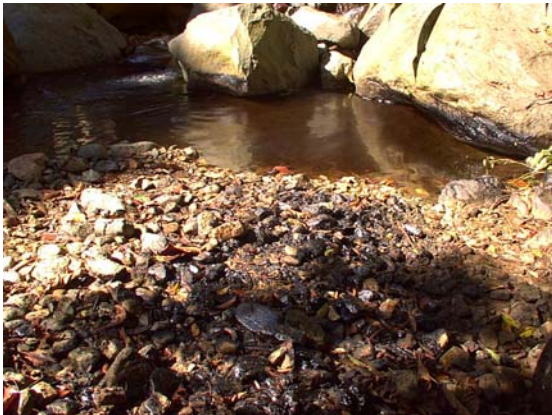
The river rocks still had oil stains, the best solution to clean them was to rub each one with absorbent pads and synthetic cotton. The rocks were all hand cleaned one by one on the river and put back on their original place. This job took a month to finish. The cleaning cloths were sent to burn on a co-processing plant.

Fig. 21 – Oil stained portion of Rio dos Padres.

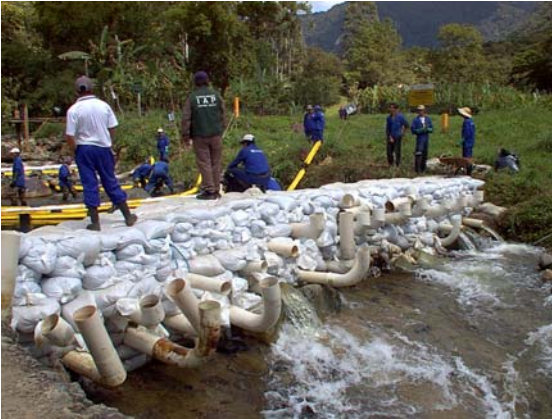
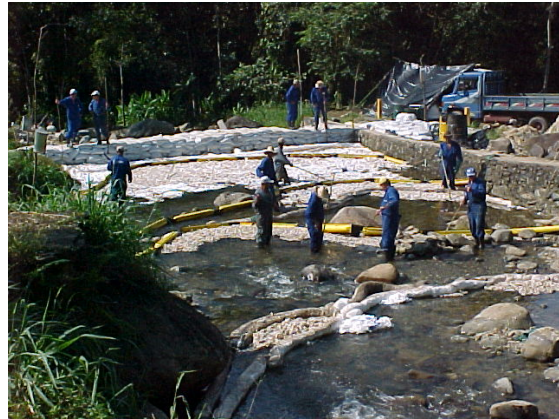
Fig. 23 – The dam close to Rio dos Padres mouth in Rio dos Pintos.

Fig. 24 – Upstream view of the dam.

Sweeping the river was then proposed to the State Environmental Agency. They decided to try a pilot test. We bought some brooms and used them to sweep the surface of the water and rocks. The rocks were already stained with oil, brooms would not cause any additional damage or add difficulty. The water flow carried the oil down river. The test proved successful and then brooms were used in the steep portion of the river. To collect the oil, the response team had luck on their side. Right at the section where the unpaved road ended, which was the best access point to the river, there was a buried oil pipe crossing the river, to avoid erosion and damage to the pipe this portion of the riverbed was covered with cemented rocks forming a square profile. At this point, a dam with bottom draining was built using sand filled bags. The increase in the water level reduced the water speed enough to permit oil to coalesce and float. Containment and absorbent booms and other regular material and equipment could then be used to contain and recover the oil. This location was also safe to work, had good access and some local people had their houses in the neighborhood. The main operational base was placed at this location to provide office space to the response team and unified command, cafeteria, storage and parking area, chemical toilets, medical post and other needs.

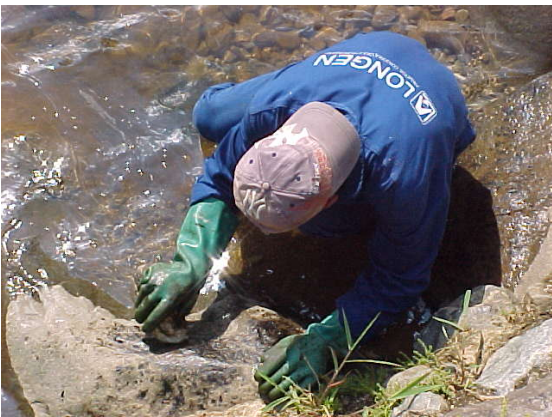
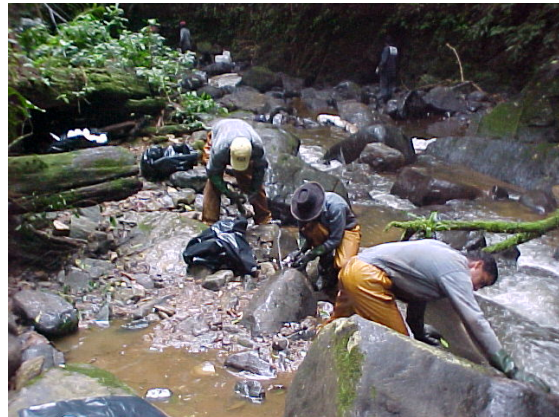
Fig 25. – Manual cleaning of river rocks.

Fig. 26. – Manual cleaning of river rocks.

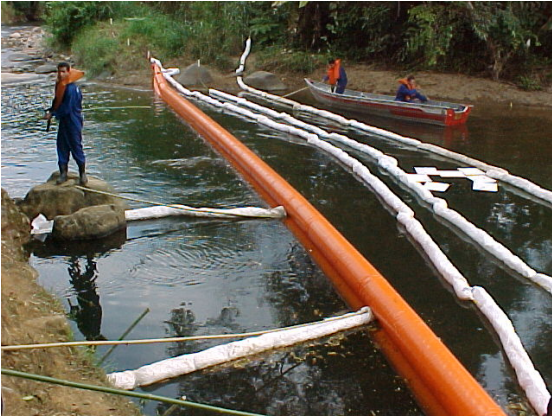
Fig. 27 – Rio dos Pintos containment point.

This river had standard response techniques, with the use of containment and absorbent booms, absorbent pads, vacuum trucks for oil recovery. This response does not require any further comments or description.

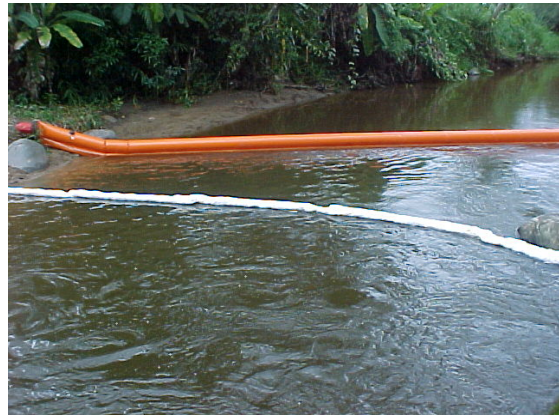
Fig. 28. – Booms on Rio dos Pintos.
