# In-stream Remediation of a Hydrocarbon Release in North Central Alberta, Canada

Wayne Wiebe, A.Sc.T., CCEP  
General Manager

May 2-4, 2006

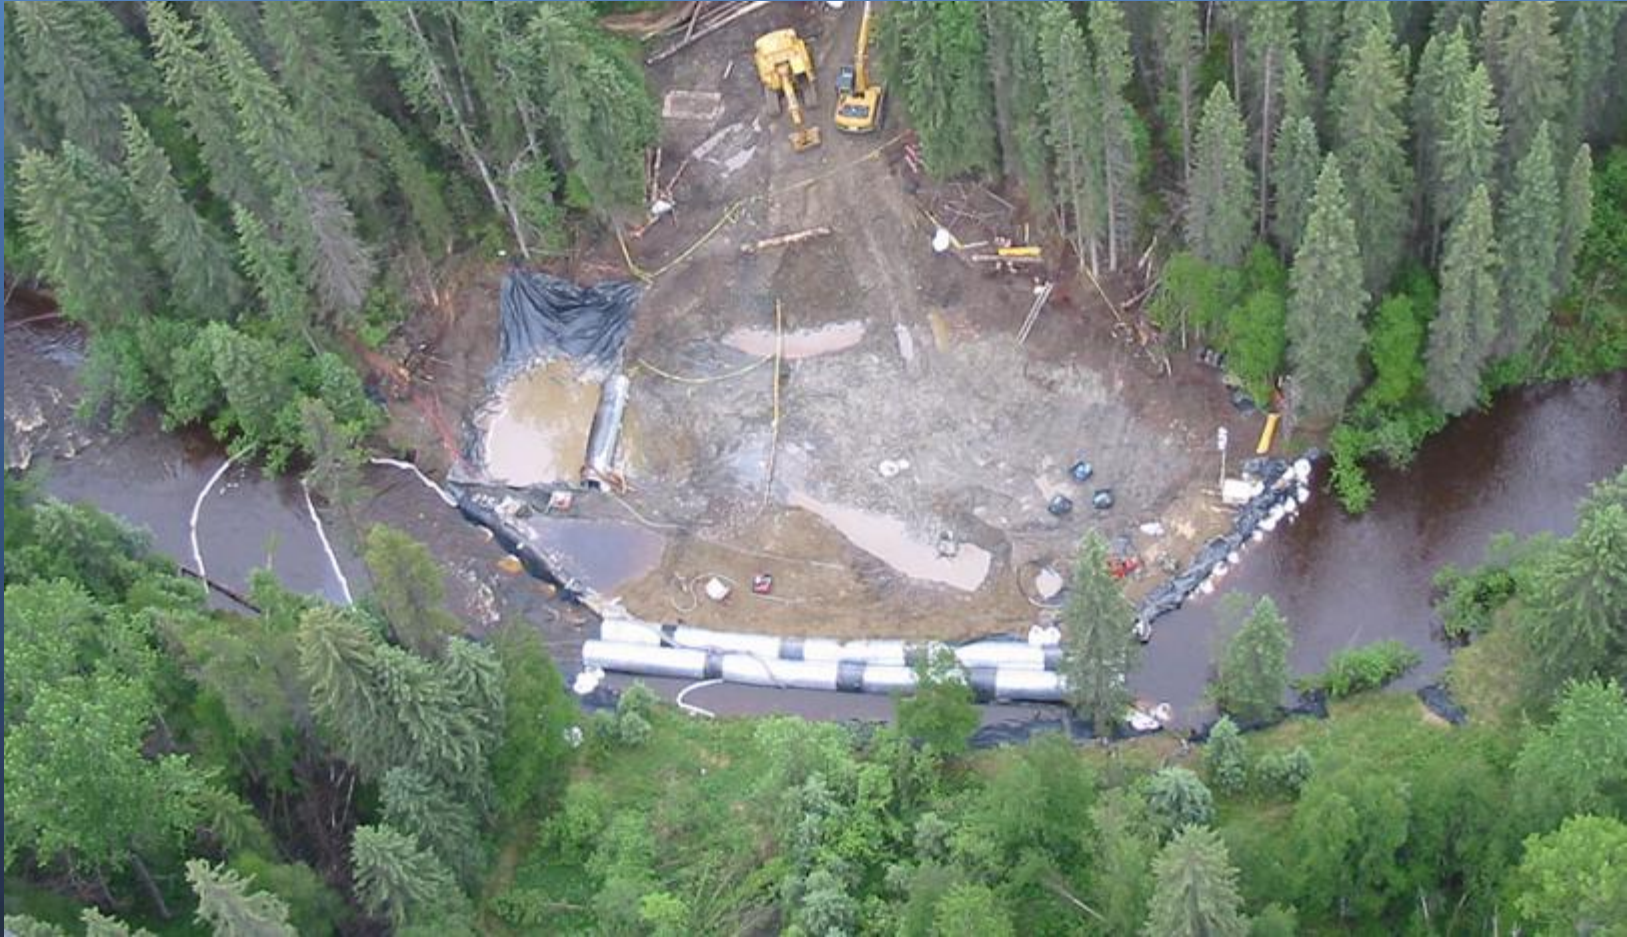
- Release identified on May 6, 2005
  - 3 ½" diameter steel pipeline failed, caused by stress fracture due to unstable slope at stream bank
  - Released volume was estimated at 65 barrels of light crude oil
  - Breakpoint was located adjacent to streambed of watercourse

Overview of breakpoint (initial stream diversion in place)

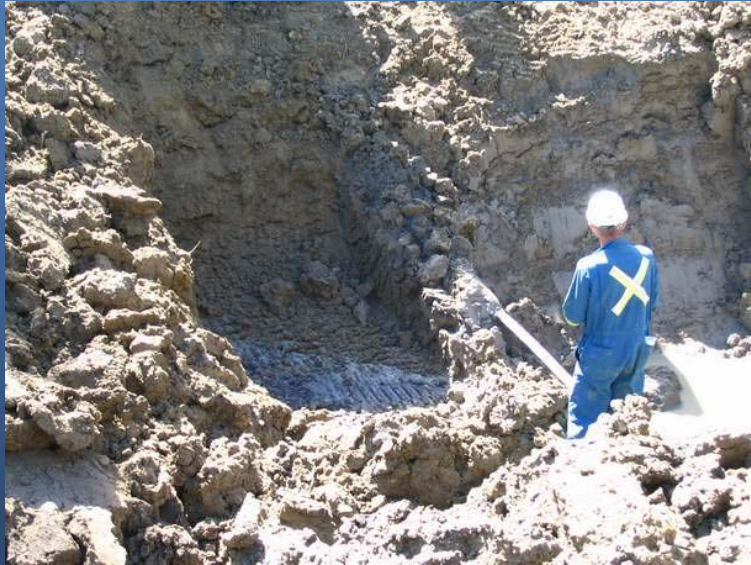
Initial pipeline exposure

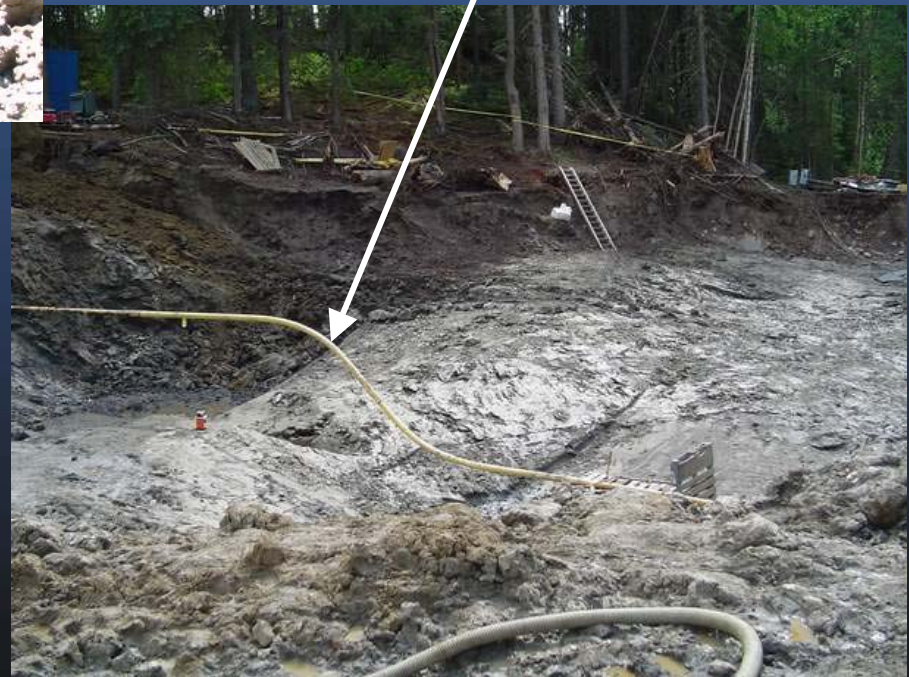
Exposed pipeline
