# USDA Forest Service

## Aviation Safety Summary July 2002

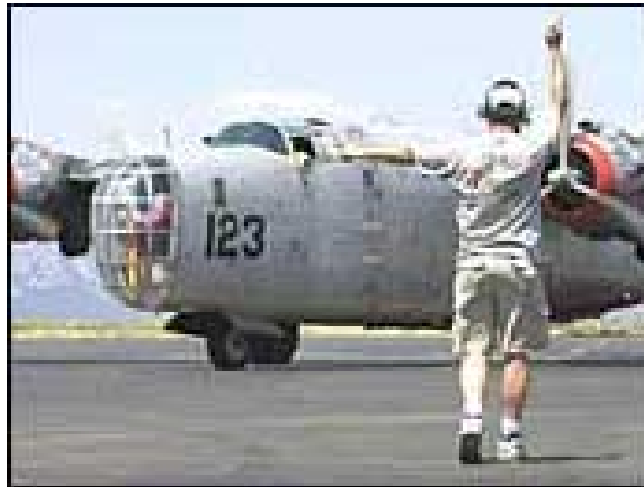
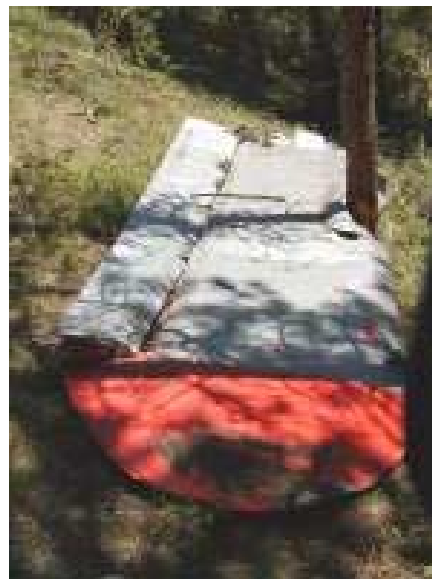
On July 18, 2002, at 1840 mountain daylight time, a Consolidated-Vultee P4Y-2, N7620C, operated by the U. S. Department of Agriculture Forest Service and piloted by a commercial pilot, was destroyed when it impacted into mountainous terrain 6 miles southwest of Estes Park, Colorado. A post-crash fire ensued. Prior to the impact, the airplane's left wing separated and aircraft control was lost while maneuvering to deliver fire retardant on the Big Elk wildfire, burning in an area northwest of Lyons, Colorado. Visual meteorological conditions prevailed at the time of the accident. The public use flight was being conducted under the provisions of Title 14 CFR Part 137, aerial application. A flight plan was not on file. The pilot and second pilot on board the airplane were fatally injured. The flight originated at Broomfield, Colorado, at 1815.

The copilot of T-161 said Tanker 123 was in his base turn for the drop and in a "smooth 15 to 20 degree bank turn," when the left wing separated from the airplane. "The aircraft then went into a rotation and impacted the ground." The copilot said that operations were normal and the weather in the area consisted of "the smoothest, least turbulent conditions of the day."

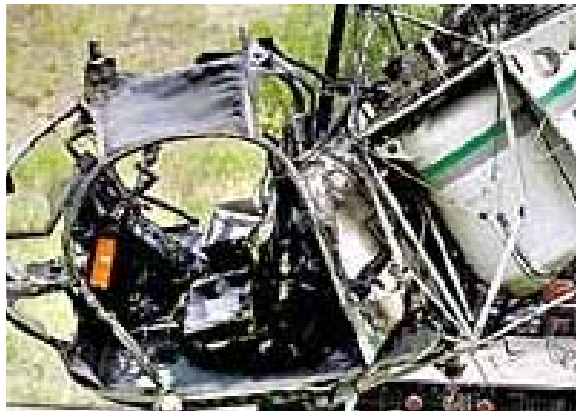
The helicopter was being operated by the U.S. Forest Service and was engaged in fire suppression activities at the Big Elk fire in the Rocky Mountain National Park. It had been refueled and had taken off to apply water along the fire boundary. Witnesses heard the pilot give a warning over the radio: "Helicopter going down." They heard a high pitched whine and saw the main rotor blades turning slowly as the helicopter descended. There was a postimpact ground fire that was quickly extinguished.

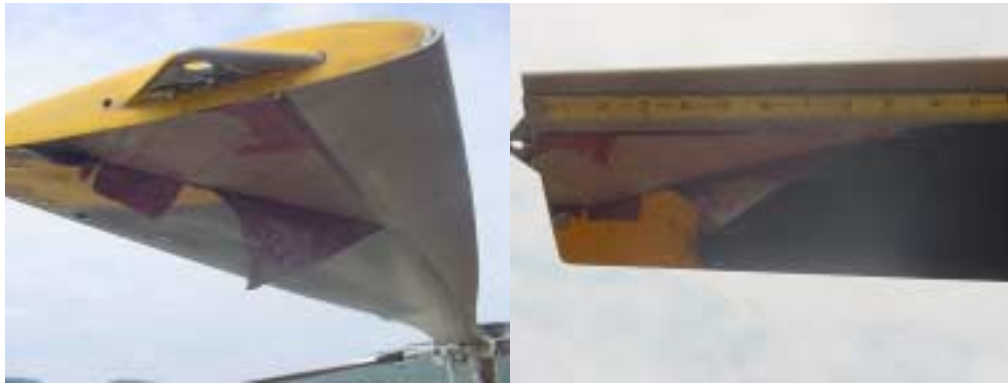
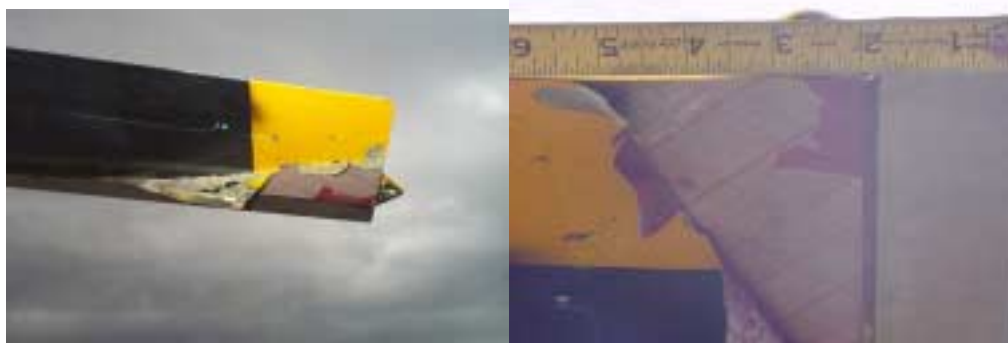
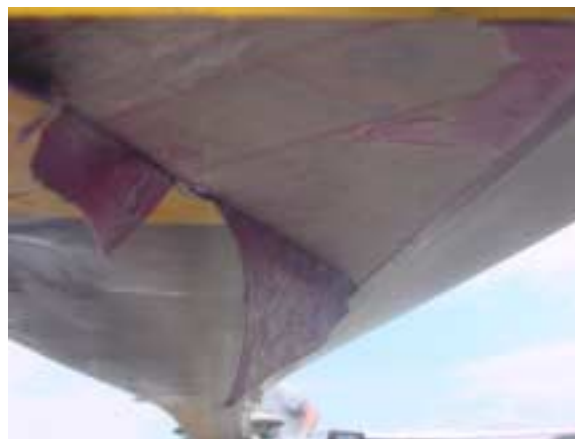
Discussion: On July 16, 2002 a Bell 407 helicopter was on short final to a helibase in Arizona when the pilot experienced a slight yaw to the left, shaking of the cyclic, and a vibration in the helicopter. The pilot chose to take the aircraft to an open flat field approximately ¼ of a mile away to avoid possible injury to personnel on the ground at the helibase. After the helicopter was shut down the aircraft was inspected and it was discovered that the skin on the underside of one of the main rotor blades had de-bonded and separated from the blade tip extending inboard approximately 8 ½ inches. The skin tore away from the blade along a line at the aft lower edge of the leading edge abrasion strip and de-bonded aft approximately four inches. The occurrence is currently under investigation to try to determine the cause of the failure.

The USDA Forest Service is asking all contractors to assure airworthiness of all Bell BHT 407 Main Rotor Blades. This assurance is required prior to further flight after receipt of this safety alert. Regional Aviation Maintenance Inspectors in the Forest Service Regions will be notified as to the status of all contracted (exclusive use or all when needed) Bell BHT 407 helicopters.

If any abnormalities are noted or suspected the aircraft is not to be flown and the operator needs to notify a Forest Service Maintenance Inspector immediately.
