ASBESTOS INVESTIGATION REPORT

**Building 235
Fort Chaffee, Arkansas 72917**

PROJECT # 07-0111-081

July 16, 2007

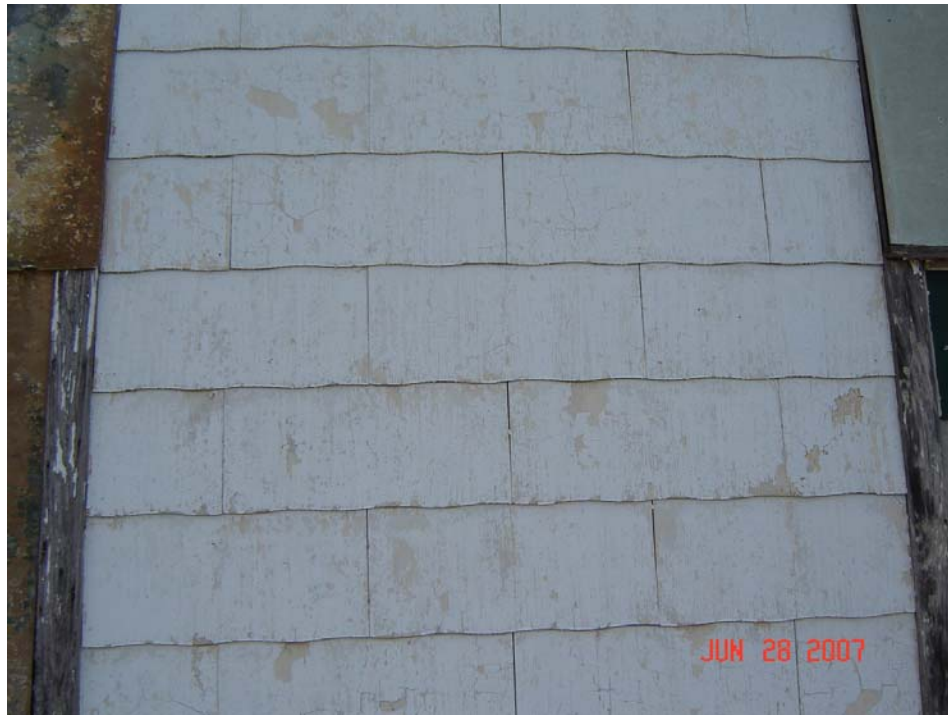
HA: LBG-1A

Material Description: Original Gray Cementitious Siding with Non-ACM Felt

Material is located on the exterior of Building 235.

The material is a non-friable, miscellaneous material and is in significantly damaged condition.

Exterior Transite Siding

EEG recommends that the ACM be removed in accordance with local, state and federal regulations. Current Arkansas Department of Environmental Quality (ADEQ) regulations require all ACM in **significantly damaged** condition be removed prior to demolition activities.

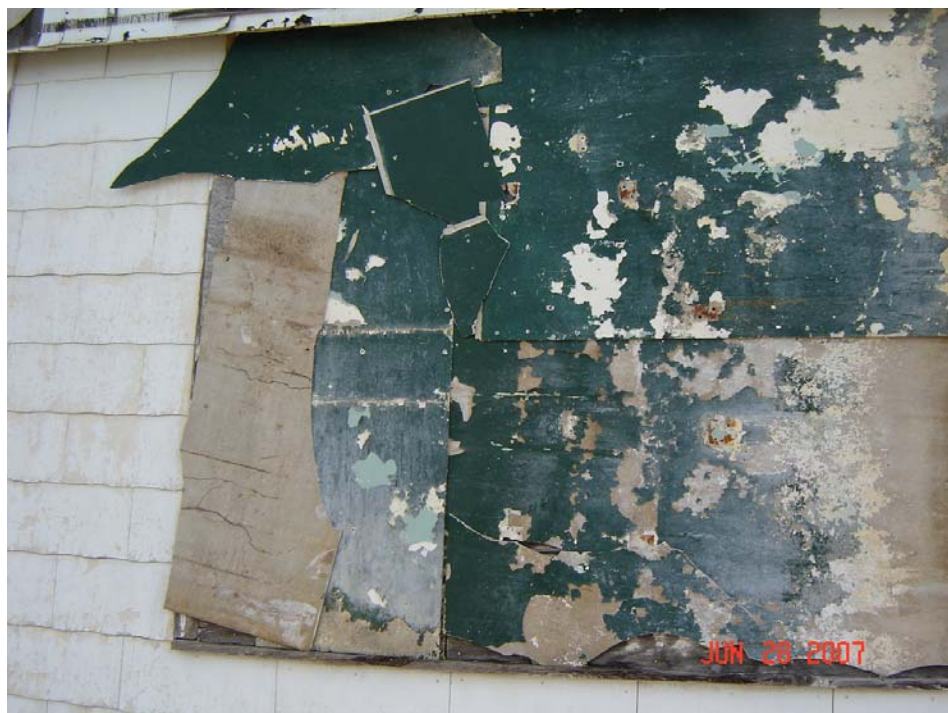
HA: LBG-2A

Material Description: Added Gray Cementitious Siding

Material is located over the exterior windows and doors of Building 235.

The material is a non-friable, miscellaneous material and is in significantly damaged condition.

Exterior Transite over Windows

EEG recommends that the ACM be removed in accordance with local, state and federal regulations. Current Arkansas Department of Environmental Quality (ADEQ) regulations require all ACM in **significantly damaged** condition be removed prior to demolition activities.

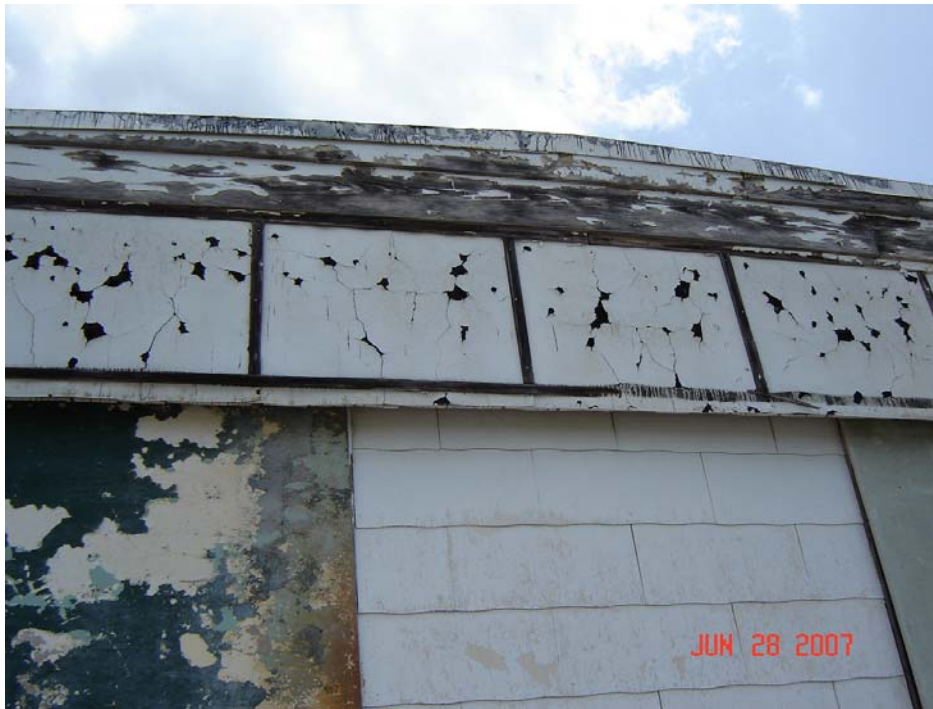
Asphalt Siding on Fascia

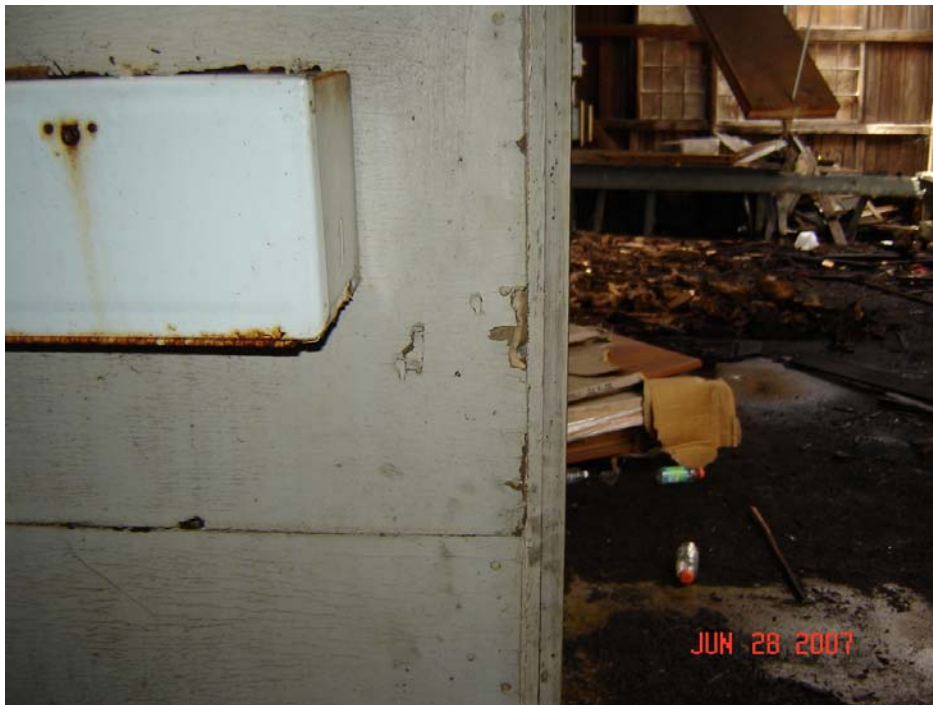
Drywall in Bathroom

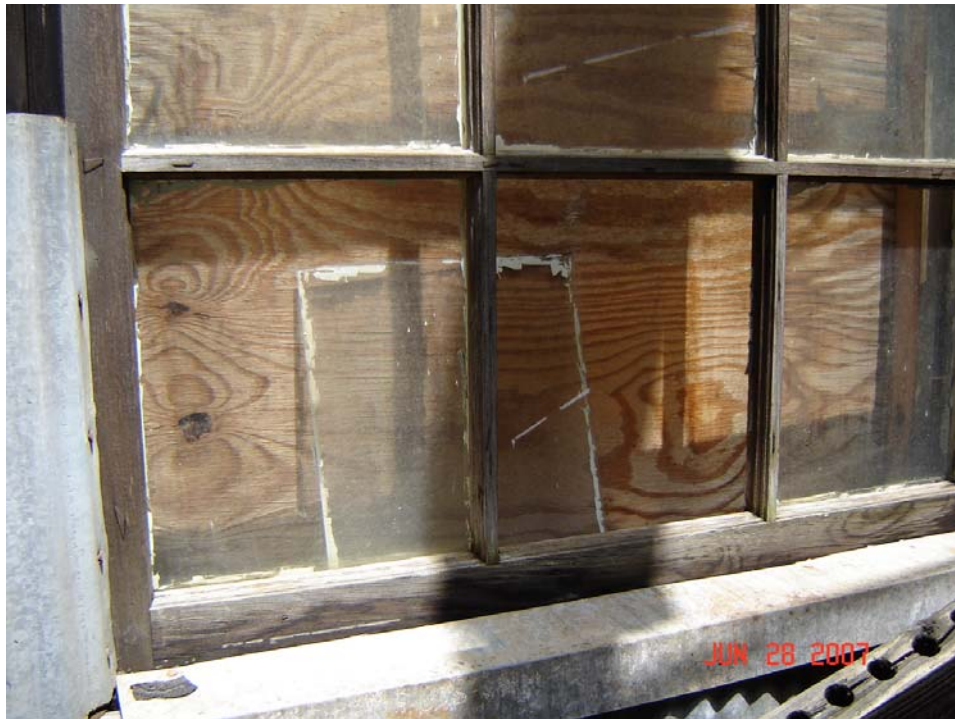
Window Glazing

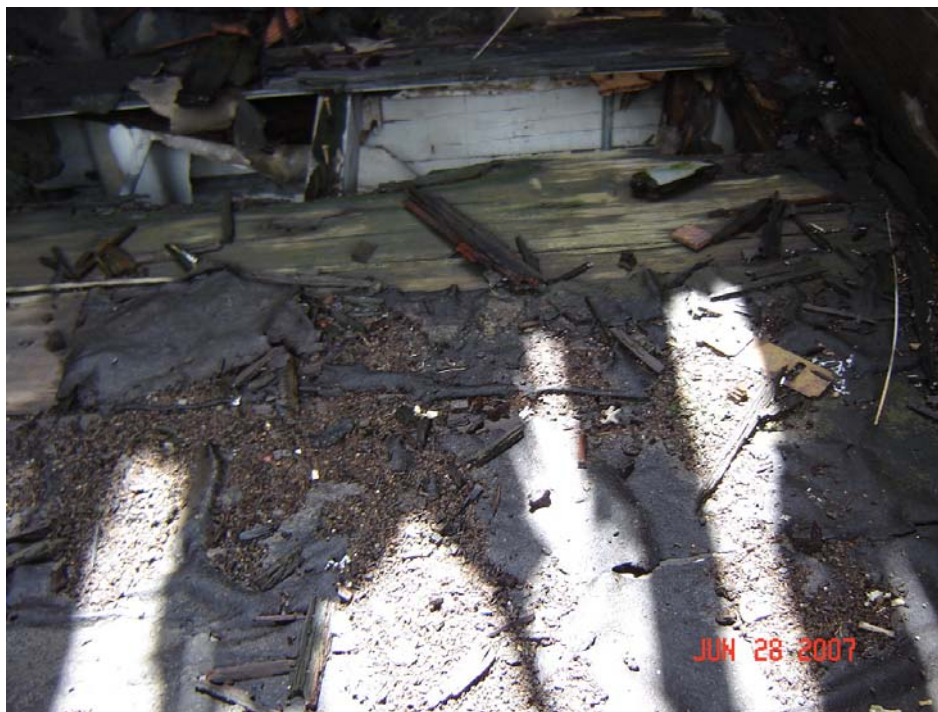
Felt Paper on Landing

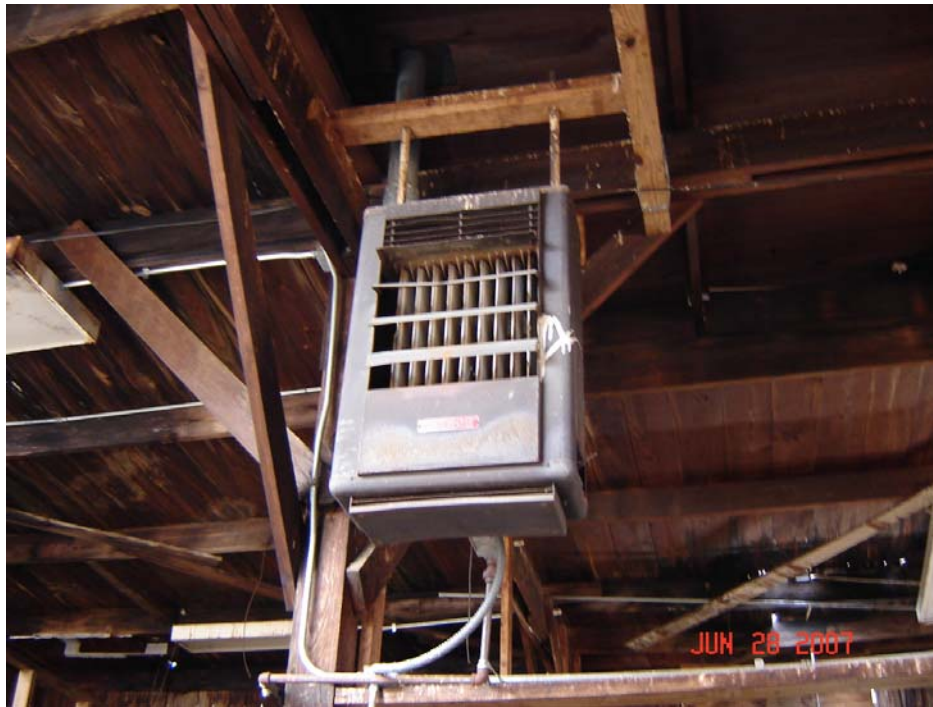
Gas Heater (No Asbestos-Containing Materials)

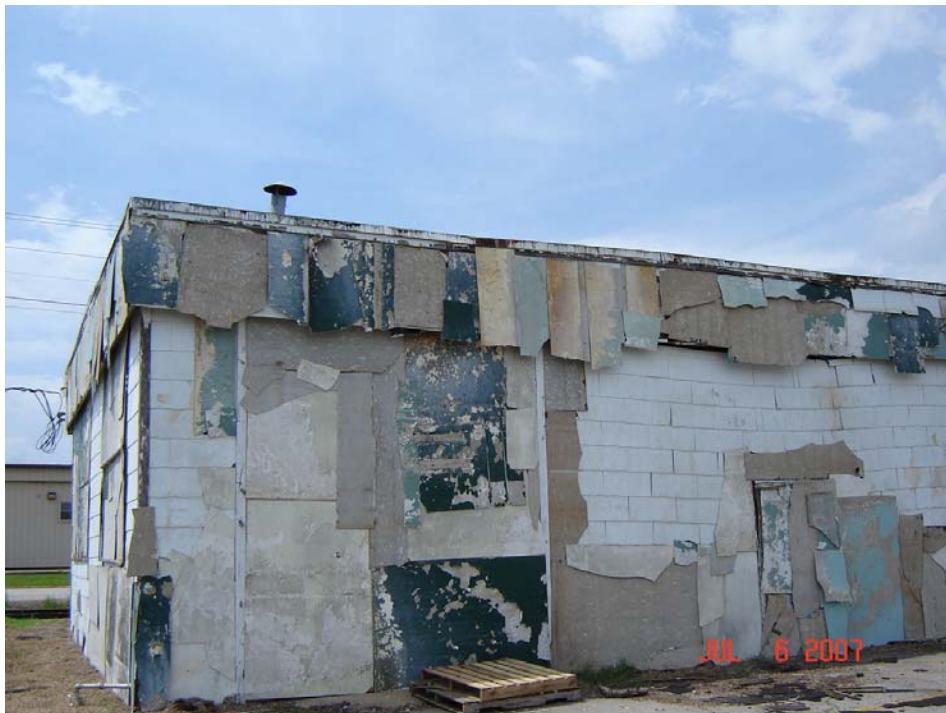
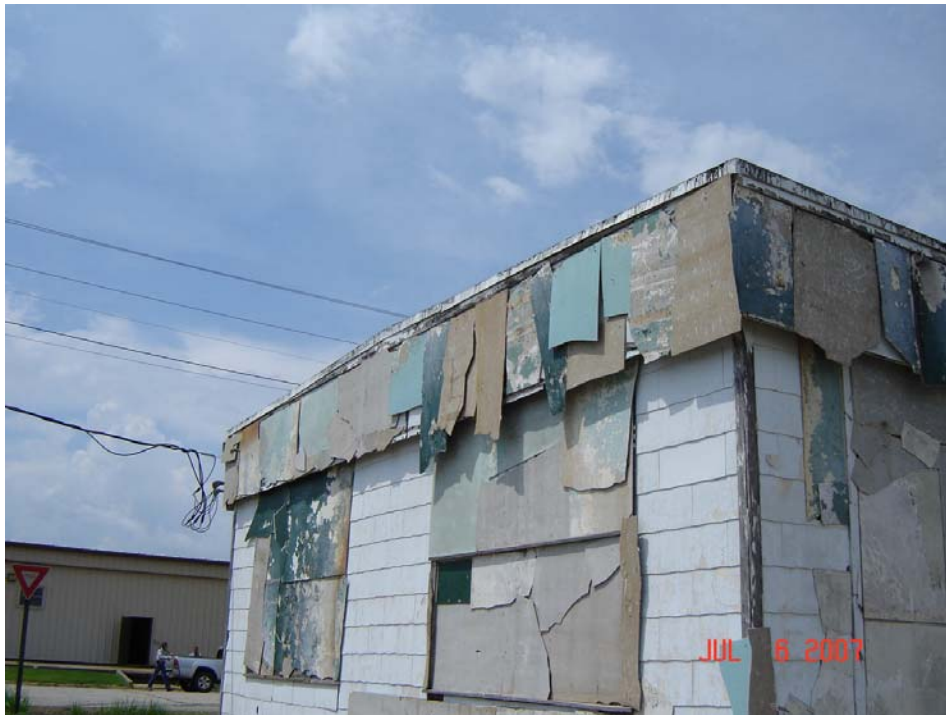
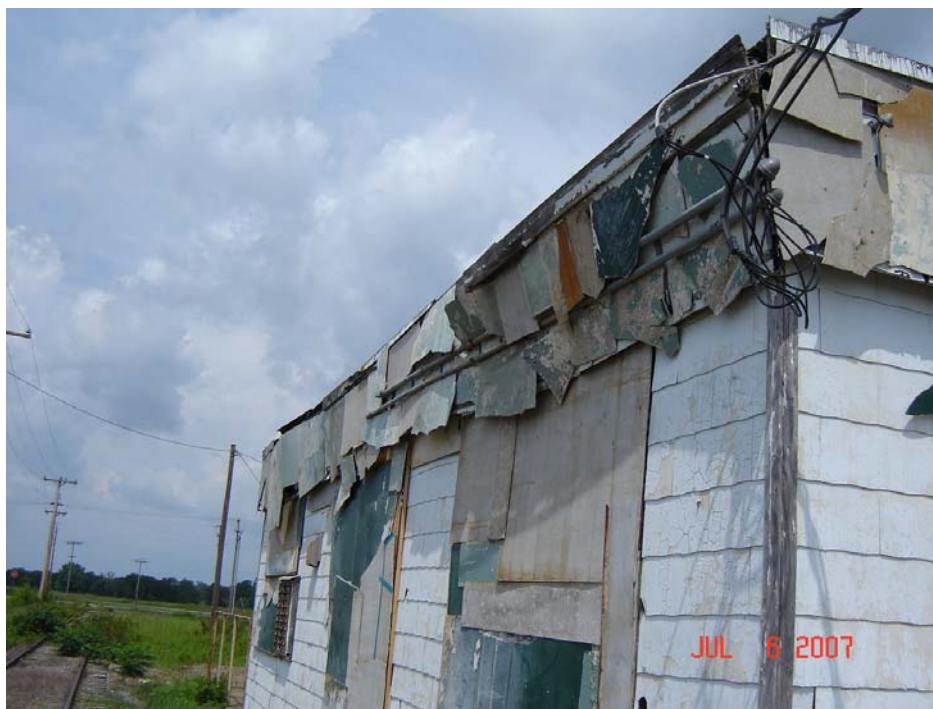
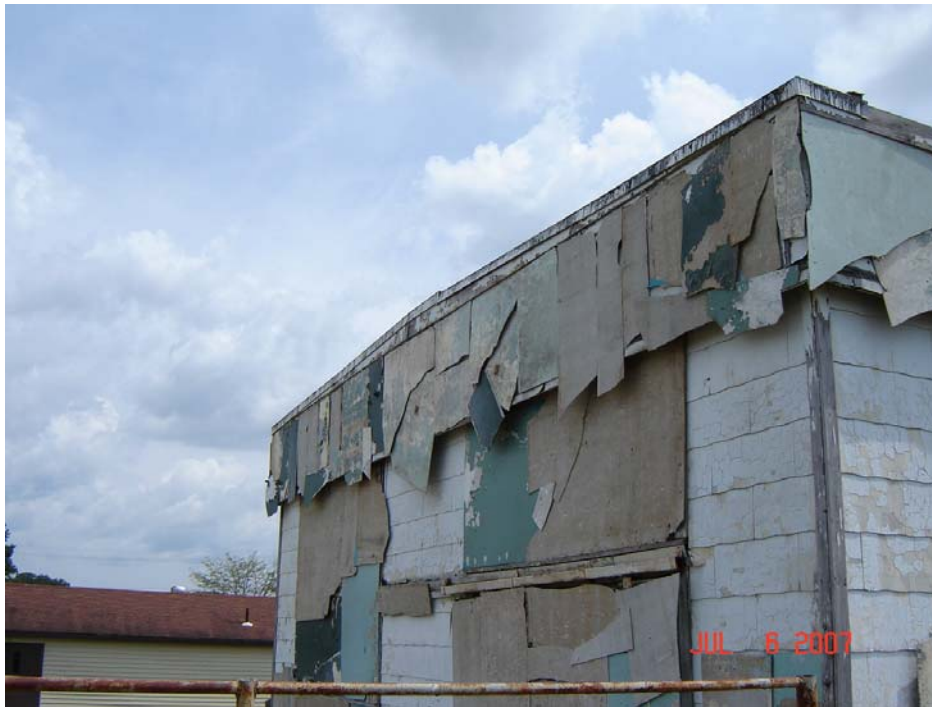
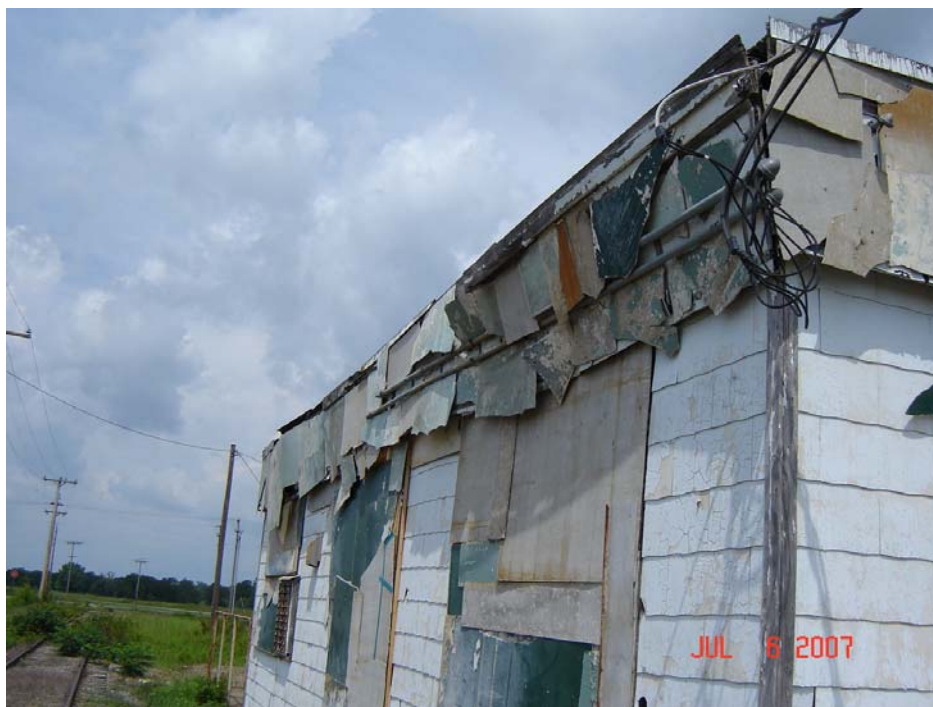
Building 235 with Additional Transite

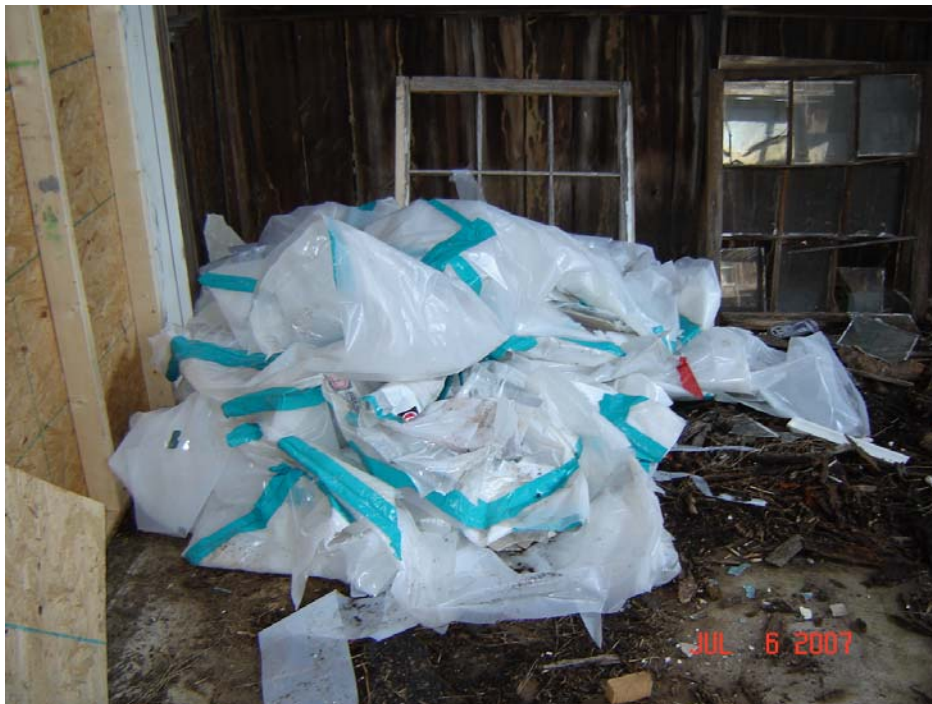
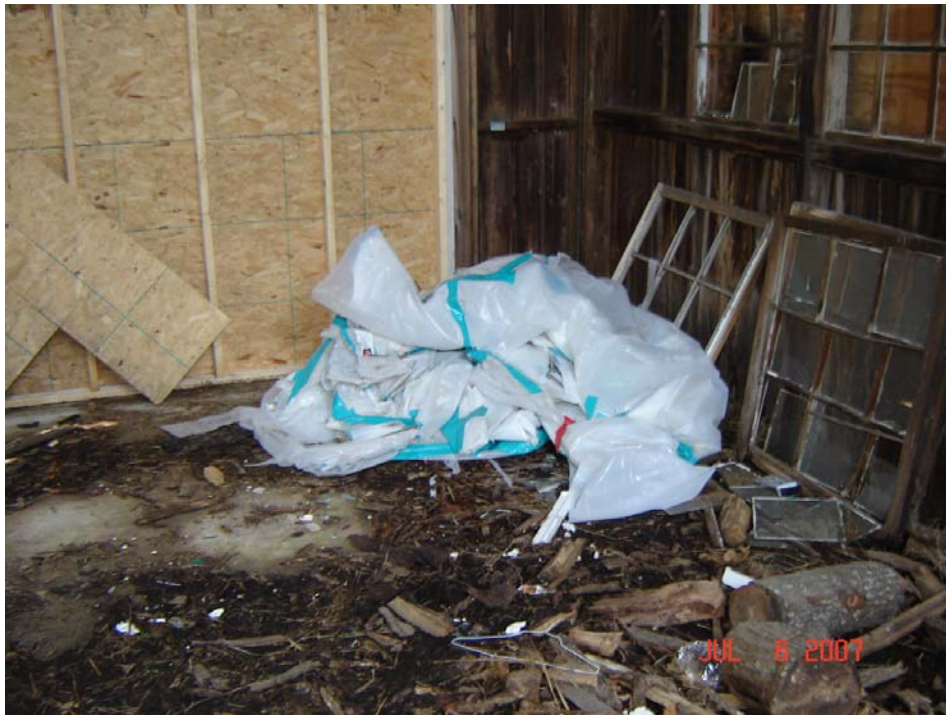
Bagged Transite Debris
