Prepared in cooperation with the **PUERTO RICO AQUEDUCT AND SEWER AUTHORITY**

COMPARISON OF STORAGE CAPACITY AND SEDIMENTATION TRENDS OF LAGO GUAYABAL, PUERTO RICO-DECEMBER 2001 AND OCTOBER 2006

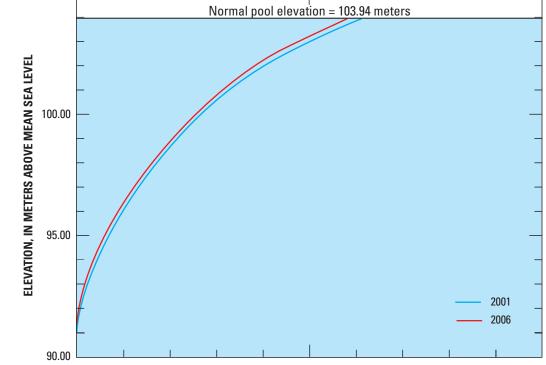
Figure 3. Relation between pool elevation and storage capacity of Lago Guayabal, Puerto

The December 2001 storage capacity of the reservoir was 6.12 million cubic meters (Soler-López, 2003), and by October 2006, the reservoir storage capacity was reduced to 5.82 million cubic meters (table 1). This represents a reduction between 2001 and 2006 of 300,000 cubic meters (or 5 percent in 5 years) for an annual storage capacity loss rate of about 60,000 cubic meters. An actualized storage capacity table and curve were generated by calculating the TIN volume at 1-meter elevation intervals (table 2,

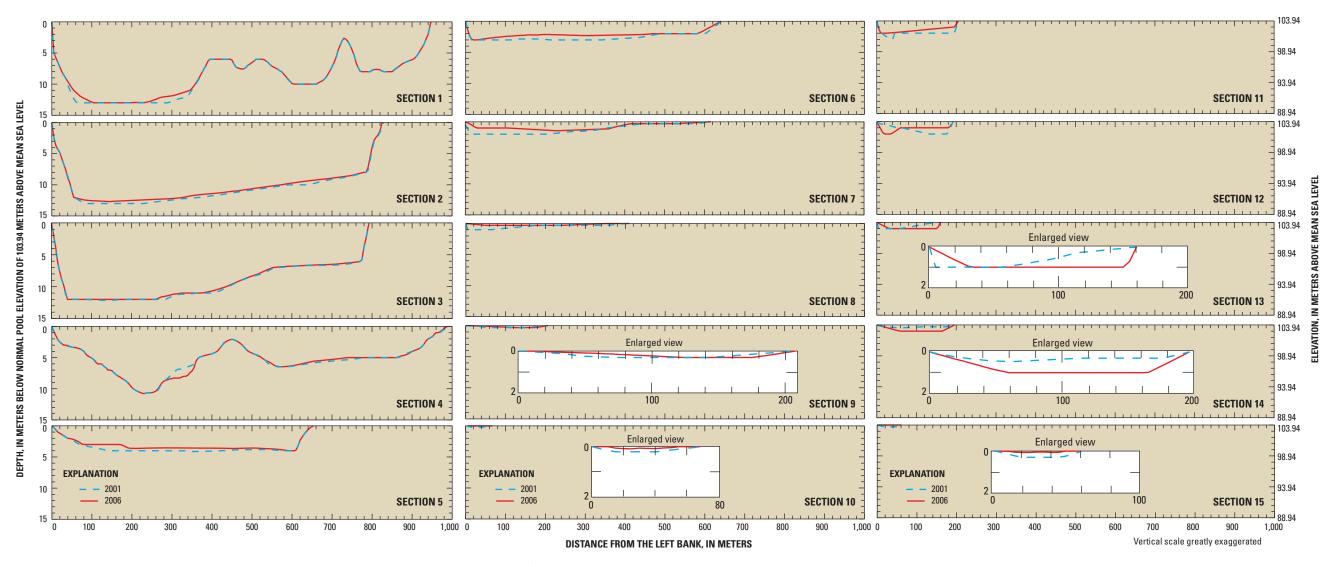
Sediment accumulation in Lago Guayabal between 2001 and 2006 has been minimal. Figure 4, which shows selected cross sections of the Lago Guayabal bottom from shore to shore, indicates that the reservoir bottom has changed little, particularly near the dam (fig. 5), where accumulation is negligible. The greatest changes, though minimal, have occurred in the reach extending from cross section 5 (fig. 2) up to the Río Jacaguas branch of Lago Guayabal (fig. 6). In this area, an average of about 1 meter of sediment has accumulated since 2001, for an average deposition rate of about 20 centimeters per

Figure 4. Selected cross sections generated from the triangulated irregular network (TIN) surface model of Lago Guayabal, Puerto Rico, for 2001 and 2006.

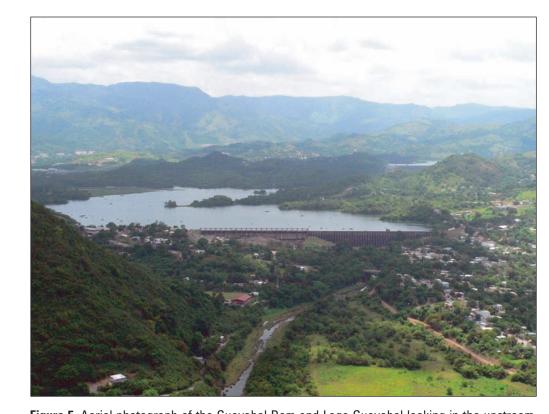
Figure 5. Aerial photograph of the Guayabal Dam and Lago Guayabal looking in the upstream direction. Photograph courtesy of the Puerto Rico Electric Power Authority, taken on May 9, 2006, during a dam-safety inspection helicopter flight.
