Report No. 10CFR21-0087
Rev. 0: 06/11/03

**10CFR21 REPORTING OF DEFECTS
AND NON-COMPLIANCE**

COMPONENT: EMD Electric Start Motors at Oyster Creek (manufactured in 1999).
P/N 10478830

SYSTEM: EMD diesel generators at Oyster Creek

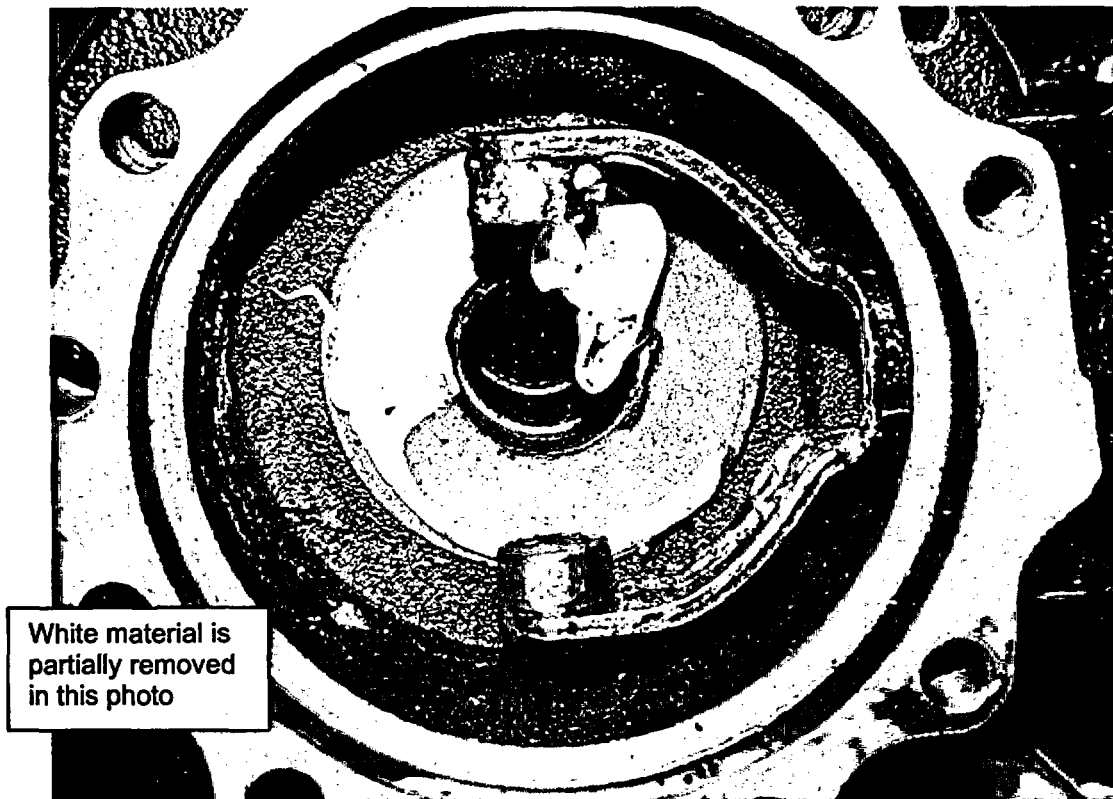
Upon removal of the Bendix assembly from the starter, a white opaque ring of material was found adhered to the lever housing. This material was in a position such that the Bendix assembly would rest against it in the de-energized state.

White material is partially removed in this photo

Internal view of lever housing, Bendix removed

Improper operation of the starter's drive assembly was caused by the presence of silicone RTV adhesive on the face of the lever housing. In this starter assembly, the brake washer was apparently adhered to the Bendix assembly using the pre-applied adhesive while RTV was applied to the lever housing and/or to the opposite face of the brake washer. The RTV surface maintained a sticky finish relative to the face of the brake washer, and this led to higher than normal required forces to separate the two. Therefore, with normal test voltage applied to the starter's solenoid, the Bendix would not engage.

After removal of the improperly applied RTV, the Bendix assembly operated properly.

1. Inspect starters with serial numbers containing "99" for a "sticking" starter drive. Two (2) starting motors are required for the engine. The solenoids of each motor are connected in series; therefore, the starter drive must engage at ½ of the minimum system voltage.
2. Starters with sticking drives should be disassembled and the RTV removed; or, returned to ESI for evaluation and repair.

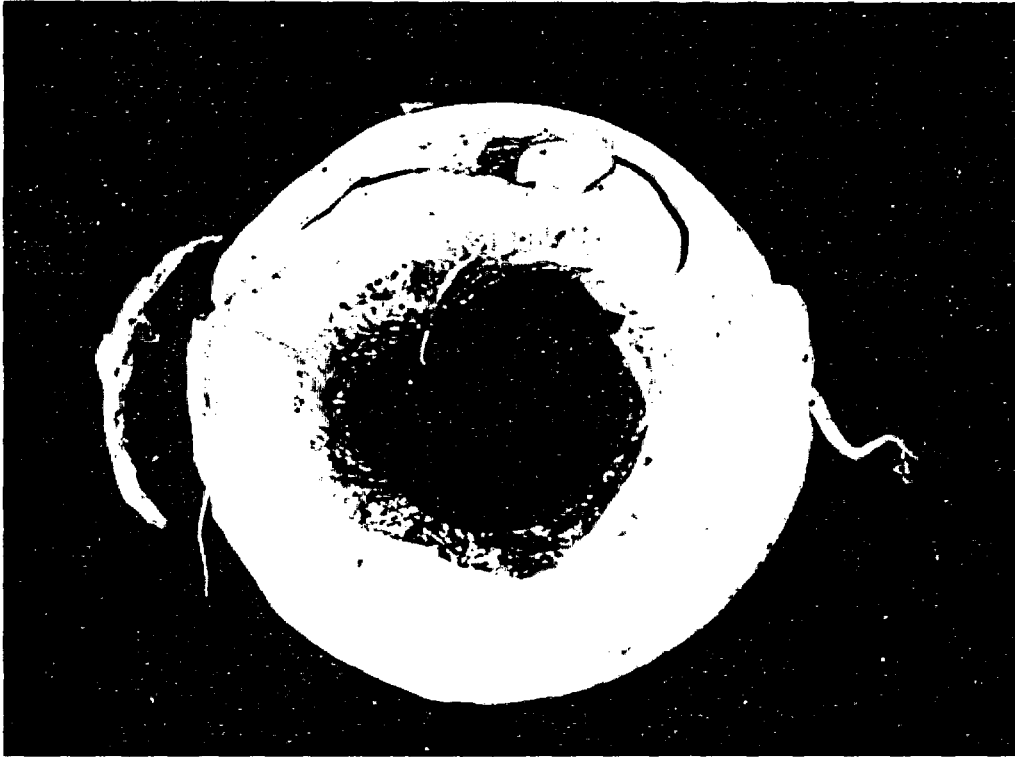
White material removed from lever housing

ESI contacted the manufacturer, Delco Remy, to discuss the findings. The representative reviewed photos of the material found and determined it was an RTV adhesive formerly used to adhere the brake washer. Delco Remy's practice is to either adhere the brake washer to the lever housing or to the Bendix assembly. In the early 1980's, RTV was used exclusively to adhere the brake washer. In 1986, their sub-supplier applied a mastic type adhesive on the brake washer. Sometimes the pre-applied adhesive did not provide sufficient bond strength, so RTV was used occasionally as a supplemental adhesive. At some point in 1999, the manufacturer stated that they had a process problem in which the brake washer was installed in the standard manner, but RTV was applied to the opposite side also. Delco Remy could not confirm the exact dates of this problem, but they estimate that it occurred only over a 2 week period. In April, 2001 a stronger adhesive was applied by the brake washer sub-supplier and the use of RTV was eliminated.

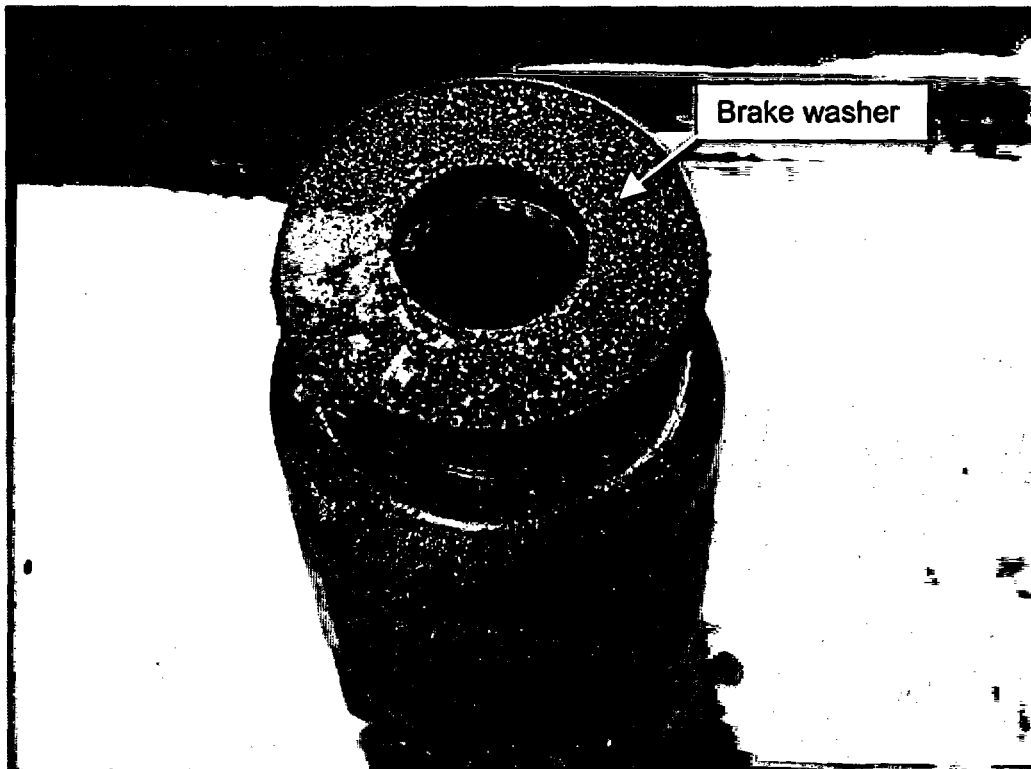
Non-drive end of Bendix assembly, brake washer surface

The function of the brake washer is to slow down the starter's armature after the engine starts and the pinion disengages. This reduces the starter's coast down time and conserves brush life.
