January 14, 2002

SUBJECT: Potential manufacturing problem with certain limit switch assemblies used in ASCO General Controls Hydramotor® Actuators.

December 21, 2001

**POTENTIAL MANUFACTURING PROBLEMS WITH
LIMIT SWITCH ASSEMBLIES USED IN ASCO GENERAL CONTROLS
HYDRAMOTOR® ACTUATORS**

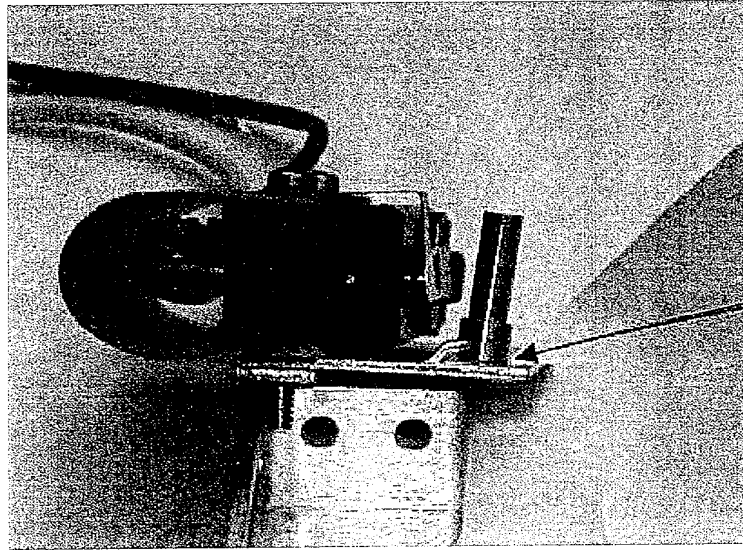
TYPICAL INSTALLATION
NH95 LIMIT SWITCH ASSEMBLY

Analysis of the returned Limit Switch Assembly (see attachment 1) revealed that the shaft on which the position sensing lever operates was not secured tightly to the plate, causing wobble of the shaft. This wobble may result in the rotation of the lever past its actuation point, which would leave the switch contacts in the normally open (N.O.) position. This condition will result in the failure of the actuator piston to retract when the Hydramotor® is powered. The shaft is staked to the plate assembly. Manufacturing instructions for this assembly defines the maximum pressure to be applied for the staking press, but no minimum value. This led to variation of the staking process, which resulted in inconsistent and incomplete attachment of the shaft to the plate. (See attachment 2). In addition to the field return, Asco has found several limit switch assemblies in our inventory with this condition.

ASCO will notify all purchasers of affected product of the potential problem. If the affected product is not in service, ASCO will offer to rework it at our factory at no charge. If the product is in service, ASCO will offer retrofit kits at no charge with complete instructions for installation of new limit switch assemblies. The method of forming this staked joint is being revised to ensure complete and consistent assembly of the shaft to the plate. In addition, the manufacturing instructions are being revised to fully define the parameters of this process as well as the testing necessary to confirm the reliability of the shaft-to-plate joining process.

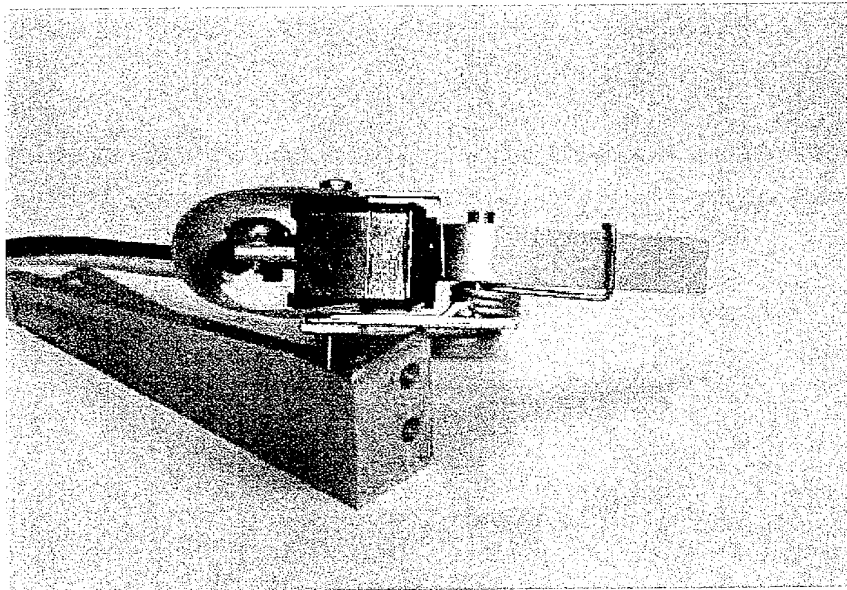
The rotation of the lever past its actuation point will result in the failure of the actuator piston to retract when the Hydramotor® is powered. We believe that in most, if not all, cases the return of the piston to the spring-extended position is considered the fail-safe condition for the Hydramotor® actuator. As such, the described failure of the Limit Switch assembly would result in the unit moving to the fail-safe condition. Depending on the nature of the application, the utility should determine what the fail-safe mode of the Hydramotor® is.

POINT OF FAILURE

VIEW SHOWING ANGULATION CONDITION OF FAILED SHAFT JOINT
