FACE 87-47: Worker Dies Inside Filtration Tank in Michigan

FACE 88-14: Labor Foreman Falls to His Death Inside Municipal Water Tank in Indiana

FACE 94-01: Hotel Grounds Maintenance Man Dies After 16-Foot Fall From Ladder--South Carolina

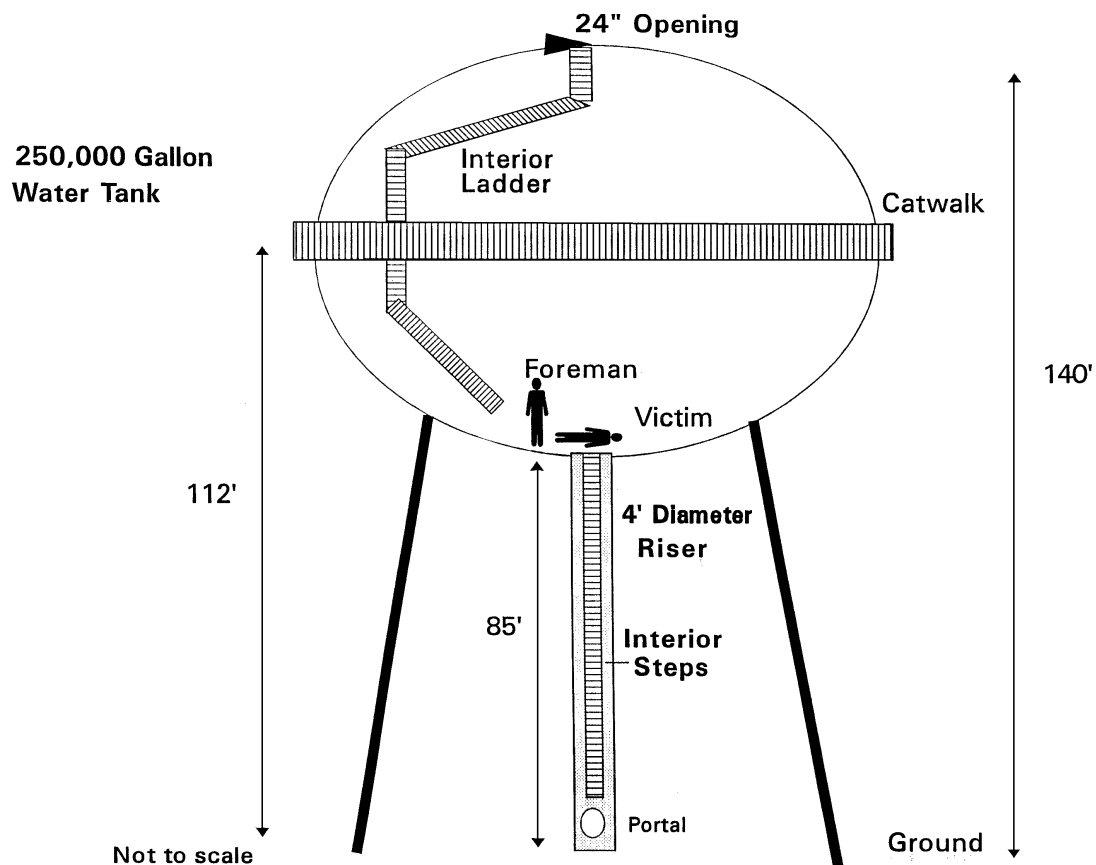
Figure.

Approximately every 30 minutes, one of the painters would climb a fixed ladder approximately 25 feet to the top of the tank to look through the 24-inch-diameter opening and check on the foreman. At approximately 3 p.m. the victim, without notifying the other workers, climbed to the top of the tank and entered. The foreman, spraying the epoxy primer, heard a noise and turned to see the victim lying on the tank floor. The foreman went to the victim and found him unconscious and breathing with some difficulty. The foreman yelled to the other workers, who entered the tank to help assist the victim. The men placed a full body harness on the victim, then placed him on the foreman's back. The foreman climbed down the fixed steps in the tank riser, assisted by the two other workers, who lowered the victim with a rope attached to the body harness. When the foreman reached the ground, he pulled the victim through the portal at the base of the riser. When the other workers reached the ground, the victim was loaded into a van. The victim was given no first aid at the site and the emergency medical service (EMS) was not summoned. The three men drove the victim to the hospital, arriving at 4:18 p.m. At 5:00 p.m., the victim was life flighted to a major trauma center where he died at 9:13 p.m.

The Material Safety Data Sheet (MSDS) for the epoxy primer warned against inhalation of the vapors, stating that inhalation of vapors would affect the brain or nervous system, causing dizziness. The MSDS also advised the epoxy primer be applied in a well-ventilated area with workers wearing airline respirators. An atmospheric testing meter was on-site; however the oxygen sensor was not functioning.

The coroner listed the cause of death as excessive pooling of blood in the brainstem. The victim had also sustained fractures of the fifth and sixth cervical vertebrae.

Recommendation #1: Employers should develop and implement a comprehensive written confined space entry program.

Discussion: The safety program should include, but not be limited to, the recognition and avoidance of fall hazards. When employees are required to work from elevations, employers should provide appropriate fall protection equipment and include appropriate worker training in the proper selection and use of fall protection equipment.

Employers should ensure that Material Safety Data Sheets (MSDS) are available for all chemicals, paints, solvents and other substances that are used, and that supervisors and workers are aware of their potential hazards and appropriate protective measures. It is unclear whether the workers were familiar with the hazards associated with the epoxy primer that was being sprayed inside the tank.
