FACE 86-10: 33 Year-Old Apprentice Substation Electrician Fatally Injured

FACE 88-46: Female Receiving Clerk Dies in Fall in Warehouse

FACE 89-45: Welder Dies in Fall from Fork Lift

FACE 90-35: Electrical Lineman Dies After Falling 35 Feet to the Ground from a Burning Aerial Bucket in South Carolina

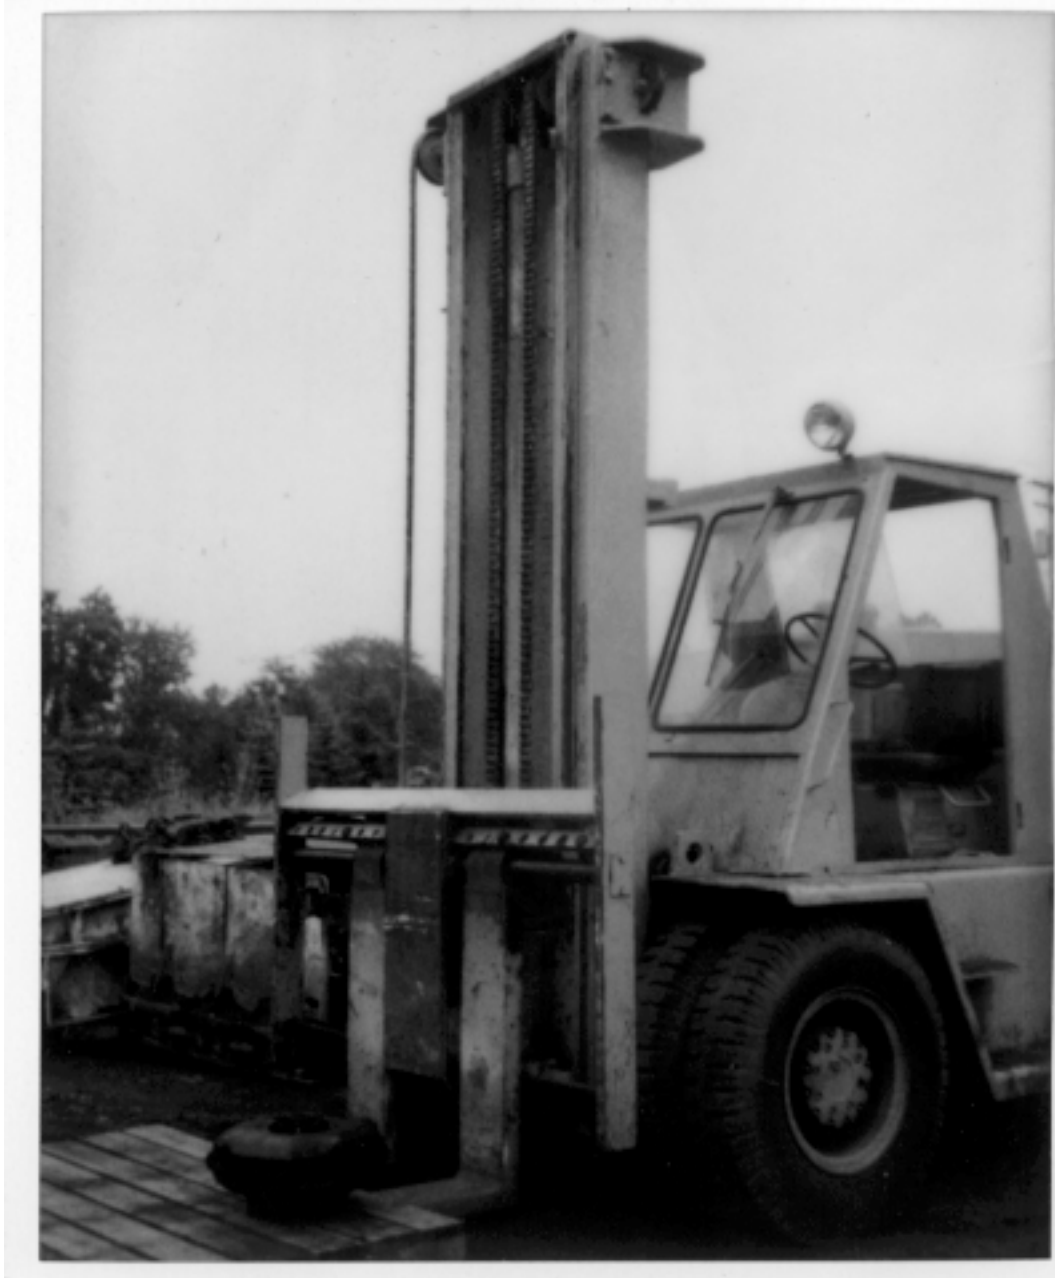
The victim noticed that a wear guard strip, attached to the side of the telescoping channel on the mast, had come loose and was binding against the guide roller. This caused the top of the fork carriage to jam

approximately 8 feet from the ground. The victim, carrying a cutting torch, climbed up the carriage and stood on an angled, 6-inch-wide steel support to cut out a section of the wear guard strip as the co-worker observed. The victim then used a pry bar to move the wear guard strip away from the guide roller. As the strip dislodged from the roller guide, the carriage dropped approximately 1 foot.

Figure. Fork Truck Components: 1) fork carriage (assembly to which the forks or other attachments are mounted, and 2) mast (steel upright assembly consisting of hydraulic cylinders, inner channels, telescoping outer channels, chains, and guide rollers).

Recommendation #1: Employers should review, revise where applicable, and enforce current safety programs.

Discussion: Although the company has a written safety program, including maintenance procedures for fork trucks, the procedure was not followed. If the victim and co-worker had informed the jobsite foreman of the fork lift problem, according to procedure, the truck could have been moved to the maintenance shop and repaired according to company maintenance procedures, thereby avoiding the incident. Employers should review, revise where applicable, and enforce the current safety program. The program should be clear and should emphasize the importance of following established operating procedures.

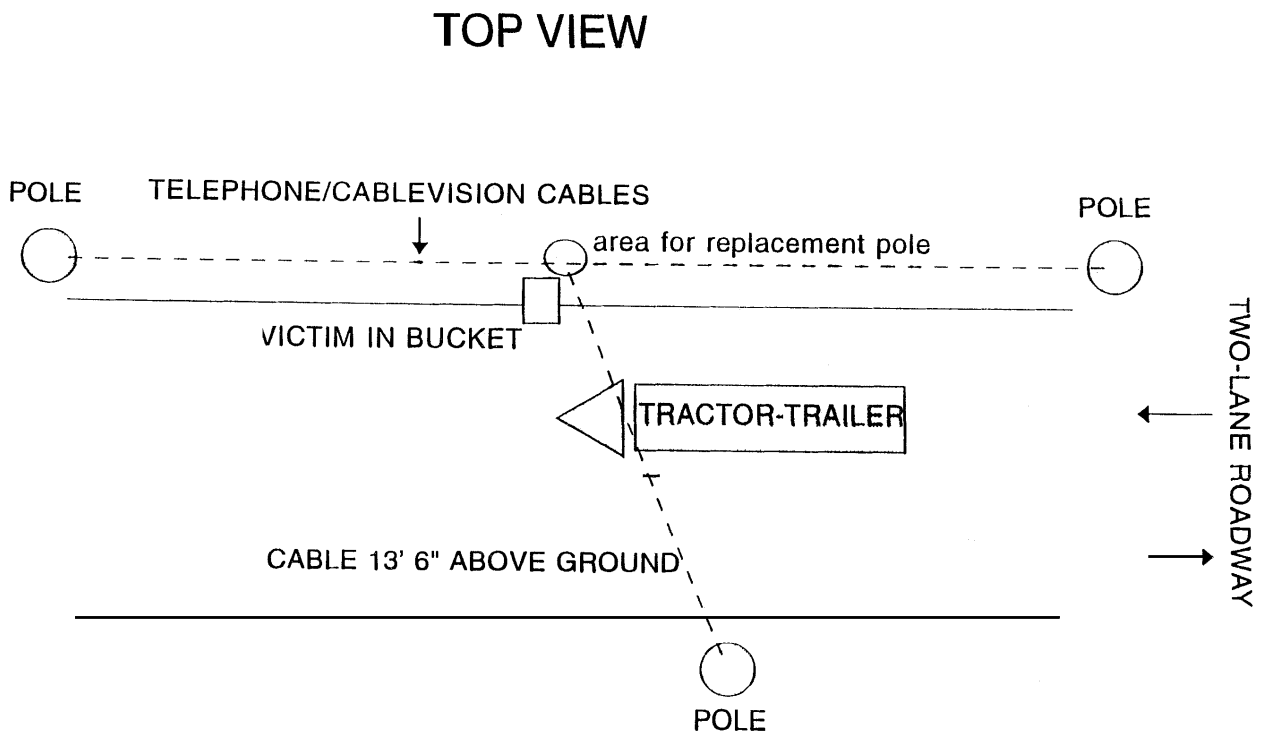
The victim and four crew members had been assigned to replace a cracked wooden utility pole located alongside a two-lane roadway. The top of the pole was about 20 feet above ground. The pole supported two sets of telephone and television cables which were strung 16 feet above the roadway. One set of cables ran parallel with the roadway; the other set ran across the roadway to a pole on the opposite side (Figure).

After the task was completed, the cables running across the roadway were supported, in absence of the cracked pole, by the telephone and television cables which ran parallel to the road. The victim instructed the two crew members directing traffic to cease their work and help with setting the new pole. The victim stated he was going to use the bucket truck to check the height of the cables running across the roadway. Without donning the fall protection equipment provided on the truck (safety belt and lanyard which secured to an anchor point in the inside of the bucket), he entered the bucket and raised it about 16 feet from ground level to a position adjacent to where the cables running across the roadway intersected the cables running parallel with the roadway. As the victim was occupied judging the height of the cables, a tractor-trailer attempted to drive under the outstretched cables. The top of the trailer caught the cables, which were about 13 feet 6 inches above ground at that point, and pushed them toward the victim. The cable contacted the victim's abdomen and knocked him out of the bucket, causing him to fall to the concrete roadway below. The local emergency medical squad (EMS) responded 5 minutes after notification by a paramedic who had witnessed the incident and provided first aid to the victim. The victim was transported by the EMS to a local hospital. He was later transported to a trauma center, where he died the following day.

Recommendation #1: Employers should ensure that appropriate fall protection equipment is available and correctly used when working from elevations where there is danger of falling.

Discussion: The company had provided appropriate fall protection equipment on the aerial truck, a safety belt and lanyard to be secured to an anchor point inside the bucket. However, the victim was not wearing the safety equipment while inside the bucket as required by the Code of Federal Regulations 1926.556(b)(2)(v), which states "A body belt shall be worn and a lanyard attached to the boom or basket when working from the an aerial lift." Employers should ensure that workers follow established procedures for wearing fall protection equipment. Use of fall protection equipment may not have prevented the victim from being thrown out of the bucket, but it could have prevented his falling to the concrete roadway.
